## MEMORANDUM

SUBJECT: Overlap Analysis

74-15617

Pond Spring, Project #364482

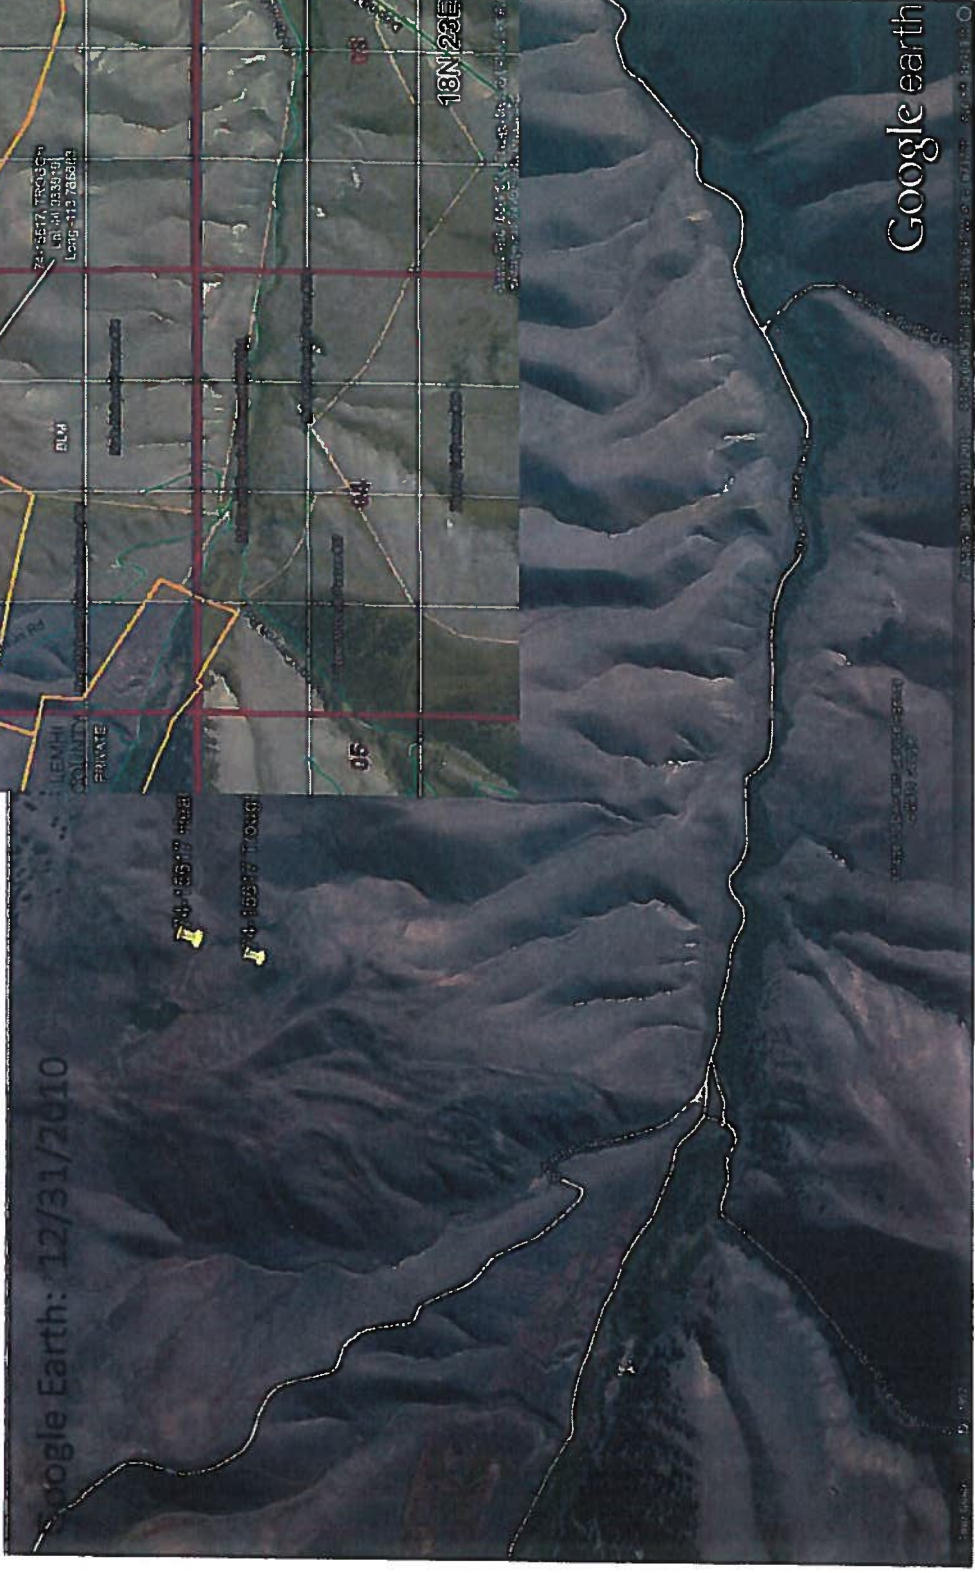
POD -Spring Headbox (same spring as 74-11948)  
T19N, R23E, S33, NESWNE  
Decimal Degrees: 44.935144, -113.736343  
Deg-Min-Sec: 44° 56' 6.5184"N, 113° 44' 10.8348"W

POU -Trough  
T19N, R23E, S33, SWNE  
Decimal Degrees: 44.933919, -113.736883  
Deg-Min-Sec: 44° 56' 2.1084"N, 113° 44' 12.7788"W

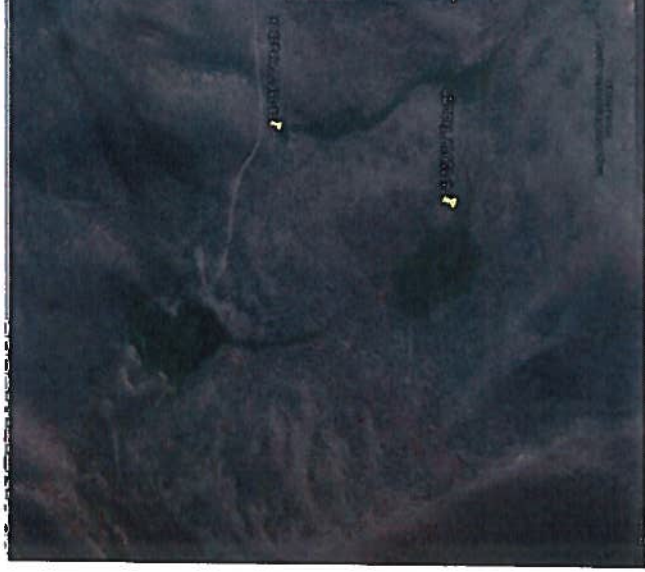
74-15617  
Pond Spring, Project #364482  
(aka McDevitt Pond Spring)  
-T19N, R23E, S33, SWNE

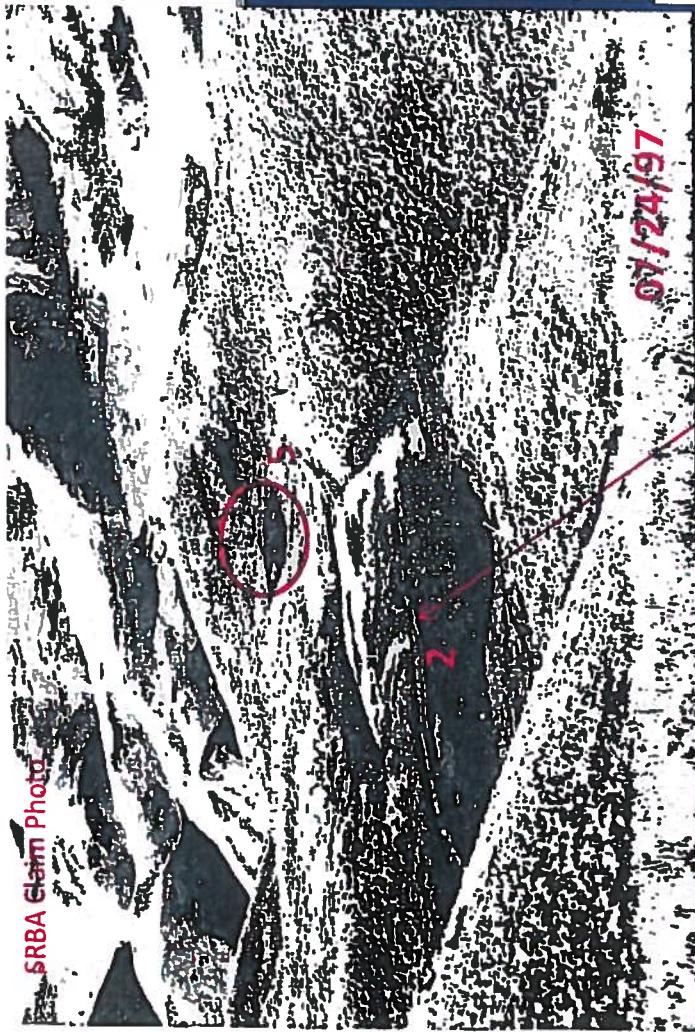
Dot #2

IDWR No: A74-11944

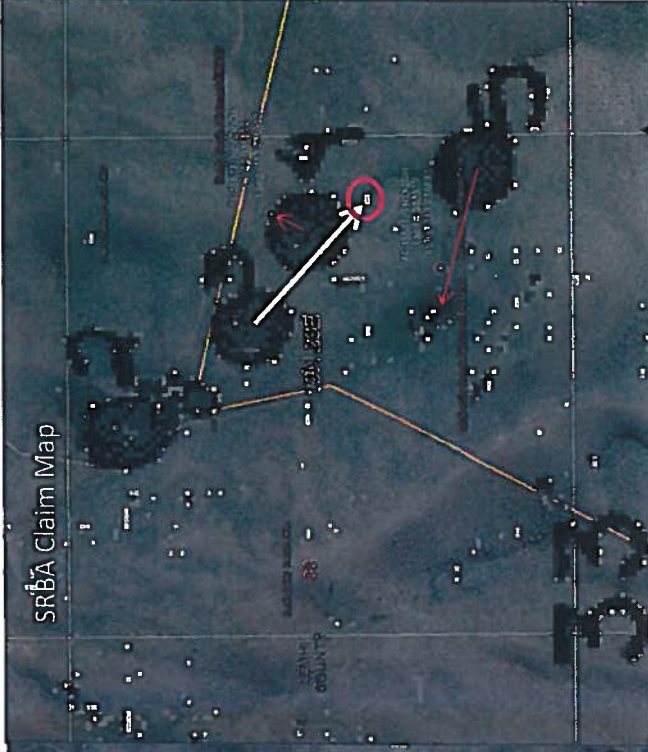
IDWR No: A74-11946 Dot #3

Site Description Site is a spring  
just below a tree road & fence.  
Spring appears to have been dug out  
with machinery, but no headbox

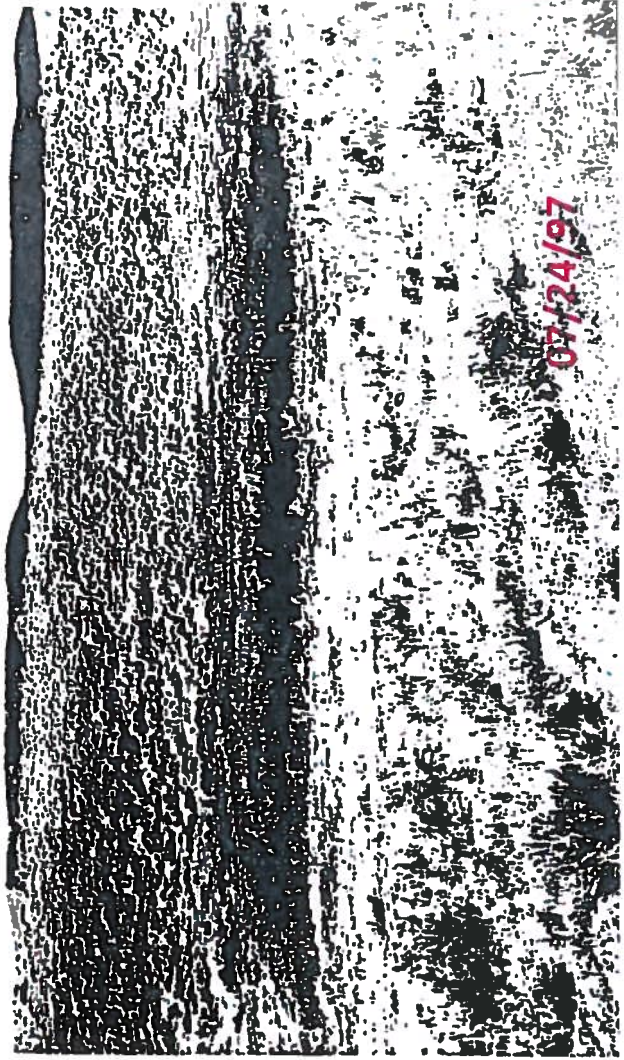
IDWR No: A74-11950

Site Description Site consists of a

small pond in a natural basin.

The trough for 74-15617 is located at the pond which is covered by 74-11950.
