STATE OF IDAHO  
DEPARTMENT OF WATER RESOURCES  
IN-OFFICE REVIEW/BENEFICIAL USE FIELD REPORT

**A. GENERAL INFORMATION**Permit No: 75-7621

Exam Date: 06/22/12

Locally known as Tormey Pipeline

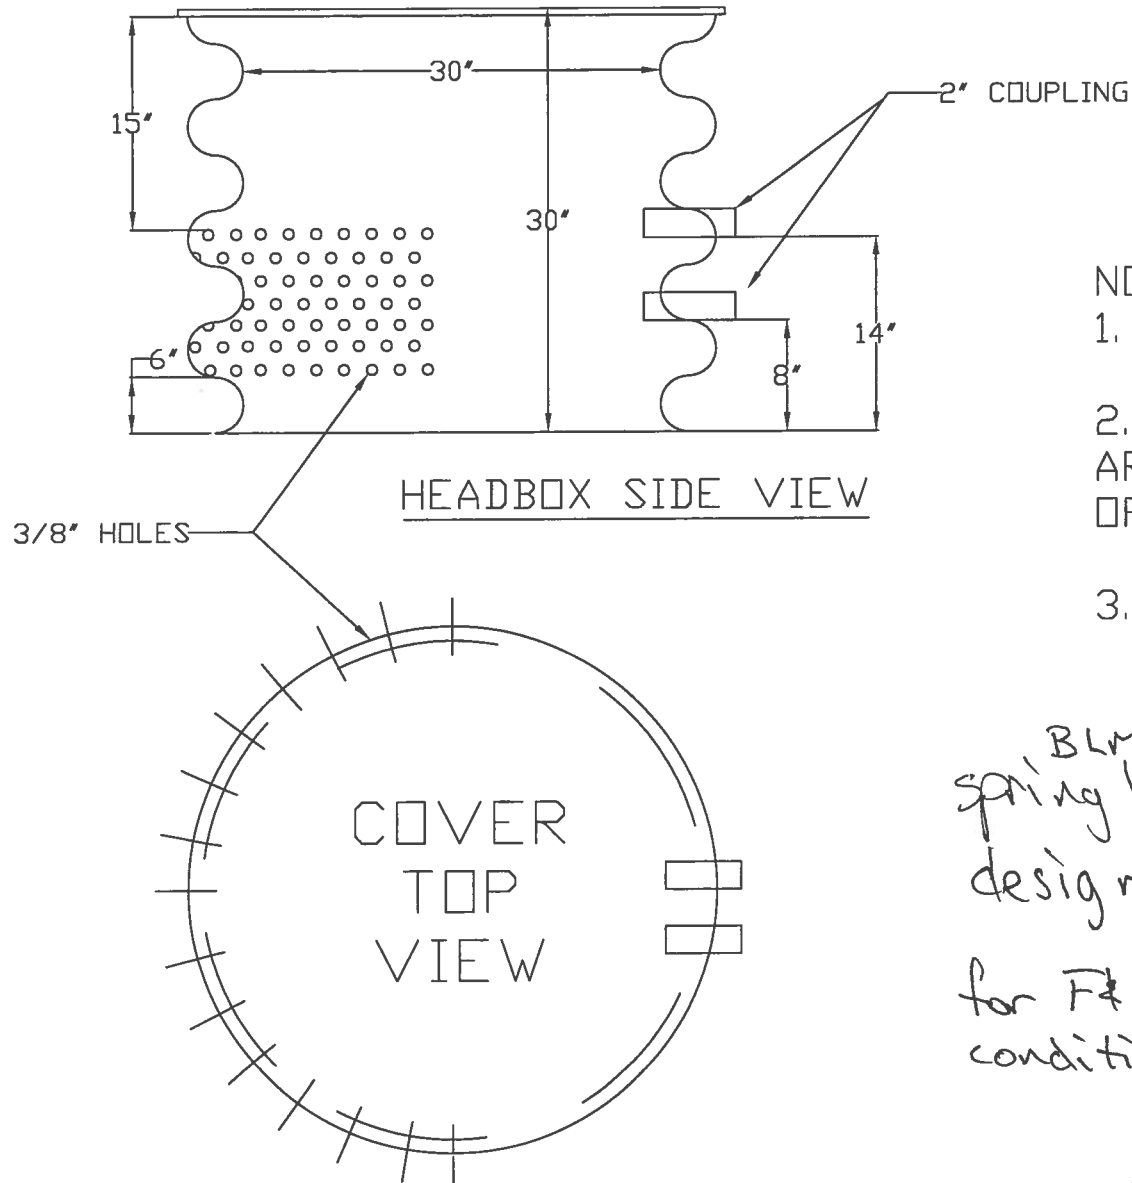
# SPRING HEADBOX & COVER DIAGRAM

NOTE:

1. 12 GAUGE ALUMINUM

2. HOLES EXTEND HALFWAY  
AROUND CYLINDER CENTERED  
OPPOSITE GALV COUPLINGS

3. 1" LIP DOWN ON COVER

BLM  
spring box  
design  
for F&G  
condition

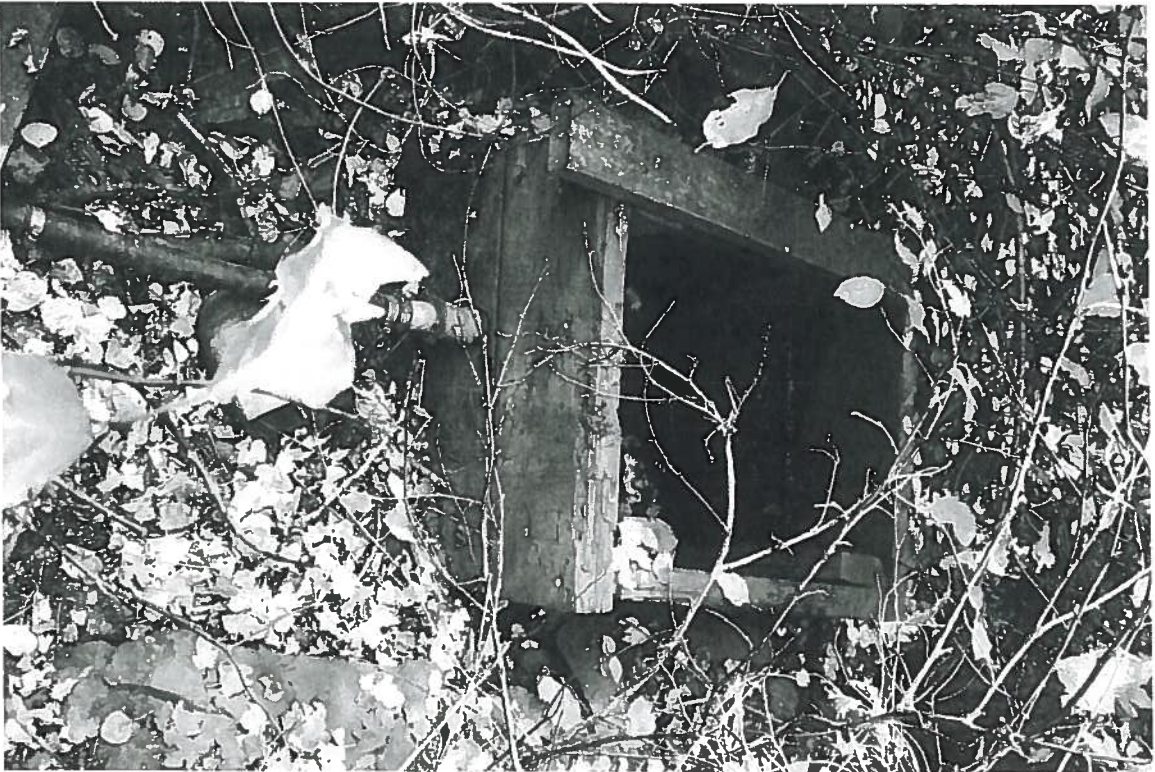
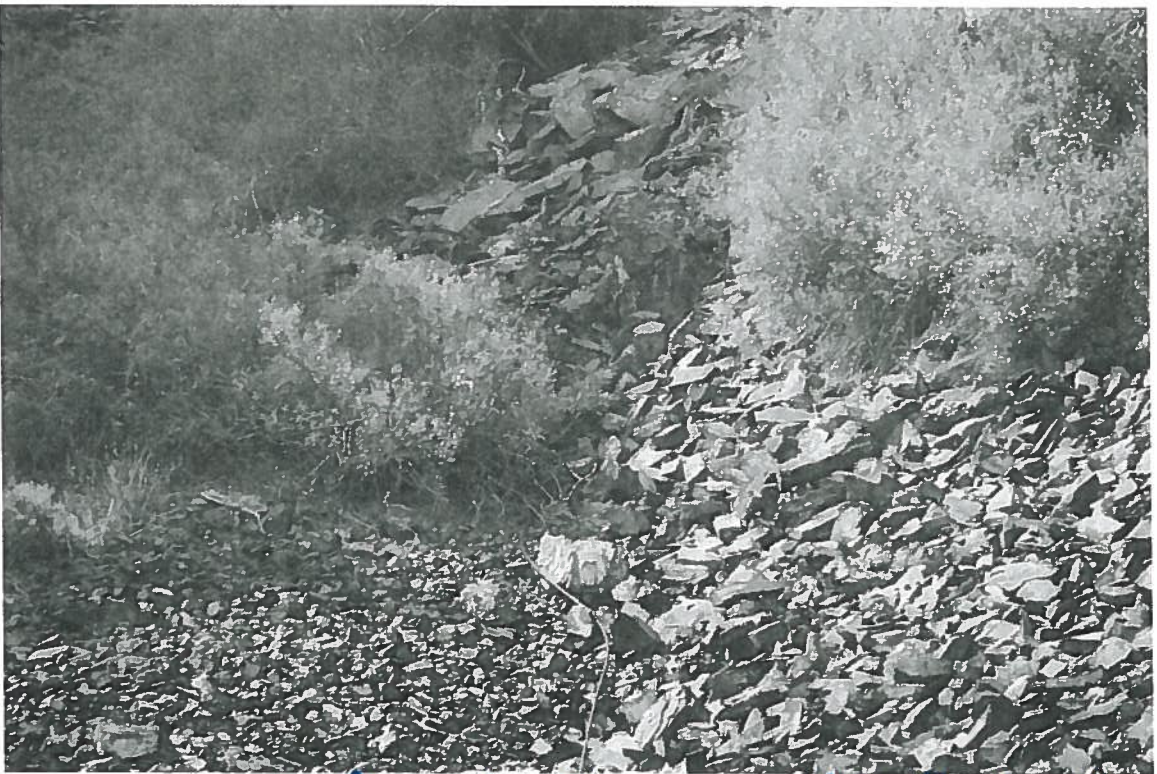
Townley Head box  
in Section 24.

PL from Headbox on National Forest

75-7621 The trough in section 35 is connected to the head box found in section 34. The troughs shown in the photo are empty due to season of use.

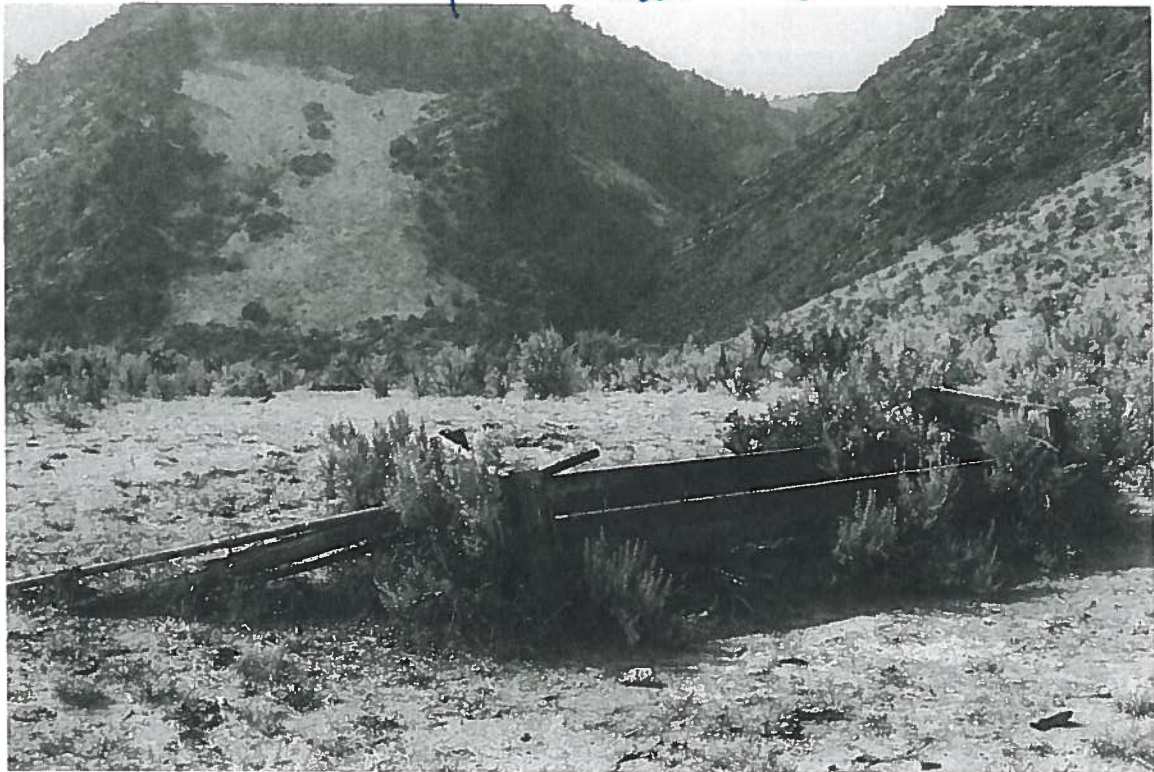
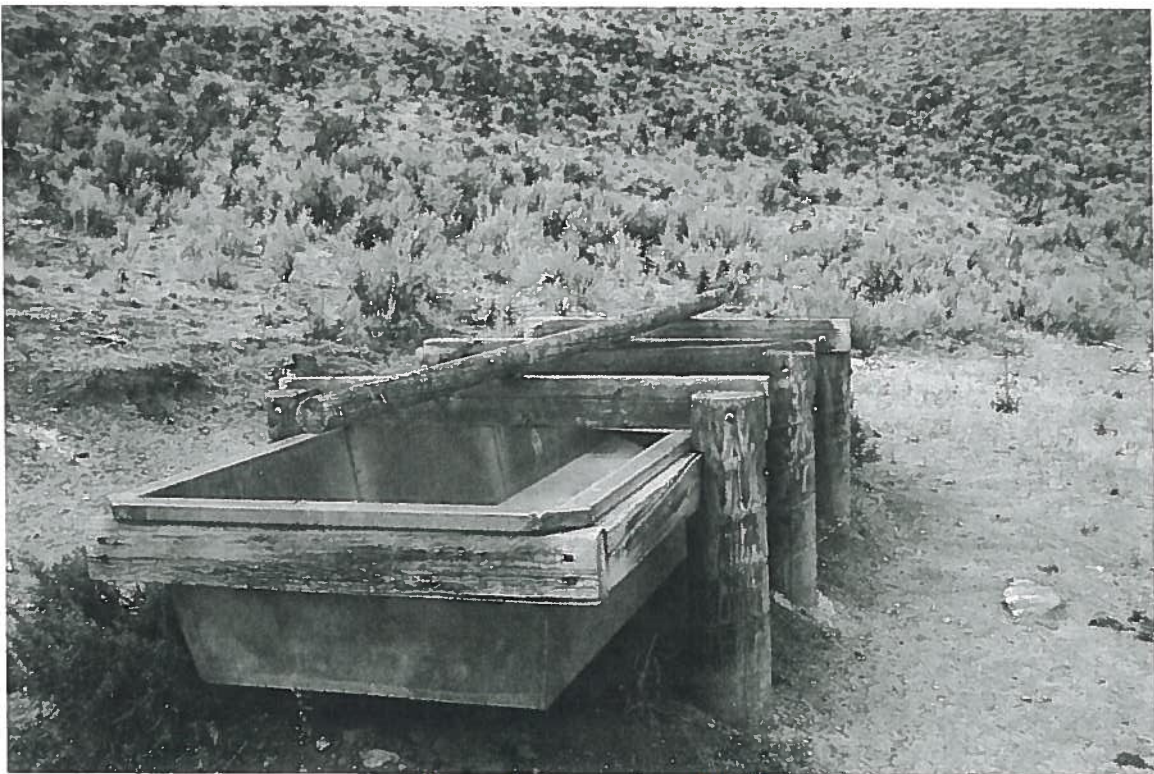
75-7621  
Tomlay 1st Trough in  
Section 35

2nd trough on line -  
Empty due to "Season of use"

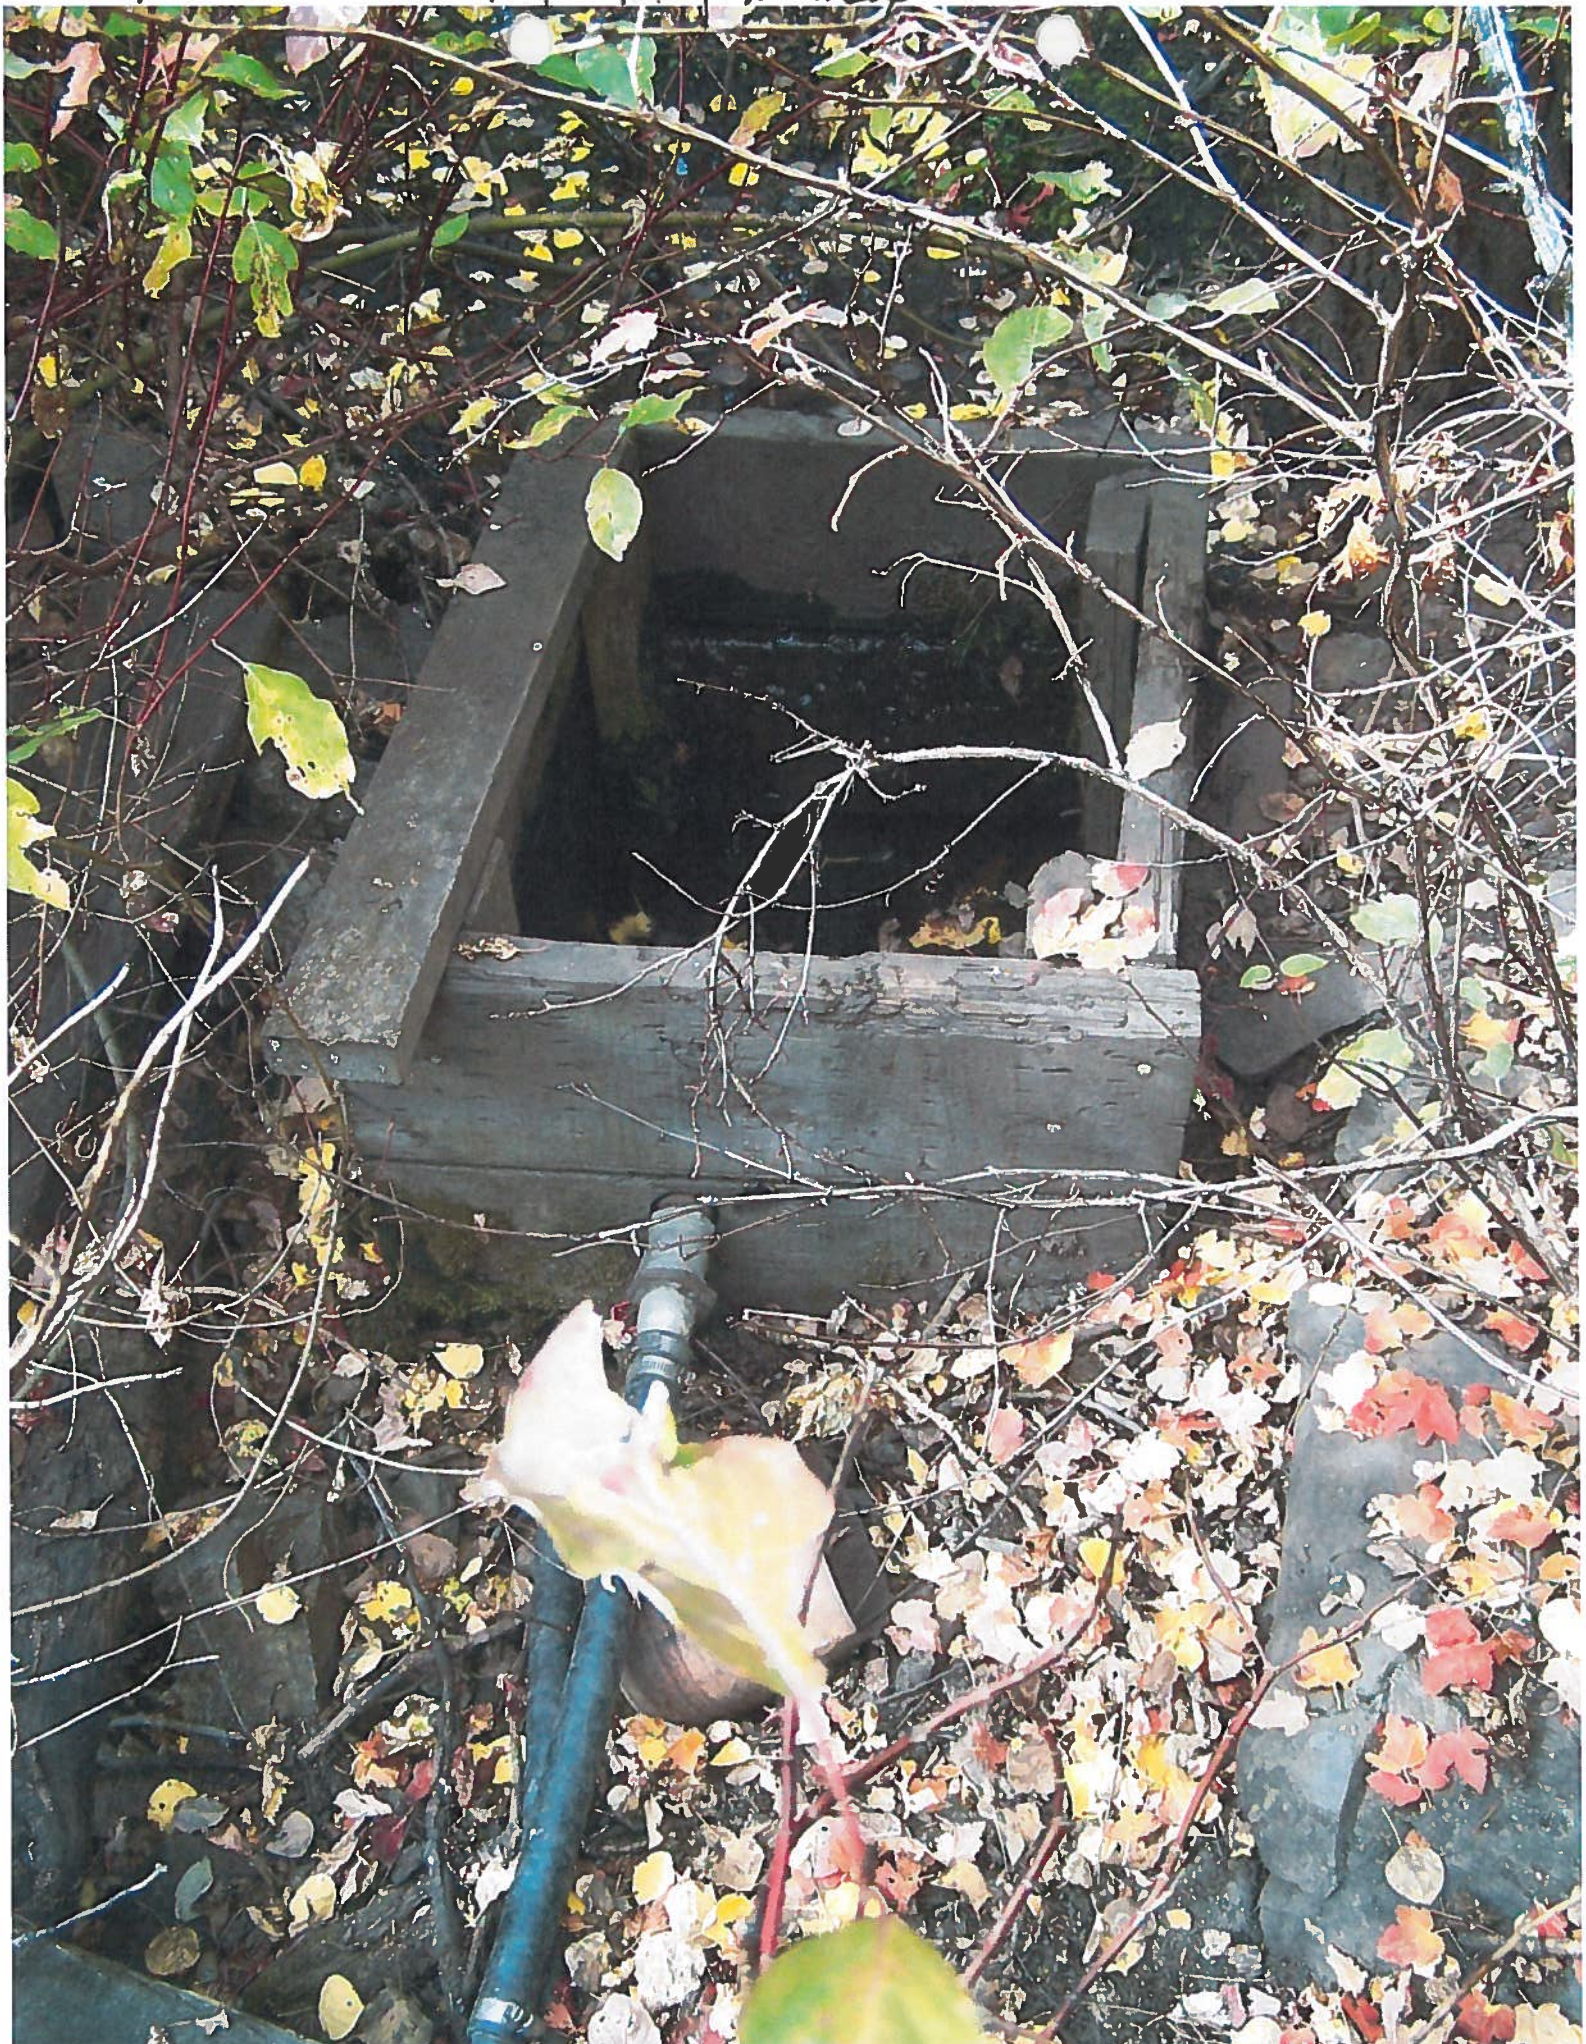
15-01021 100m air spring head box

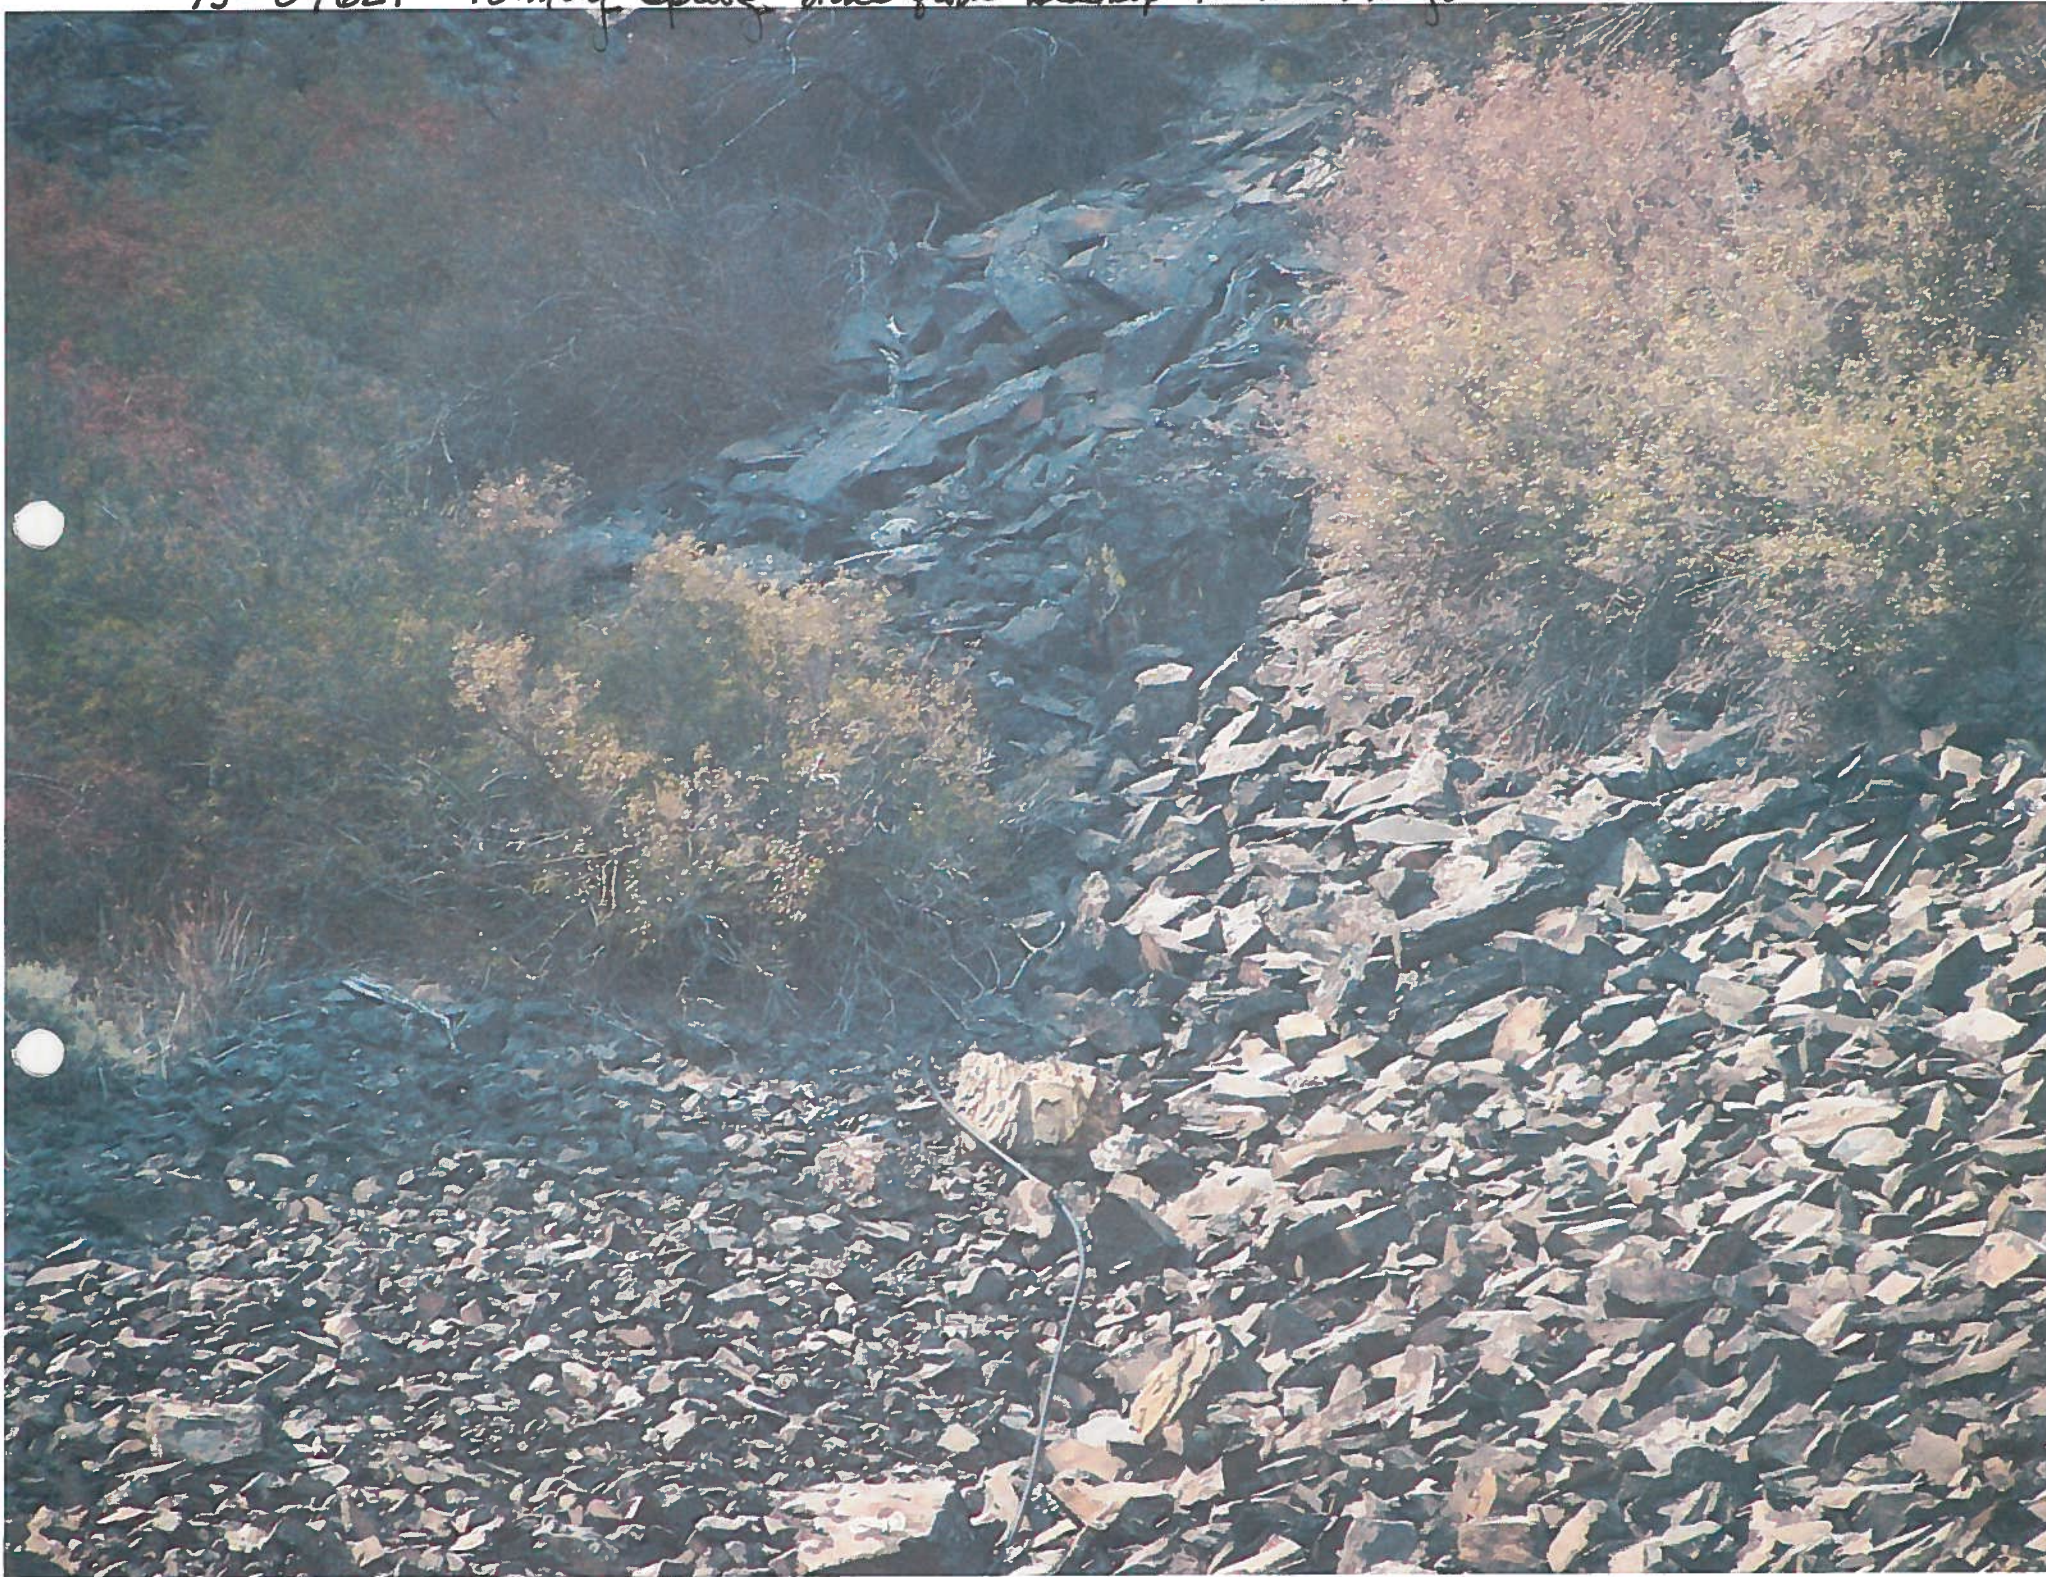
15 - 01021 10m by spring, none from 10m by 10m

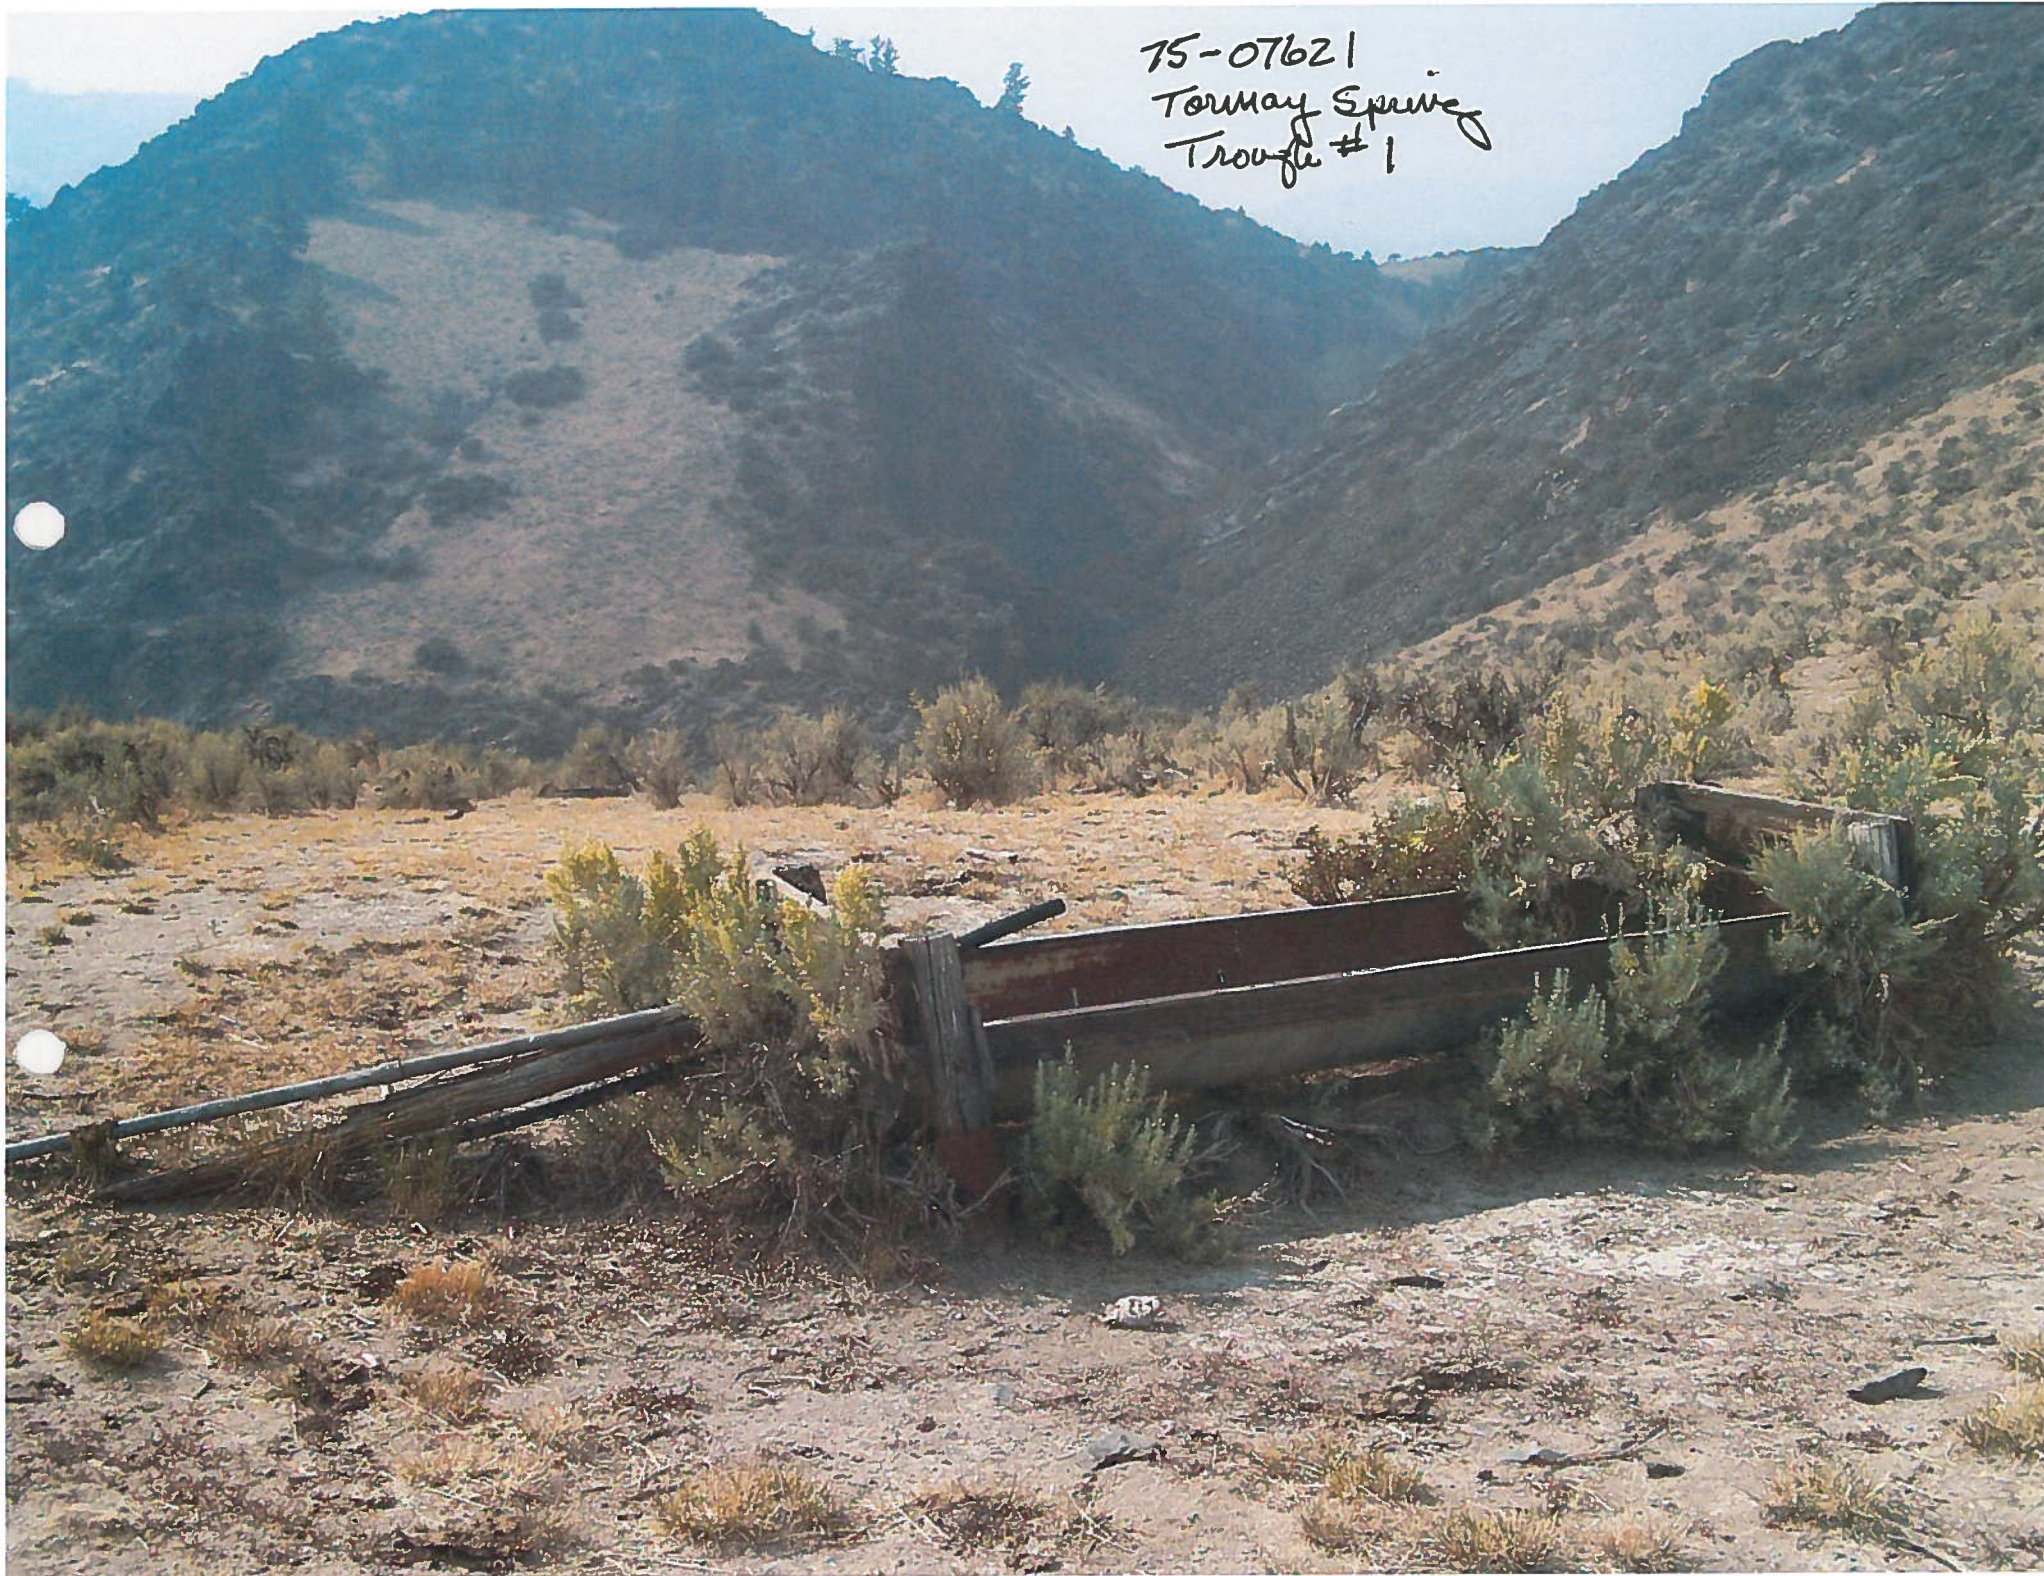
75-07621  
Tormay Spring  
Trough #1

A photograph of a wooden structure, possibly a water trough or trough, situated in a dry, hilly landscape. The structure is made of weathered wood and has a blue-painted interior. A long wooden pole is leaning against it. The background shows a steep, dry hillside covered in sparse vegetation.
