OPERATION REPORT  
(ELECTRONICALLY SUBMITTED)  
FEDERAL ENERGY REGULATORY COMMISSION  
Portland Regional Office

For the period August 14, 1996 to August 25, 1999  
Licensee Big Creek Lodge & Outfitters Project No. 10721-ID  
NATDAM ID# N/A  
Project Name Big Creek  
Location McCorkle Ck, Payette Nat'l Forest, Valley, Idaho  
(Waterway or Reservoir) (County) (State)  
License Issued Mar. 27, 1992 Expires Feb. 28, 2022 Type Minor  
Date of Last Amendment None  
Inspected by Thomas Bobal Date August 25, 1999  
Parts of Project Inspected All project features  
Weather Sunny, mostly clear, 60's  
Accompanied by Phillip Allen, Vice President (BCLO) and Plant  
Operator; and Michele O'Connell, U.S. Forest Service

**PERTINENT DATA SHEET**  
**Big Creek Hydroelectric Project**  
**FERC No. 10721-ID**

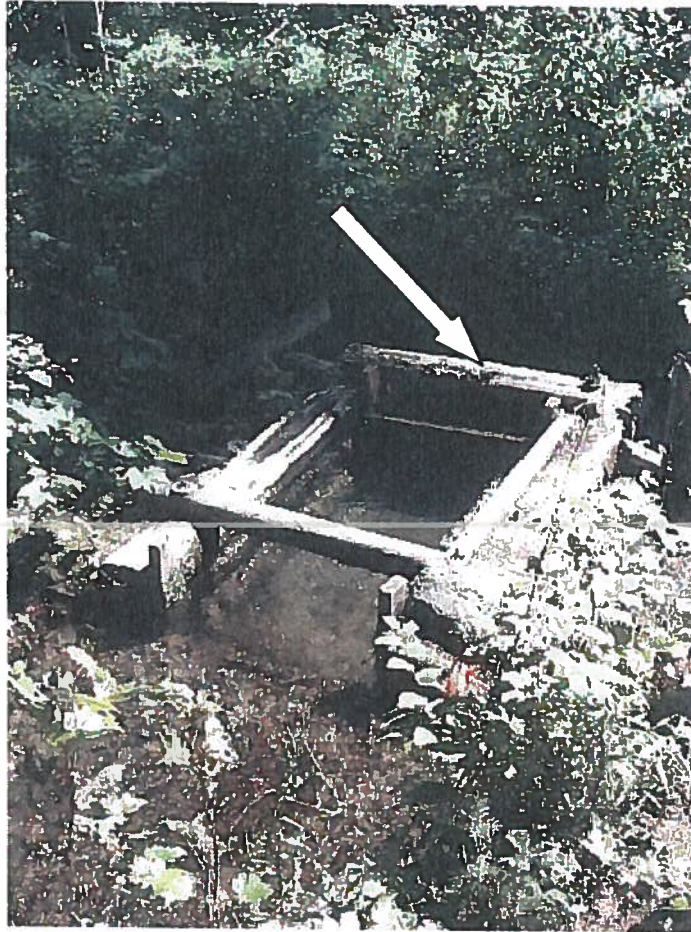
The headbox (Photo 1) utilized to impound water for the penstock intake appeared to be in satisfactory condition and better maintained than noted during the previous operation inspection in 1996. The log bracing above the overflow weir completely deteriorated and was replaced in 1997. The plastic tarp used to line the headbox has been removed.

1. Intake headbox. Note new log bracing (arrow).

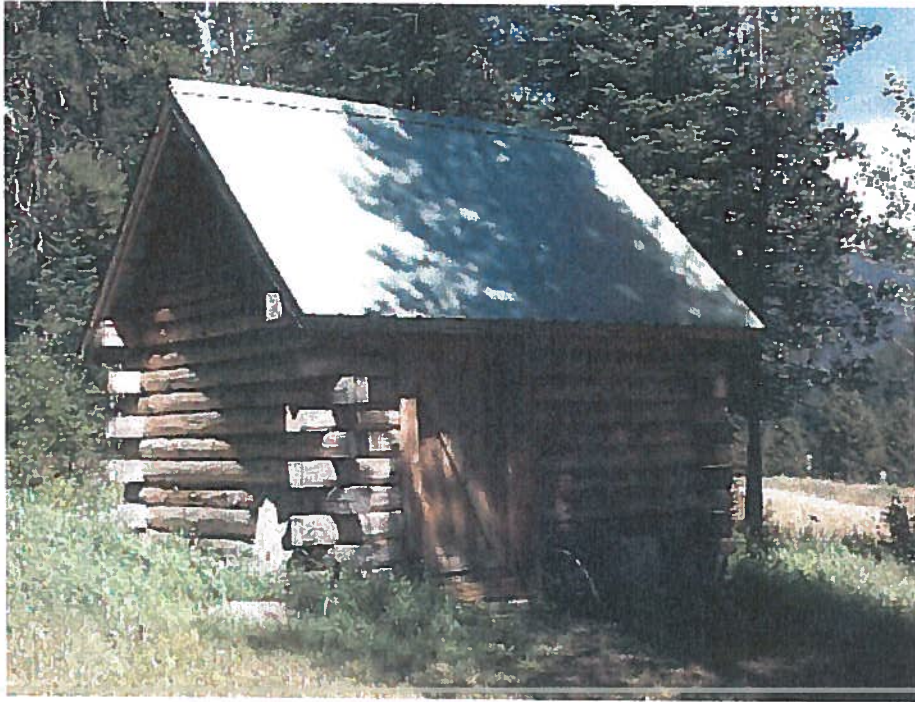
The wooden powerhouse superstructure burned down in 1983 and was replaced in 1994 by a new permanent wood-log building with a metal roof (Photo 3). At that time, the turbine-to-generator belt connections were adjusted, and the electrical boxes and wiring were upgraded to more efficiently provide power to the lodge and to improve the safety factor. Mr. Allen reported that, in the spring of 1998, the turbine nozzle was redesigned and repositioned to further improve power efficiency.

3. New wood-log powerhouse.

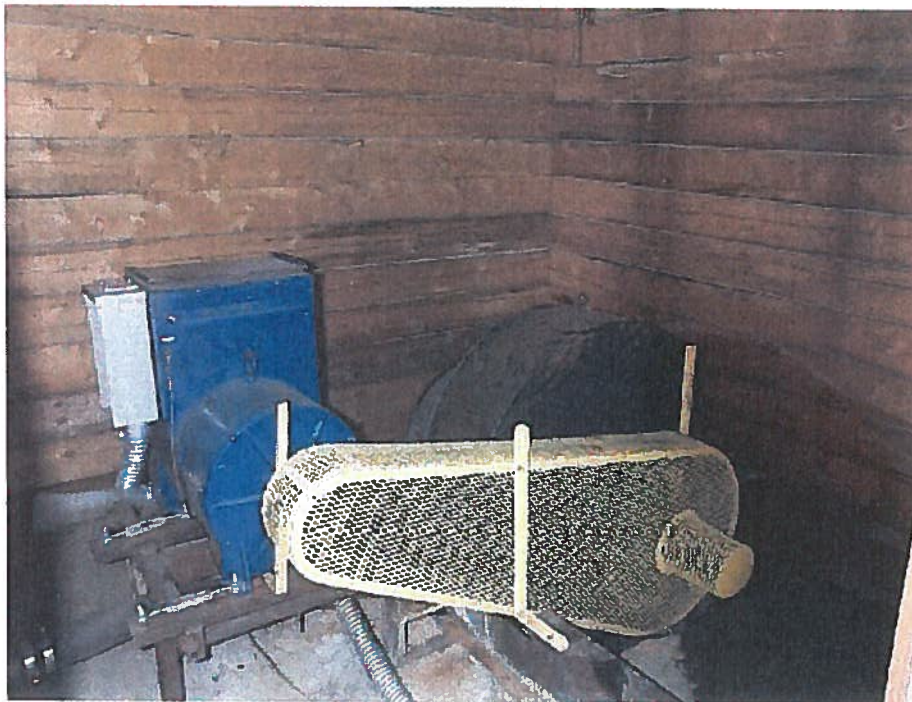
3. Power Plants. As detailed above in section A.1, the electrical and mechanical equipment have been upgraded for more efficient generation. The powerhouse interior has been cleaned up, and a new protective metal housing covers the turbine-to-generator belt (Photo 4). The enclosed tailrace conduit appeared to be successful in eliminating excessive turbine noise. The riprap placed in the outlet channel seemed to be properly dissipating tailrace flow energy and preventing channel erosion (Photo 5). There was no water leakage at the Pelton wheel shroud as reported during previous operation inspections.

4. Turbine and generator with new protective housing.
