STATE OF IDAHO  
DEPARTMENT OF WATER RESOURCES  
**BENEFICIAL USE FIELD REPORT**

Permit No: 55-13891

Exam Date: 4/27/2013

3. **SOURCE** **TRIBUTARY**  
DEER CREEK BOULDER CREEK

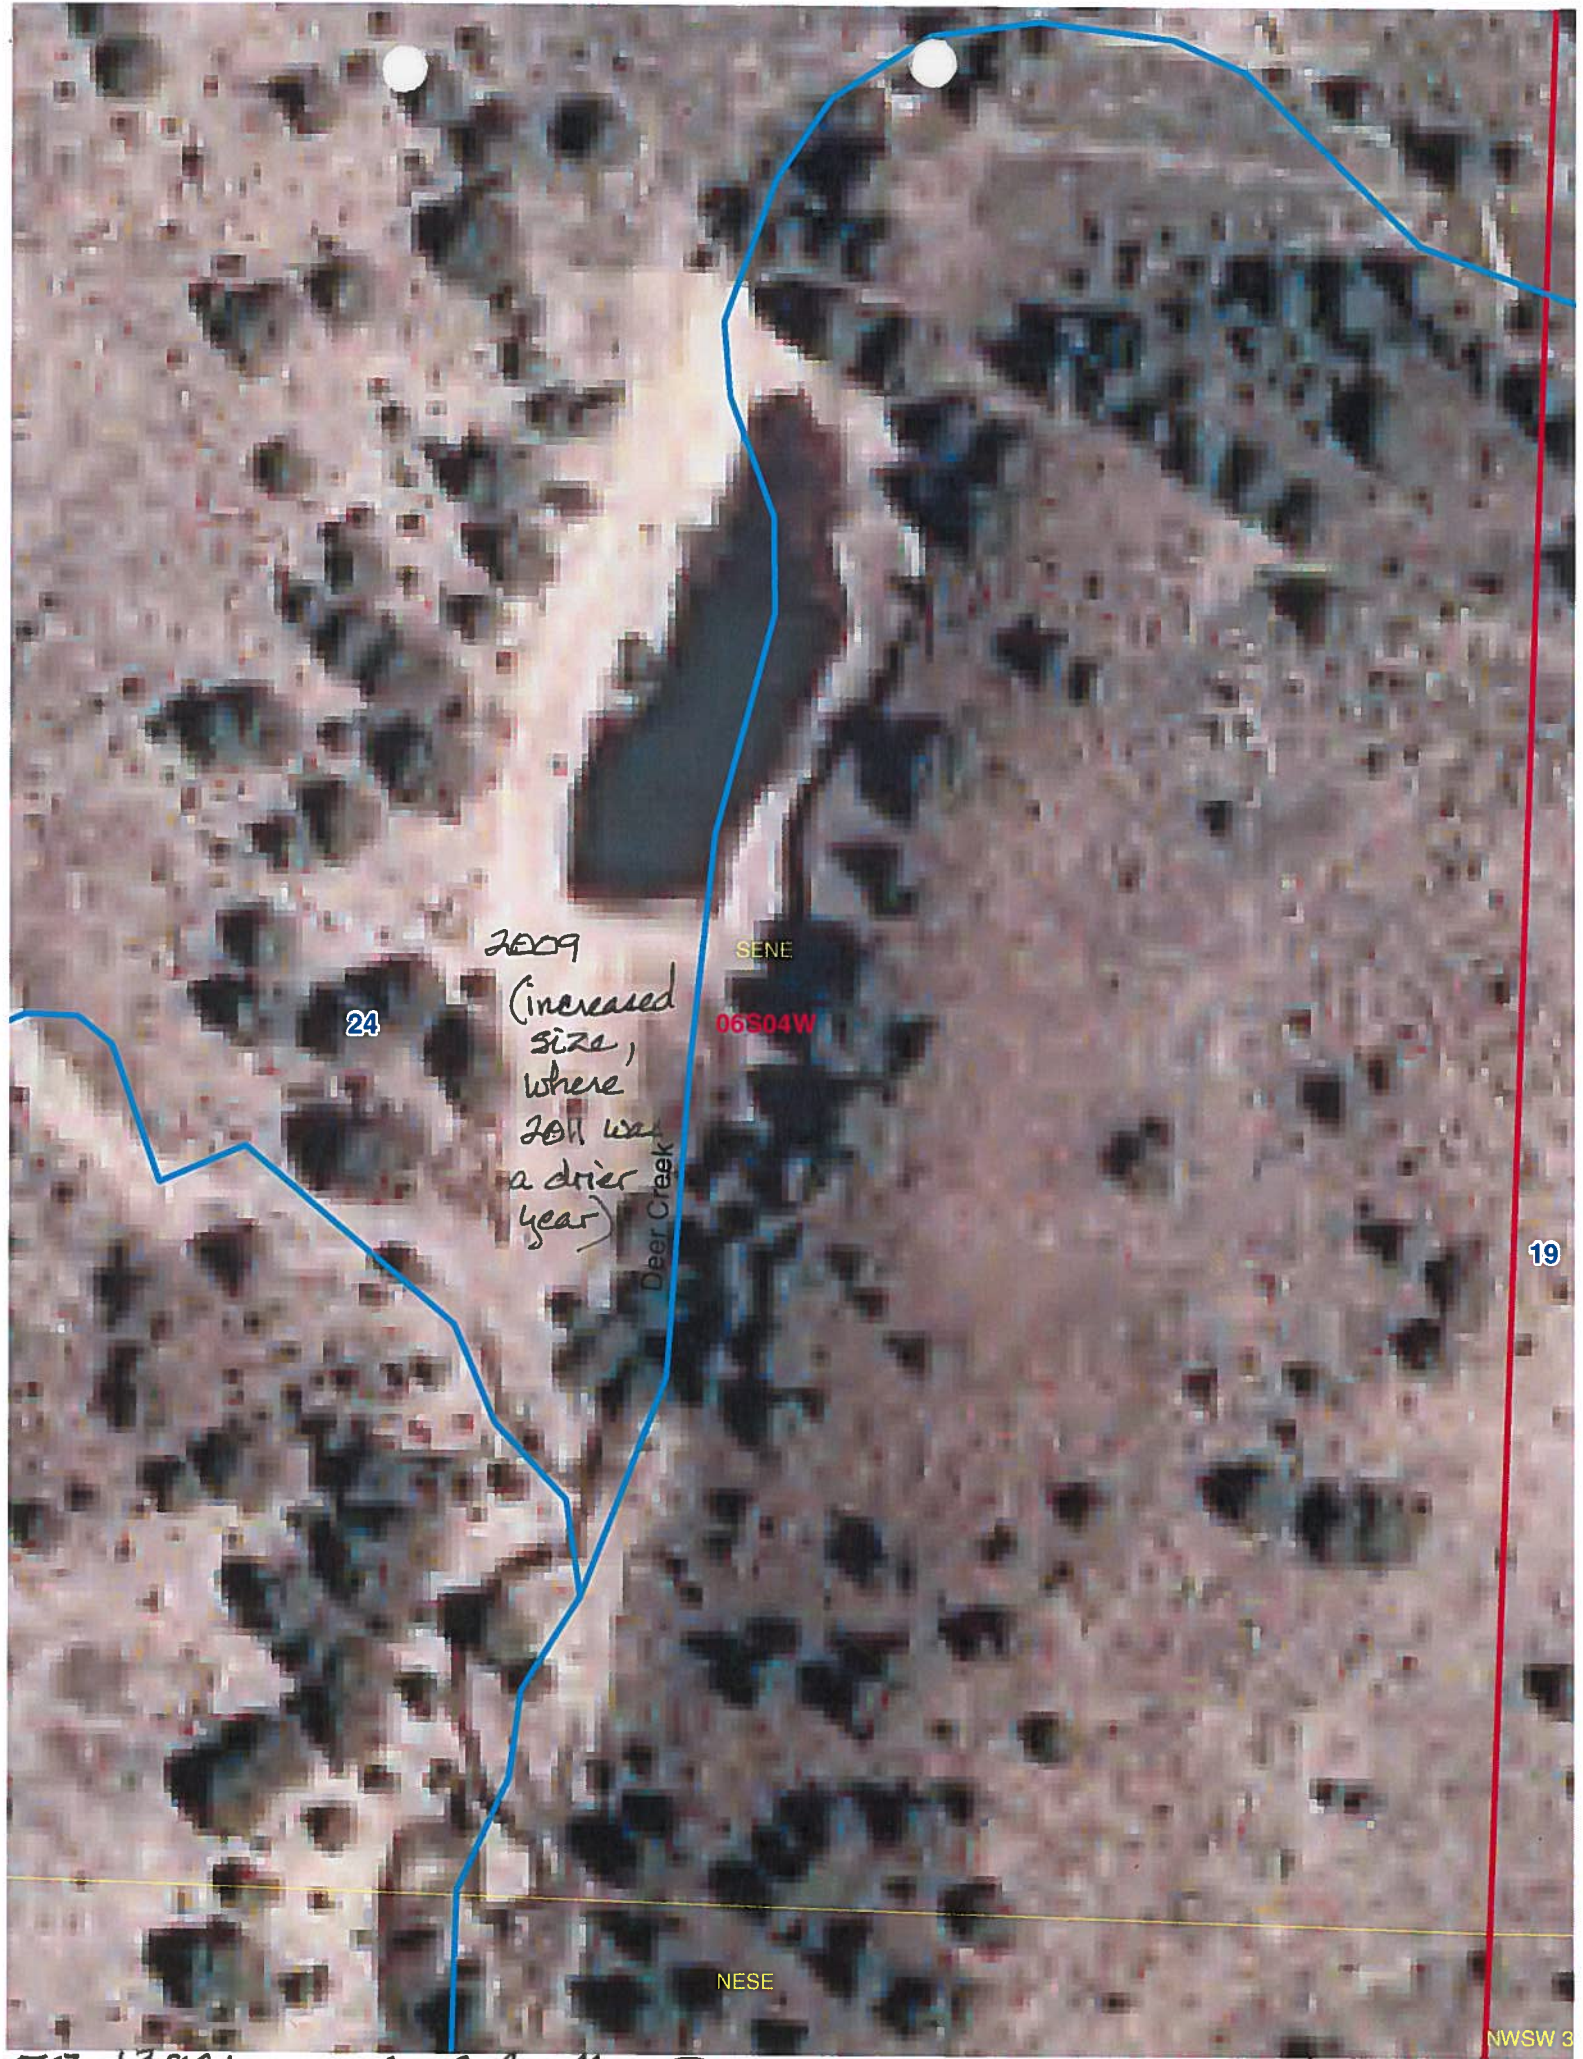
2009  
(increased  
size,  
where  
2011 was  
a drier  
year)

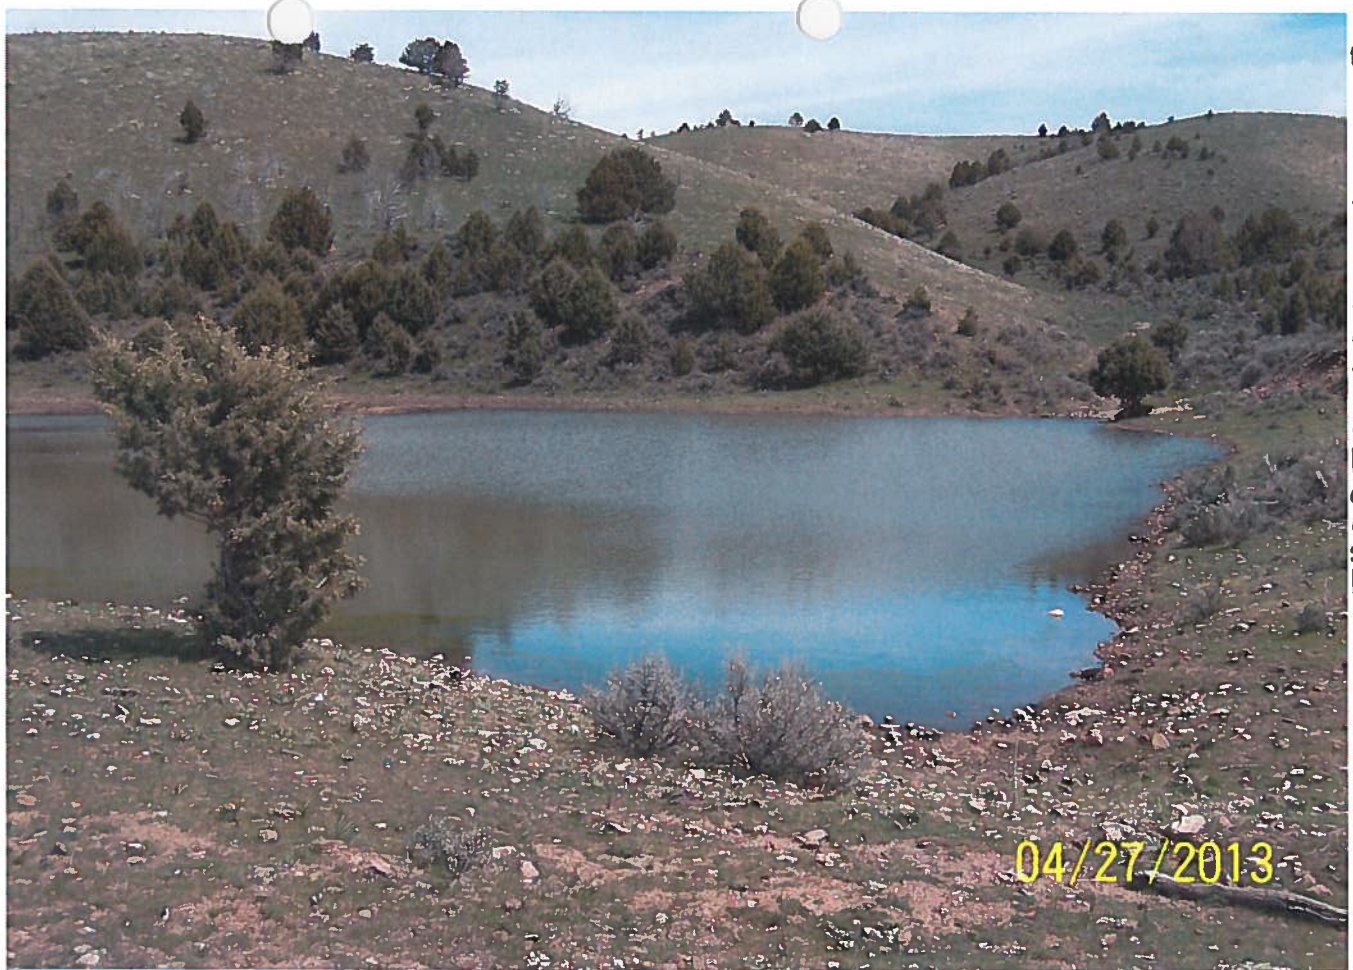
Pond #1  
POU:  
Pond #1  
Sec. 25

Average  
depth  
at time  
of field  
exam 3',  
but  
evidence  
on bank  
shows  
historical  
reaching  
7' deep.

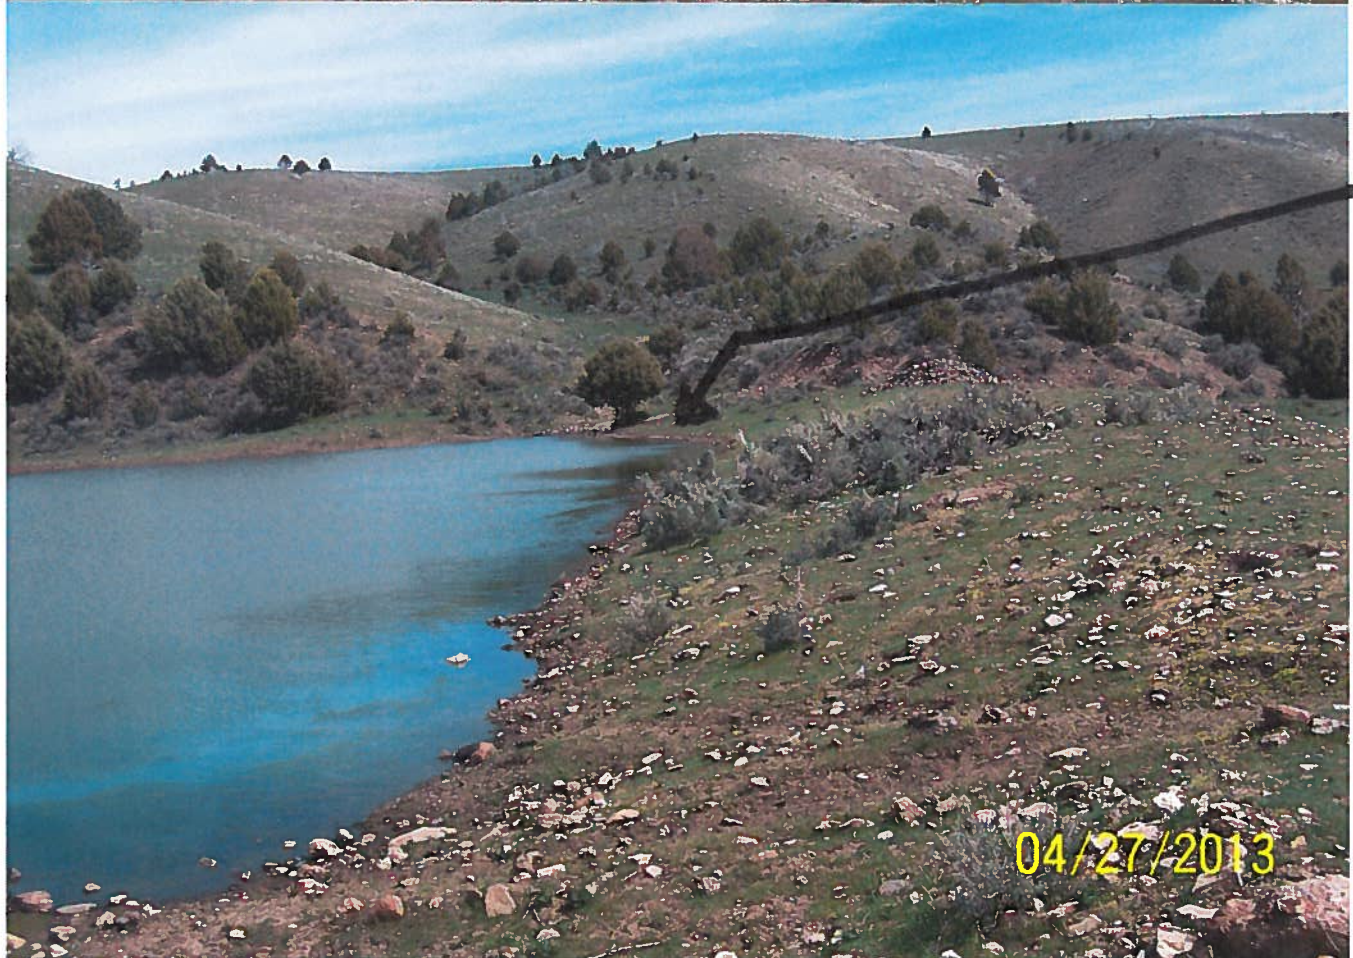
Pond #1  
POD  
spillwa

9' dam

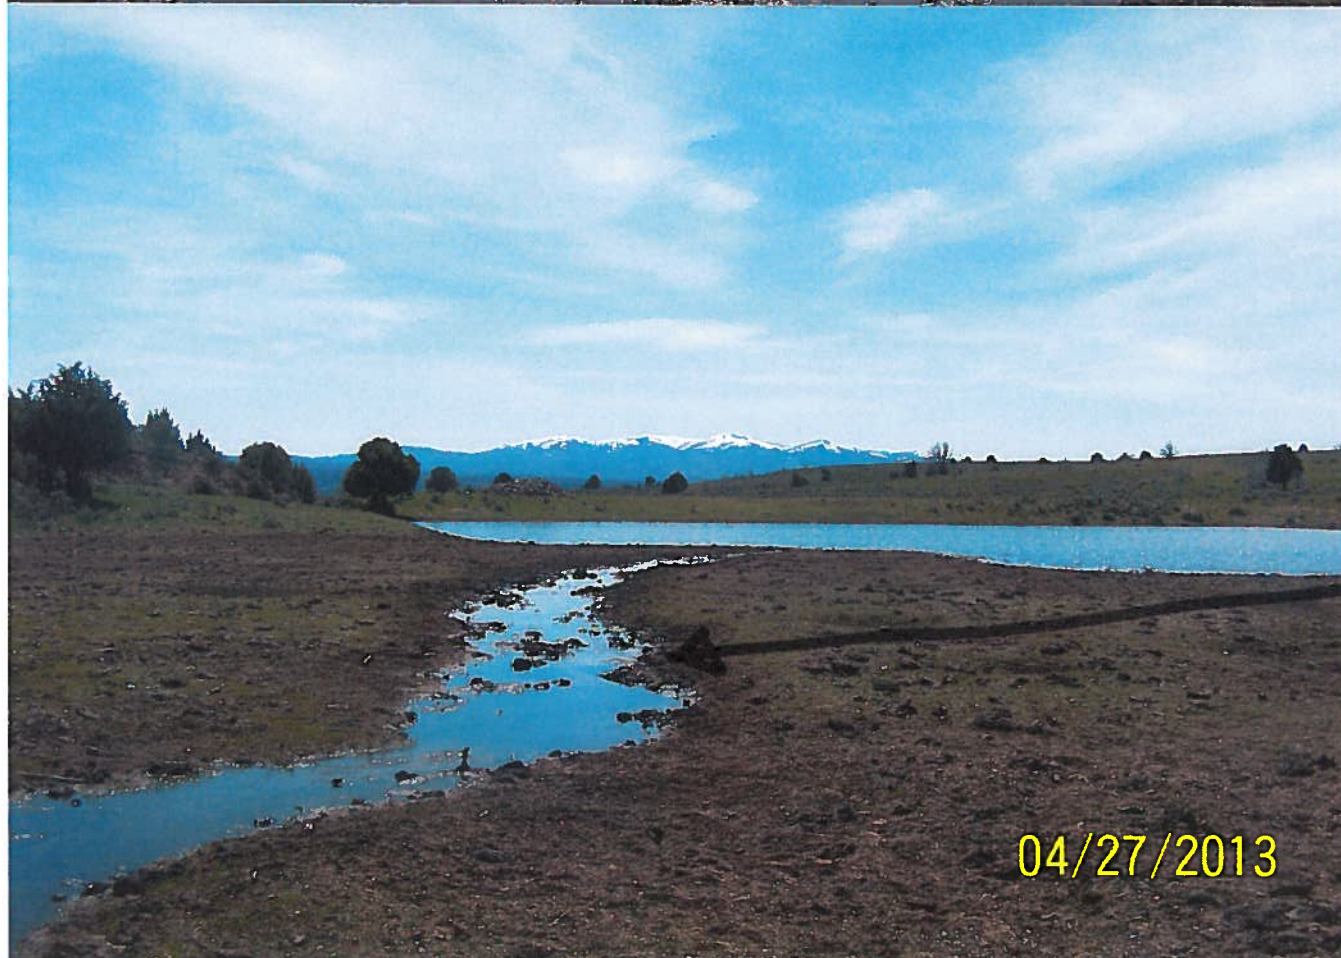
Inlet  
to  
Pond #1  
Source  
Deer  
Creek

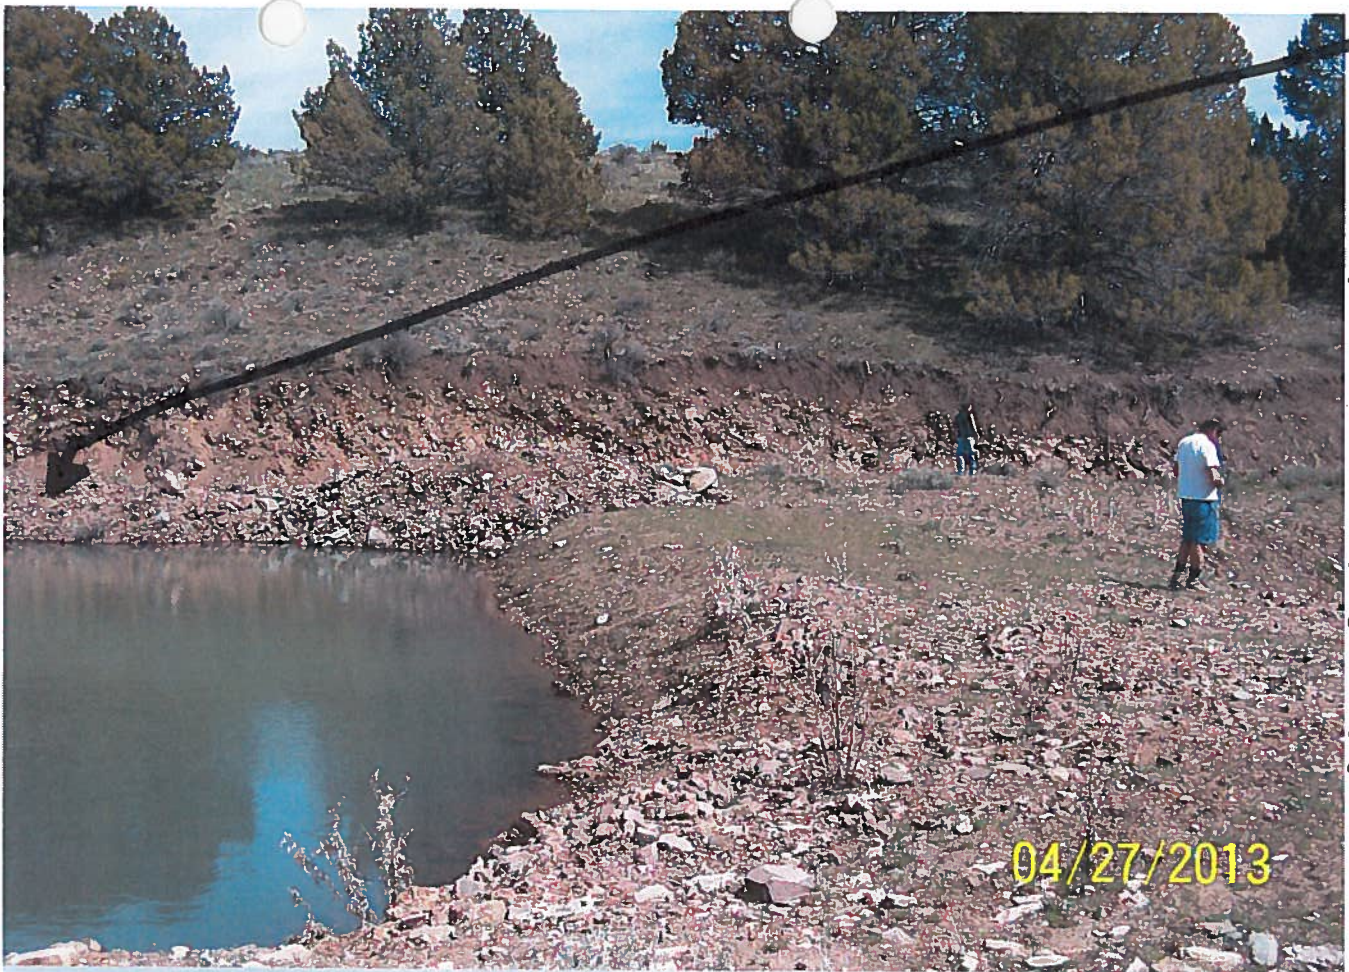
T6S  
R4W  
Sec. 24  
SENE

Pond #1  
POD  
spillway  
on the  
dam

7' dam  
3' average  
depth.  
At time  
of field  
exam,  
it was  
at  
normal  
depth.

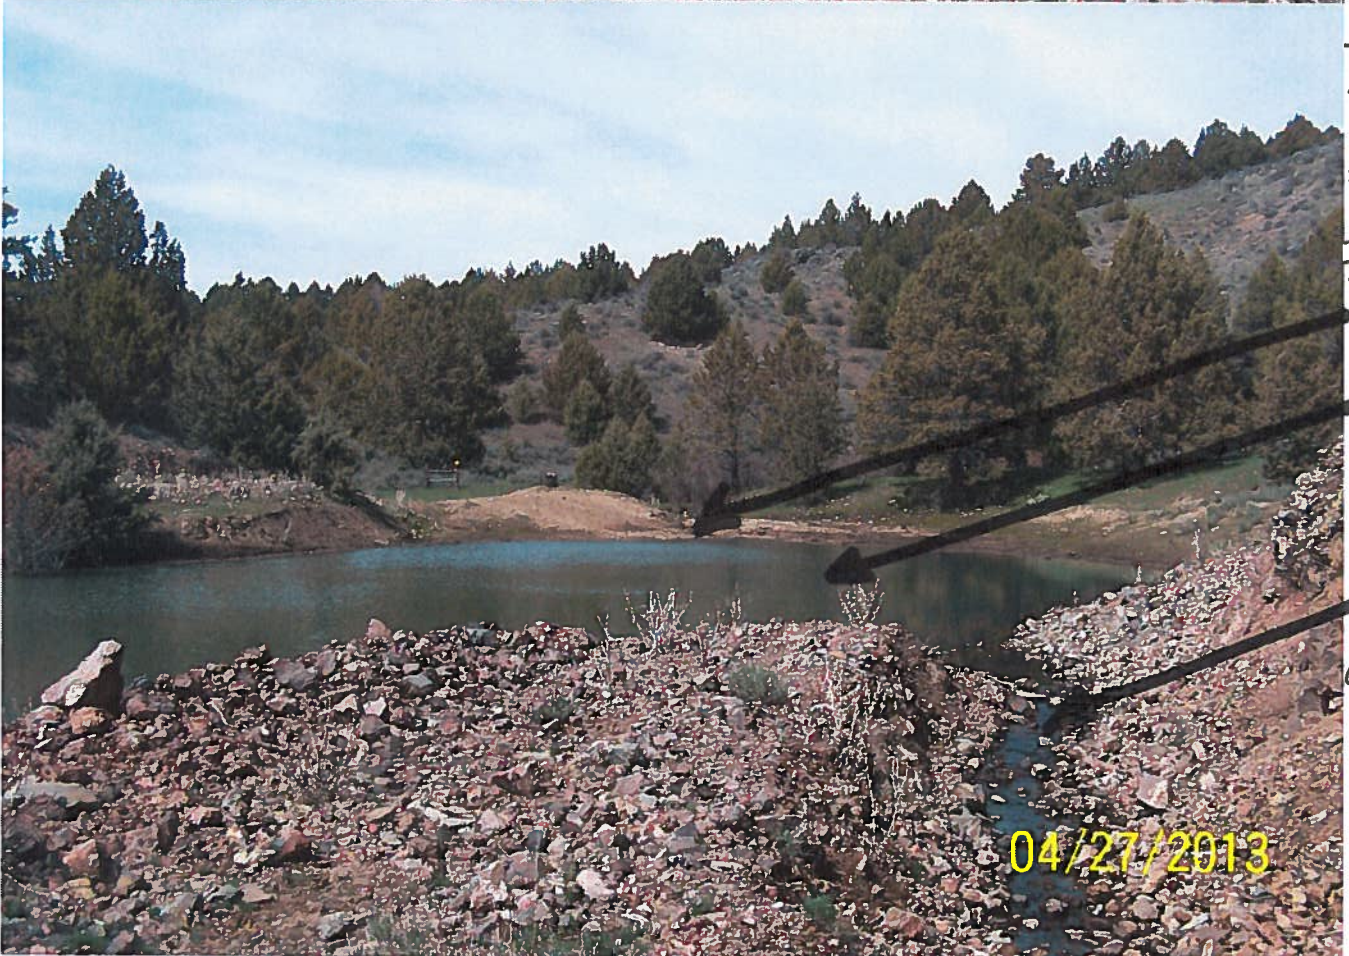
T6S  
R4W  
Sec. 24  
SENE

Inlet  
for  
Deer  
Creek

Pond #1  
POD  
spillway  
@ dam

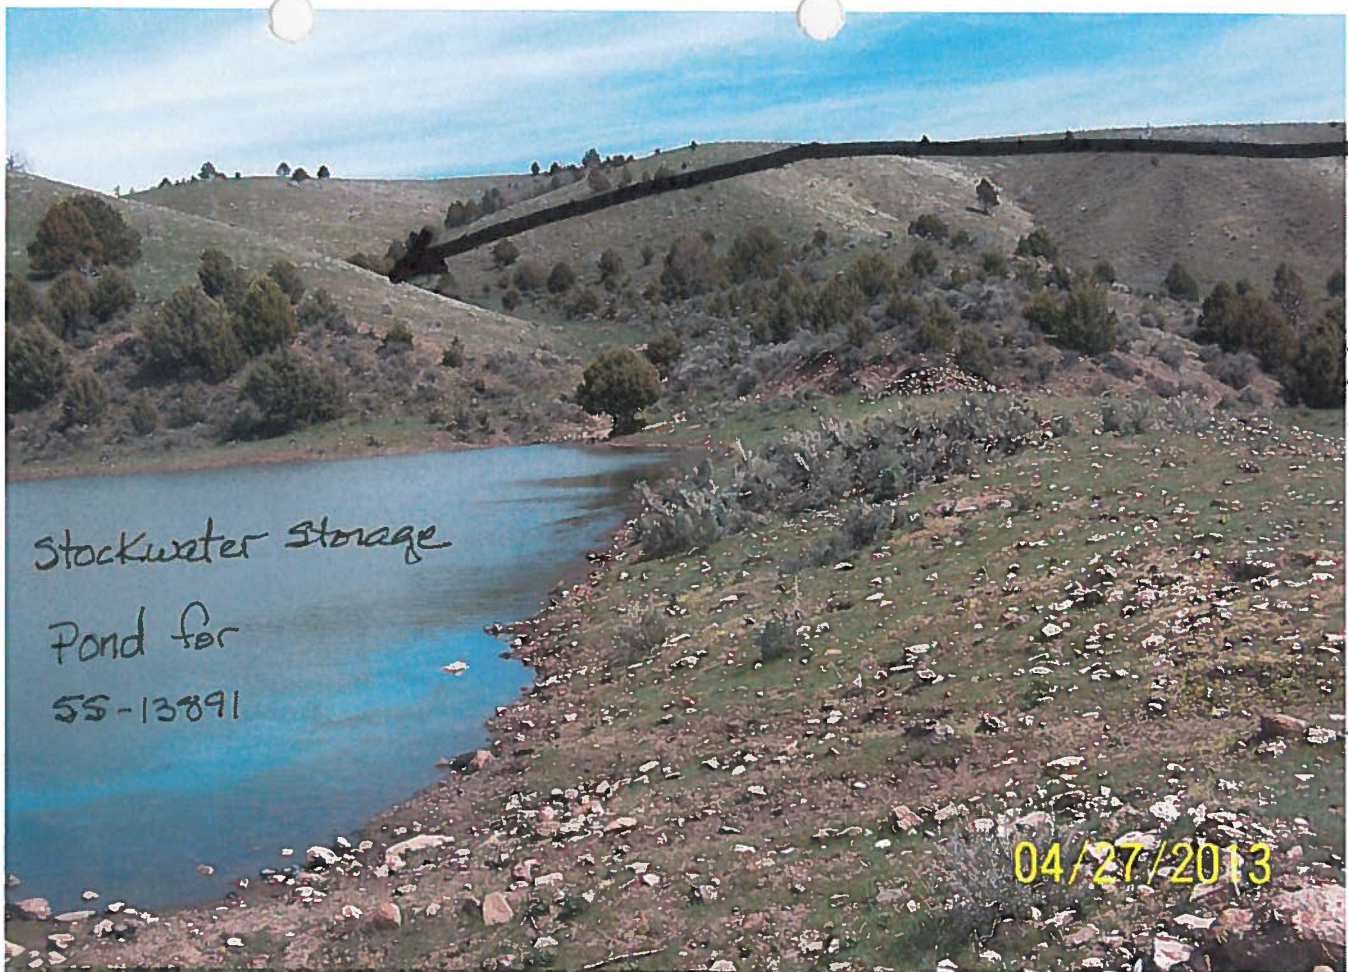
T65  
R3W  
Sec. 30  
SWNW 2

Stockwater storage

pond  
requirin  
an applicati  
for permit  
to be  
filed on  
it

Source:  
spring +  
unnamed  
stream  
from  
snow melt  
run-off  
(dry  
source  
by June)

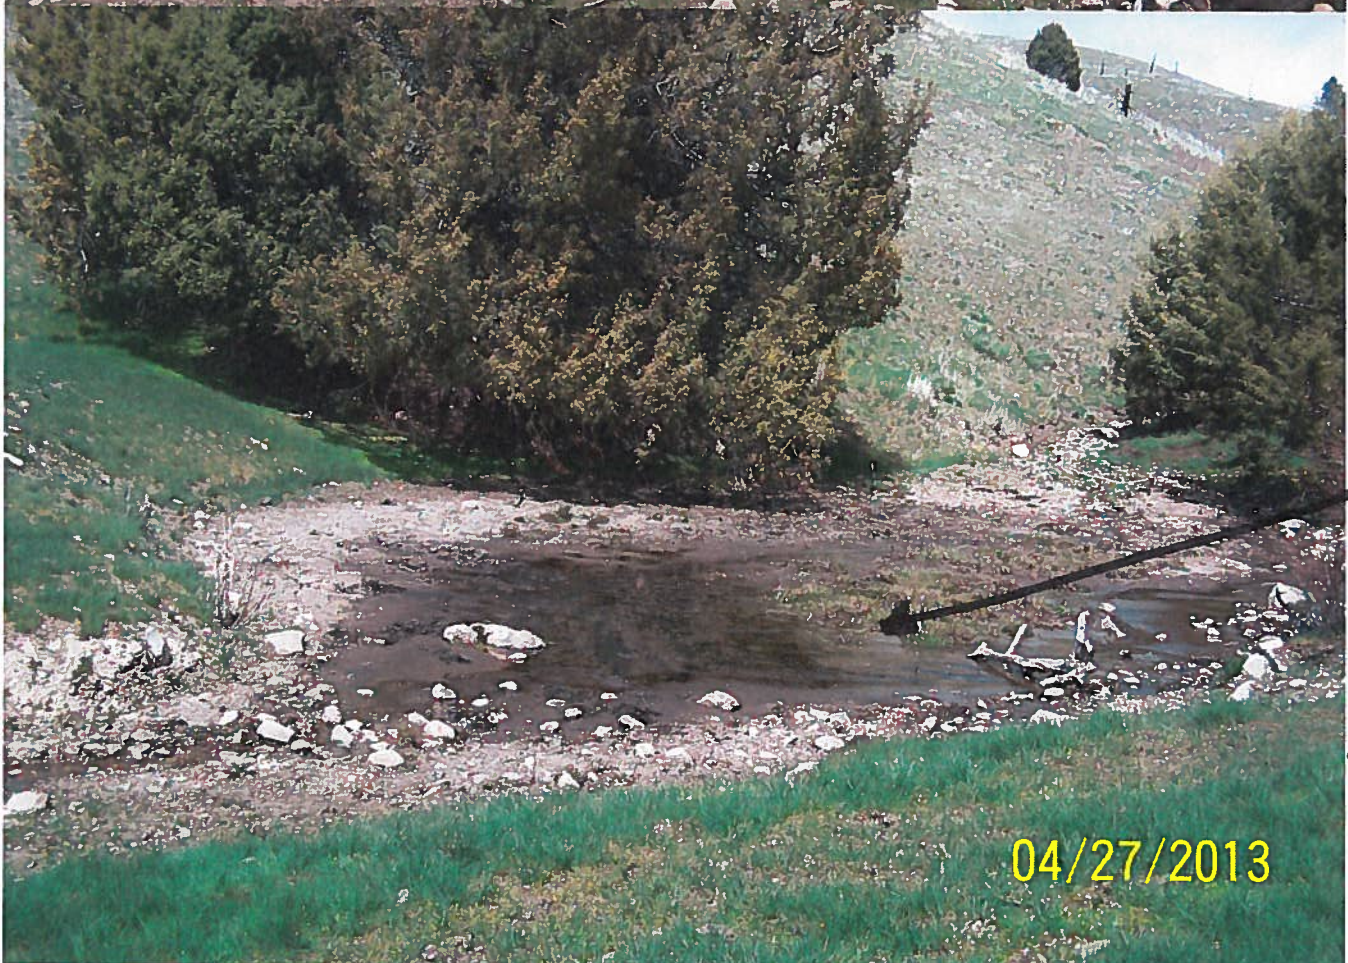
Pond Requiring Permit

At time  
of exam  
spillway  
had  
washed  
out +  
was to  
be rebuilt

4' dam,  
with  
average  
depth  
3 1/2 ft.  
deep  
pond,  
Pond  
size is  
0.04  
acres  
(0.14 af)
