**Beneficial Use Field Exam Summary**  
**Permits 11-7339 and 11-7343**

Report prepared by James Cefalo on September 6, 2013

Narrative/remarks/comments for permits: 11-7339 and 11-7343  
Prepared by: Cindy Bird, field examiner *CB*  
Report date: May 10, 2007

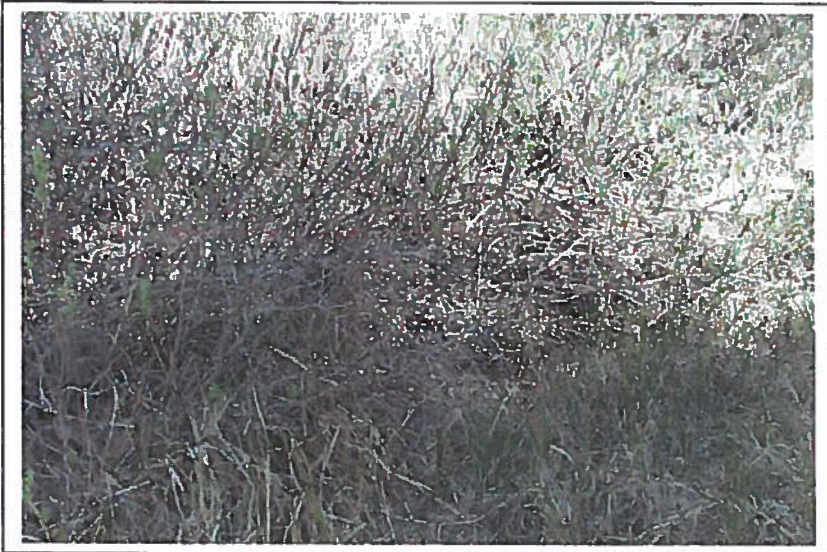
photo 1534 5/1/07 3:19pm.

Head of the spring was GPS'd on May 1<sup>st</sup>, 2007 and site tag A0012019 was attached to a vertical pipe. The head of the spring was overgrown and no development had been done. Coordinated of the spring are: N42° 36.338' W111° 35.810': GPS filename: 11-7339

Looking in a  
southeasterly direction  
at the head of the Spring  
site tag A00.12019

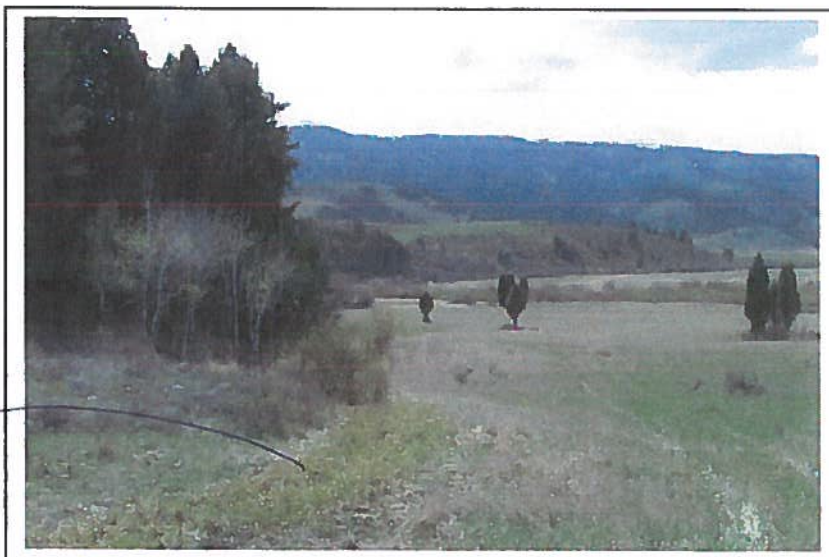
photo 1535 5/1/07 3:53pm.

ditch.

Looking in a westerly  
direction from the  
start of the ditch.

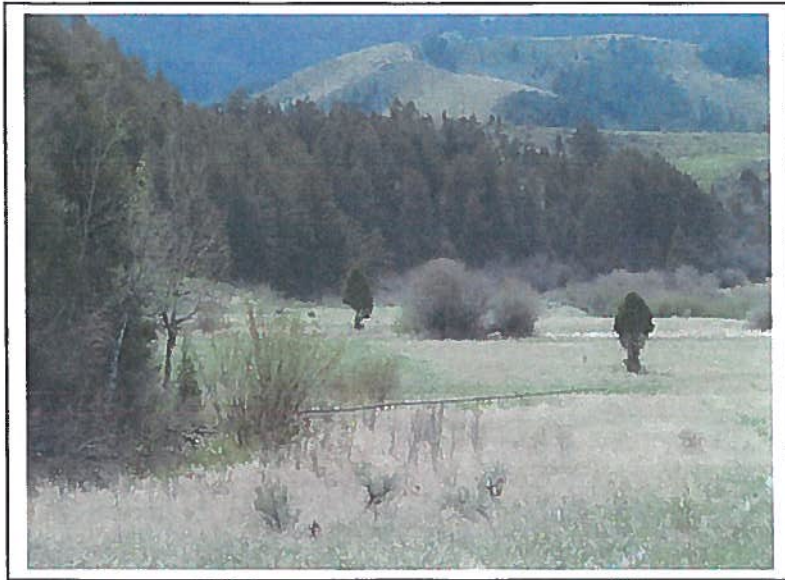
photo 1536

The spring was measured on May 8<sup>th</sup>, 2007 where it flows into a ditch. There is a small ditch that goes in a southwesterly direction below the hill towards the end of the property between sections 30 and 25. The ditch is located in the SWSW of section 30. It is approximately 900 feet long. Walking the ditch and scaling it on the 2004 imagery determined the length of the ditch. The water under this spring flows approximately 288 feet in the ditch before flowing out on the ground in a northerly direction.

This is approximately 288' down (west) or the beginning of the ditch where the water runs out on the ground.

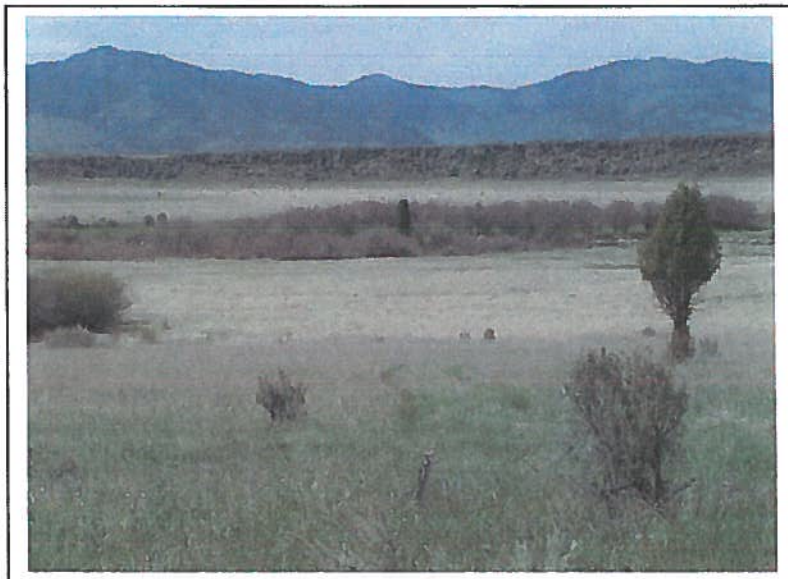
photo 1538

Looking North-easterly at what Steptany stated was irrigated. No ditch or development found.

I think Gayle Hunt intended on developing these permits by subdividing the land with multiple home sites but due to health problems he did not complete the project. Instead he placed the ground into CRP. I don't know if he thought that would protect the permits or not. I **cannot** confirm beneficial use of the water under these permits for the purpose claimed. Therefore, I'm recommending both permits be **voided**.
