## MEMORANDUM

RE: SMT Investors/Scheff Complaint Investigation

### Summary of Complaint and Site Investigation

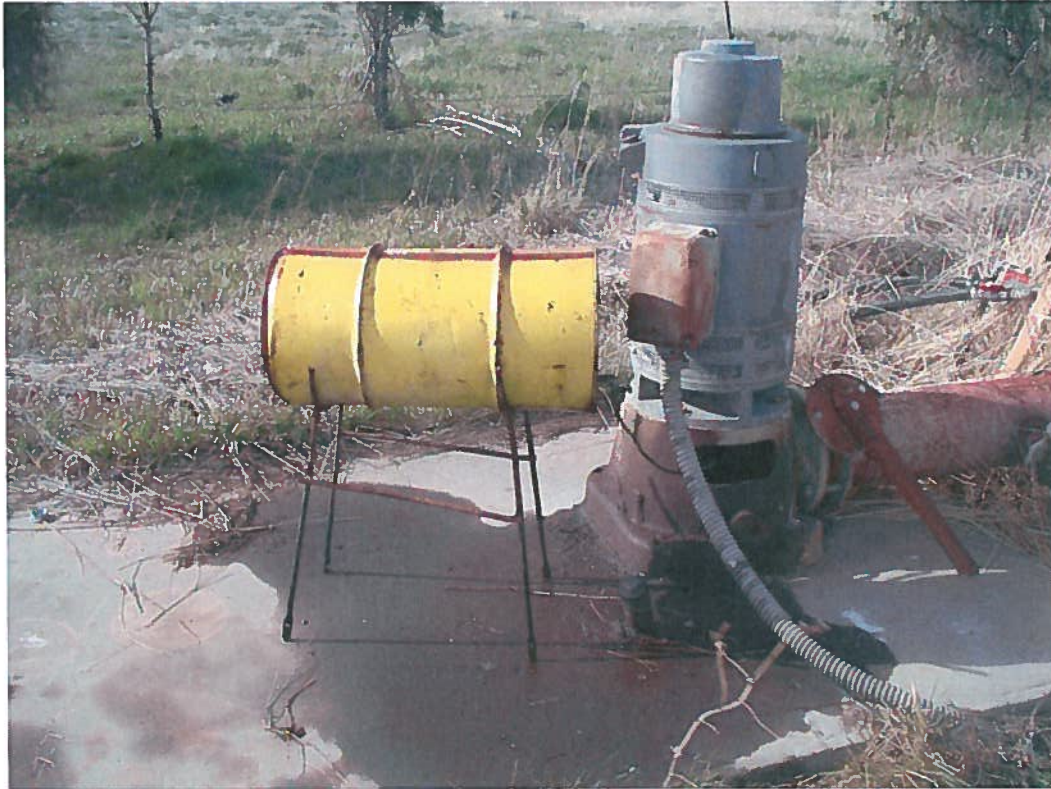
**SMT Investors/Scheff Complaint 4/13/2012 Photo #1: Well #2 facing south.**

- **Well #2 Diversion Info:**
  - Location = NENE Sec 11 T2S R5E – N 43.27307° W116.81939°.
  - IDWR Tag No. A0004702 – IDWR Monitoring Well No. 02S 05E 11AAB1.
  - Well Pump & Motor = 60 hp GE motor Model No. 5K6257xH12A Serial No. DKJ417463.
  - Booster = 25 hp booster.
  - No flowmeter.
  - Well motor Idaho Power meter number = 36 454 086 (no other uses).

- Booster Idaho Power meter number = 36 454 087 (no other uses).
- 10" discharge pipe from the well to 8" buried mainline.
- Pressure down line of booster = 50 psi.
- Total well depth and depth of bowls for irrigation pump unknown.
- Static water level 327.41 ft (3/19/12).
- Piping to hoses off 10" discharge pipe historically irrigated pasture and supplemented large pond area directly south of Well #2. Valve to these hoses closed. Mr. Orr said he does not irrigate pasture or put water into ponds from either well.
- 4" PVC piping off 8" line into small shed adjacent to Well #2. Mr. Orr stated PVC line goes to 1,000 gallon storage tank used by house southwest of Well #2. This piping not in place at time of Adjudication staff site visit in 1994.

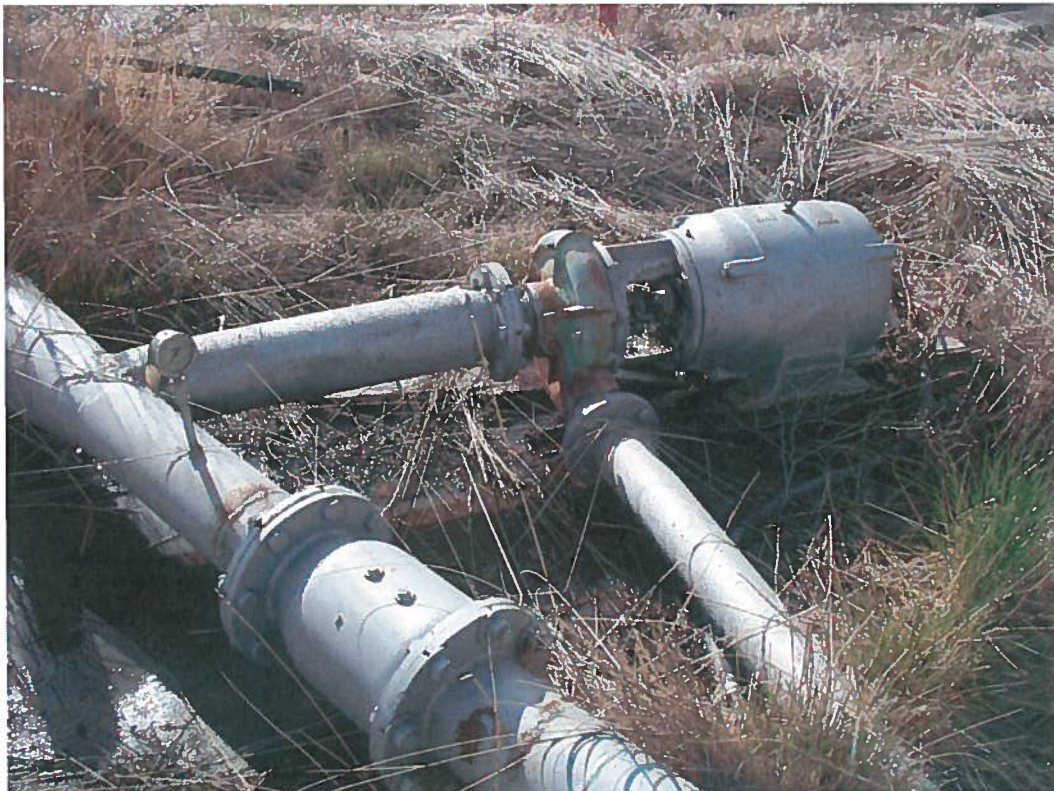
**SMT Investors/Scheff Complaint 4/13/2012 Photo #2: Well #2 booster pump facing southeast. 8" pipe to mainline on left side of photo.**

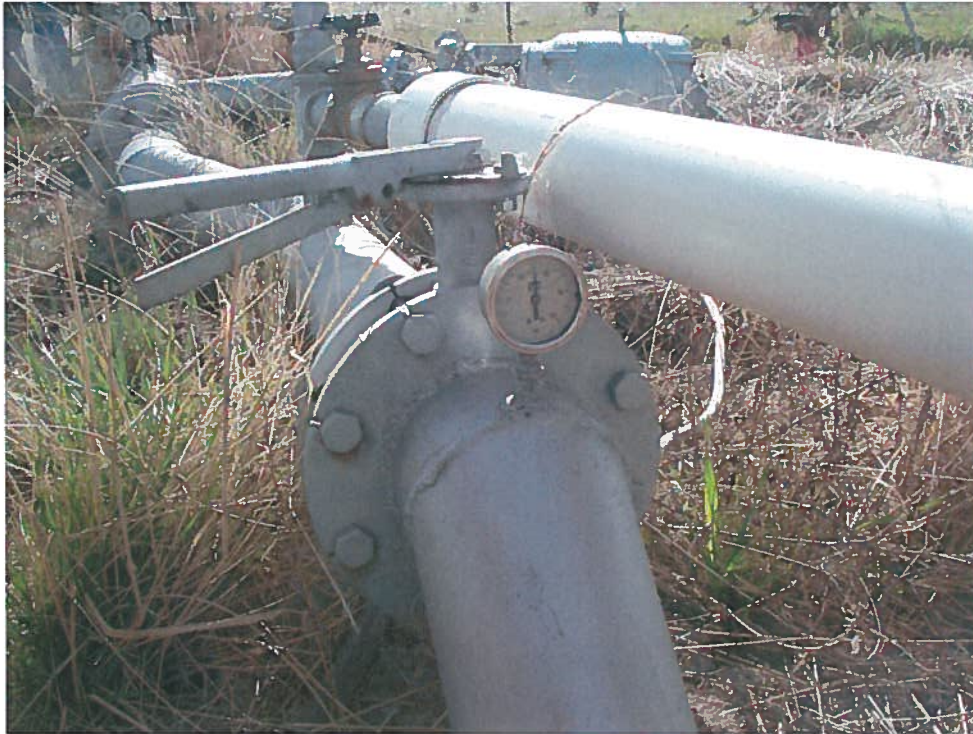
**SMT Investors/Scheff Complaint 4/13/2012 Photo #3:** Well #2 diversion system facing east. 8" pipe to mainline going into ground. Booster pump and well in background. PVC pipe in upper right of photo goes to buried 1,000 gallon storage tank for house.

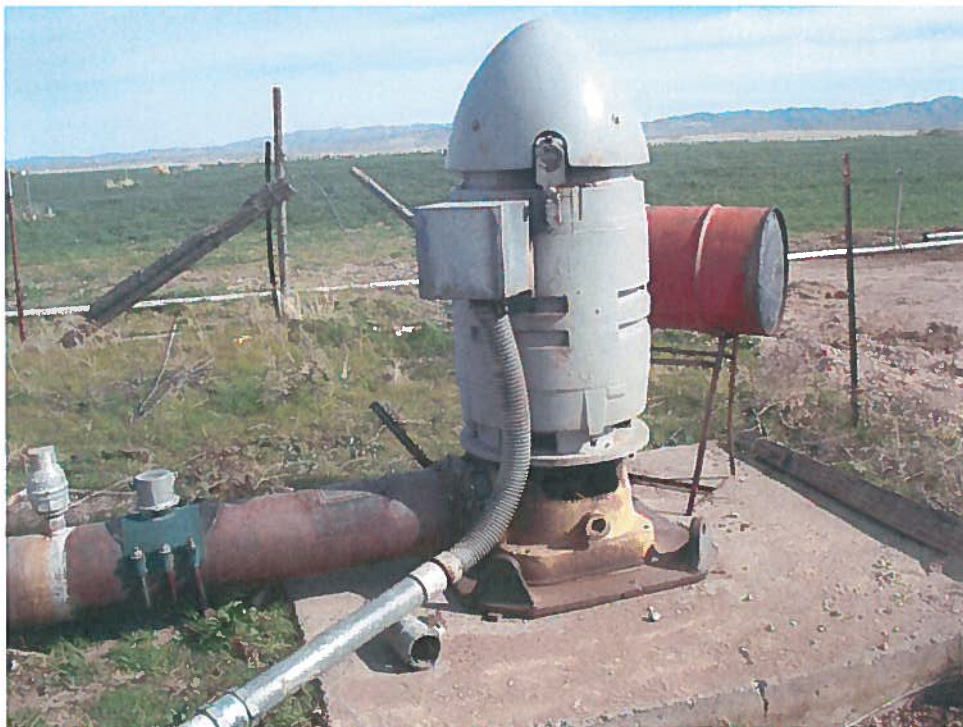
**SMT Investors/Scheff Complaint 4/13/2012 Photo #4:** Well #1 facing north. Dysfunctional flowmeter on discharge pipe on left side of photo.

- 10" discharge pipe w/ inline flowmeter (does not appear operational). Could not read flow reading, totalizer read 175276 (units and multiplier unknown). Maybe same flowmeter in place at time parent right (61-7384) licensed.

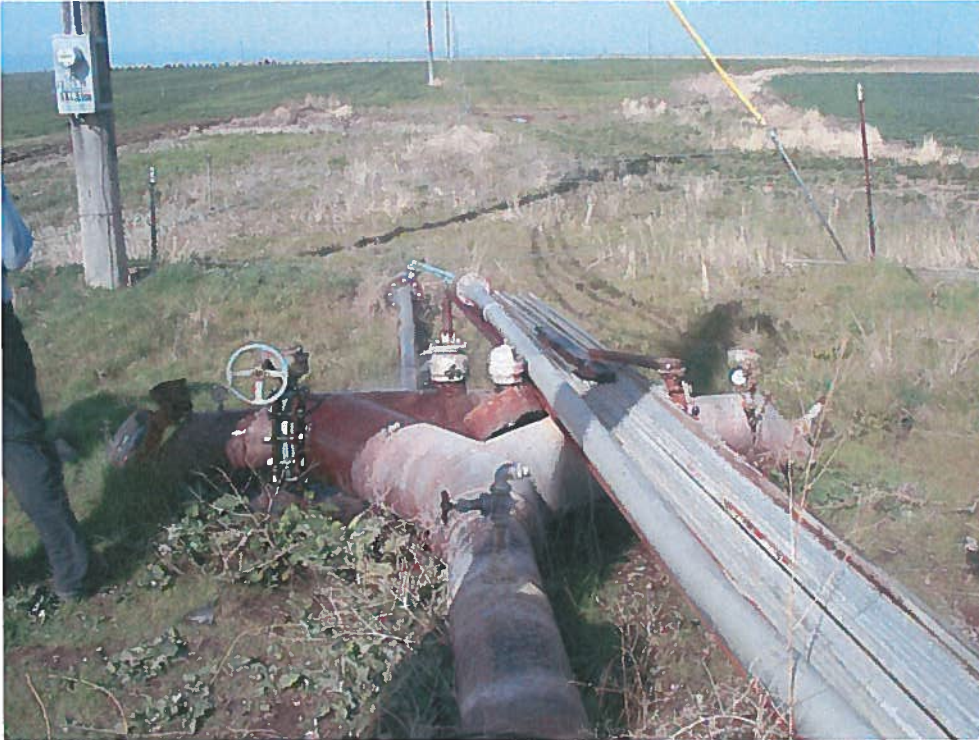
**SMT Investors/Scheff Complaint 4/13/2012 Photo #5:** Well #1 diversion system facing west. 10" discharge pipe from well in foreground of photo to 12" manifold that splits diverts water to mainline north (right) to pivot and mainline south (left) to risers for handlines.

- Well motor Idaho Power meter number = 41 121 919 (no other uses).
- 10" discharge line to 12" manifold at 'Y' back down to 10" then 8" buried mainline.

- 4" line from manifold at 'Y' to trees on far west edge of property. Historically used for irrigation of trees and wild fire protection measure, but Mr. Orr says no water diverted now for those purposes.

- Pressure readings downline of 'Y' to the north (towards pivot) ~18 psi to the south (towards handlines) ~54 psi. Not clear why only ~18 psi to the north, when all pressure readings in system ~50 psi.

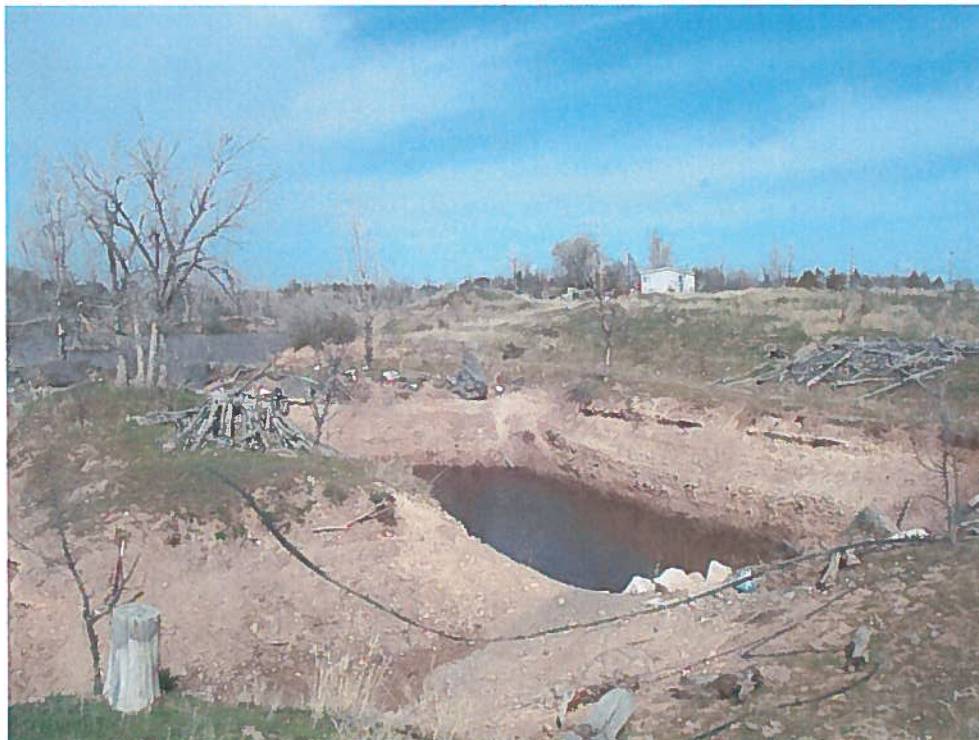
**SMT Investors/Scheff Complaint 4/13/2012 Photo #6:** Large pond area south of Well #2 facing northwest. Pond area consists of several connected excavations.

- Large pond area (3-4 connected excavations) south of Well #2 (NE NE Sec 11) filled with spring snowmelt runoff via natural channel(s). Evidence portion (~40 ft) of access road to gravel pit washed out recently likely by this year's runoff event in channel that drains to large pond area. Excavations forming this pond area occurred sometime between 1987 and 1992 (aerial photography).
- Pond (W ½ SW NE Sec 11) fills with snowmelt runoff, but also catches sprinkler runoff.
- Two smaller ponds (NW NW NW and W ½ SW SE Sec 11) are result of sprinkler runoff.
- No water is pumped from these ponds for any purpose. No water is deliberately pumped to these ponds from either well per Mr. Orr.
- Number of water fowl and other wildlife seen at large pond area south of Well #2.

- IDWR should formally inform property owners, Mr. Eric Orr, and Mr. Jim Scheff findings of this site visit by sending a copy of this memo or other documentation.
- IDWR Western Regional staff may wish to seek the assistance of IDWR Water Distribution section to confirm current diversion volume for system and compliance options with regard to the measurement device condition.
- IDWR should inform property owners of flow measurement device/means condition of water right and discuss options for compliance with this condition with regard to both wells.
- IDWR should inform property owners of water right requirement for storage associated with ponds on property. Subsequent filling of a water right application, especially for large pond area, requesting use of surface water for wildlife and/or aesthetic storage may be required.
