## MEMORANDUM

RE: SMT Investors/Scheff Complaint Investigation

### Summary of Second Site Visit

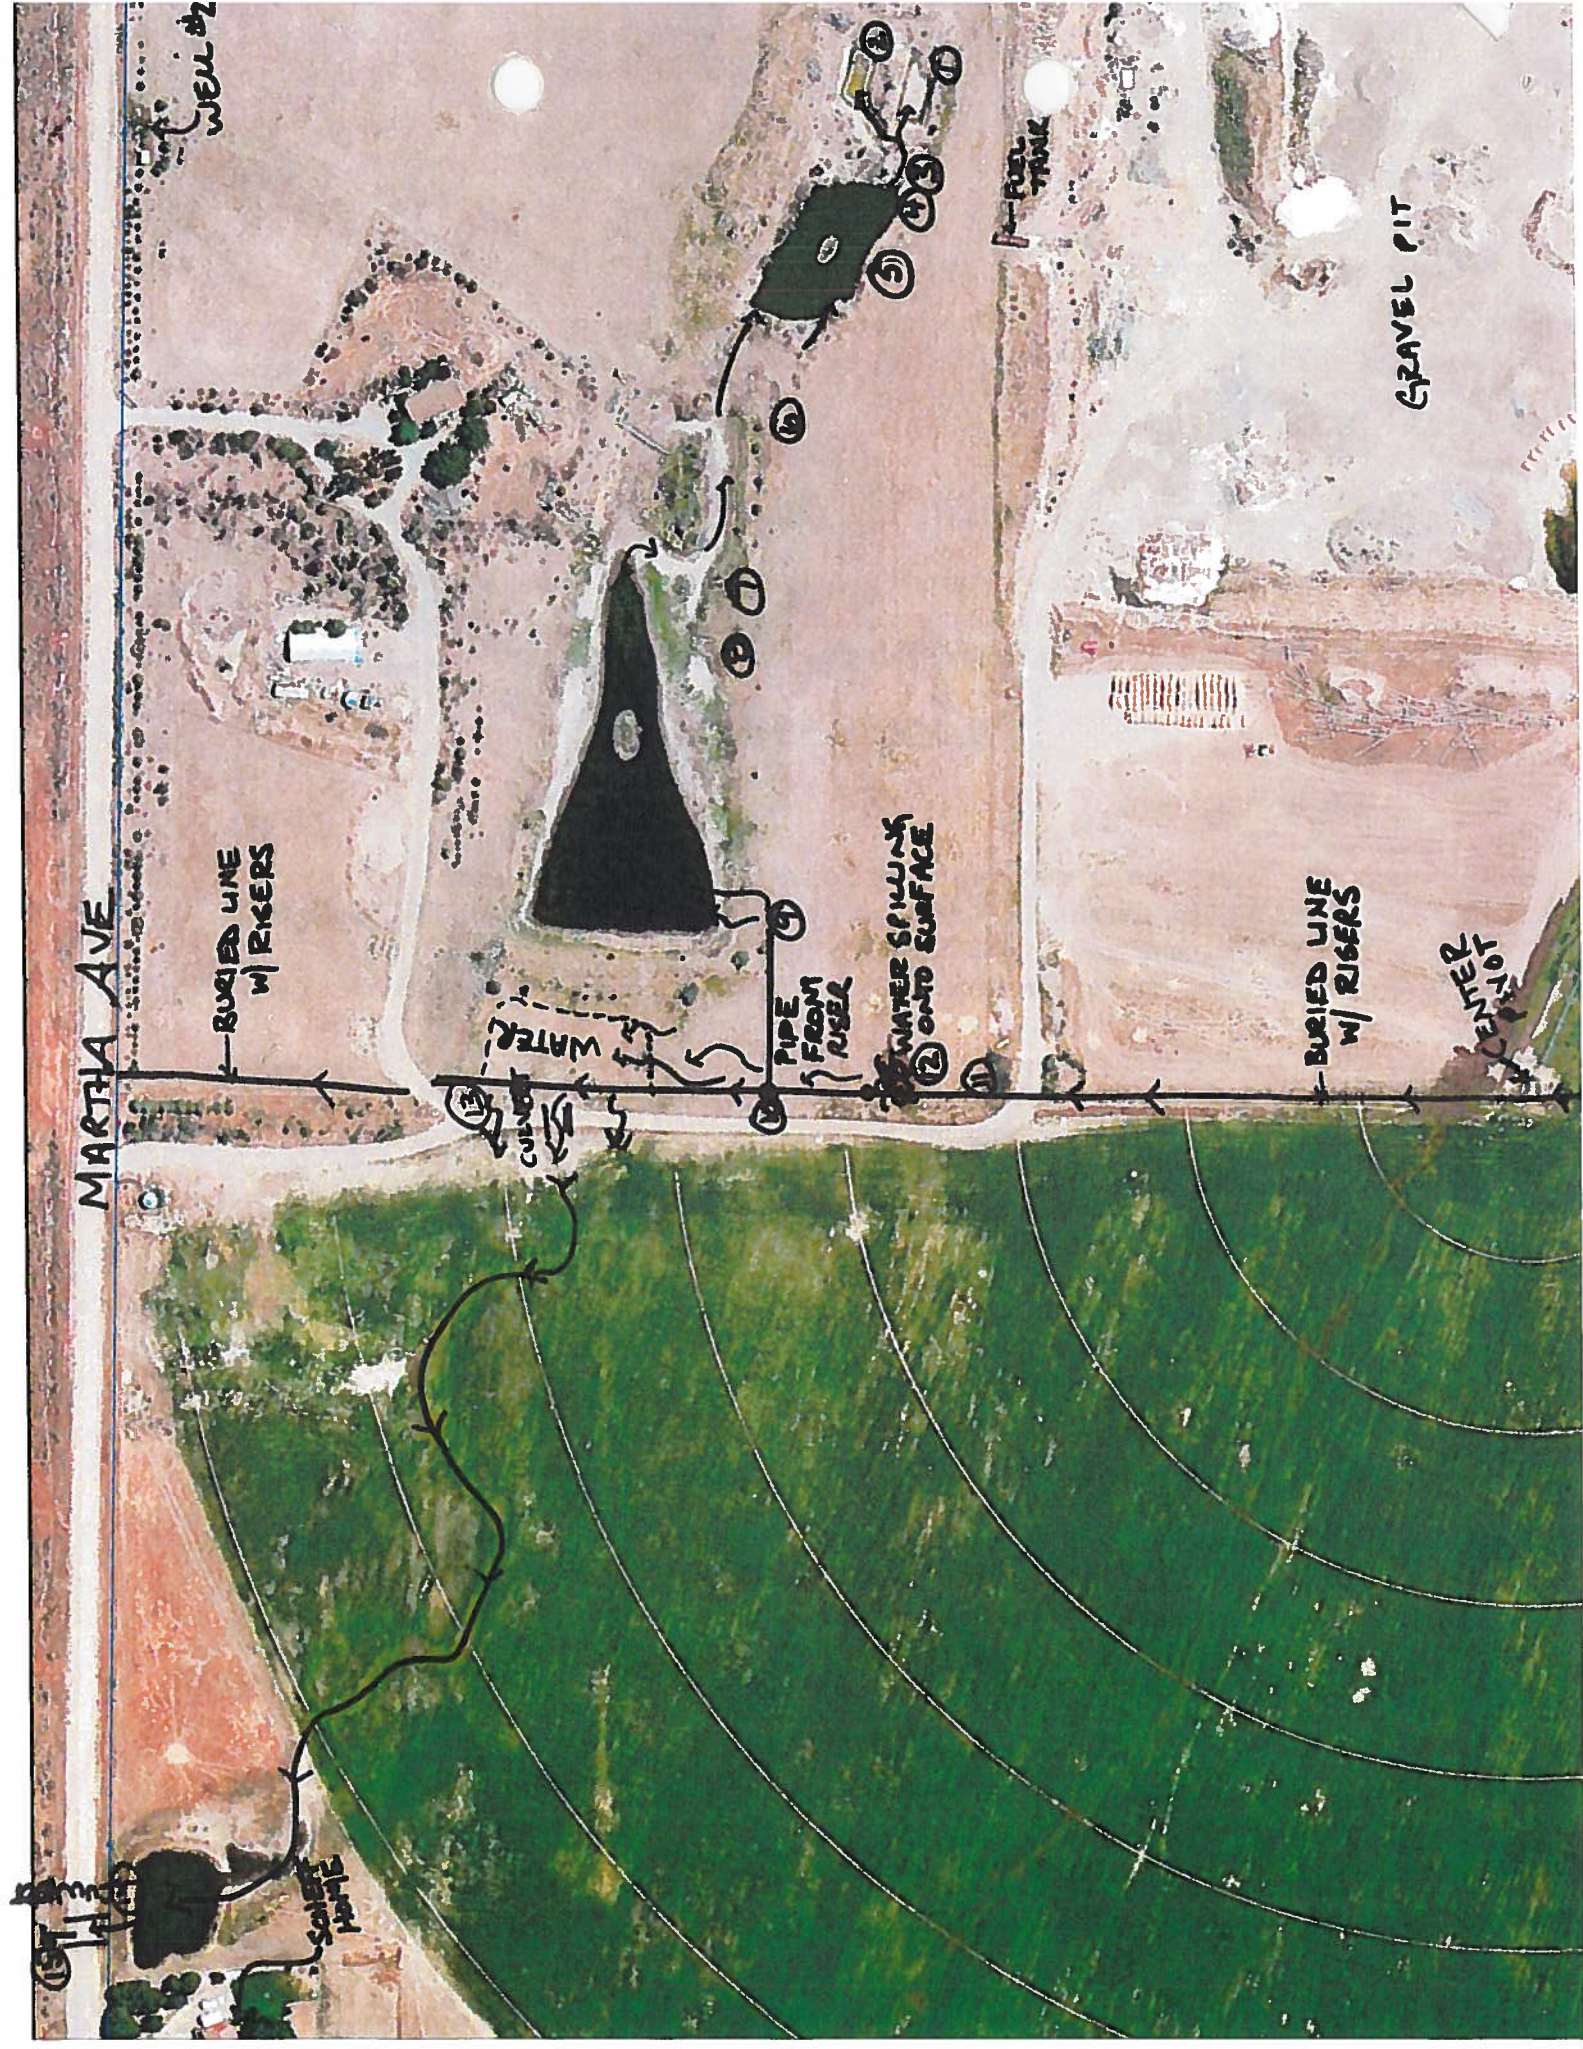
MARTHA AVE

BURIED LINE  
W/ RIGERS

GRAVEL PIT

WATER SPILL ON  
SURFACE

PIPE  
FROM  
RIVER

WELL

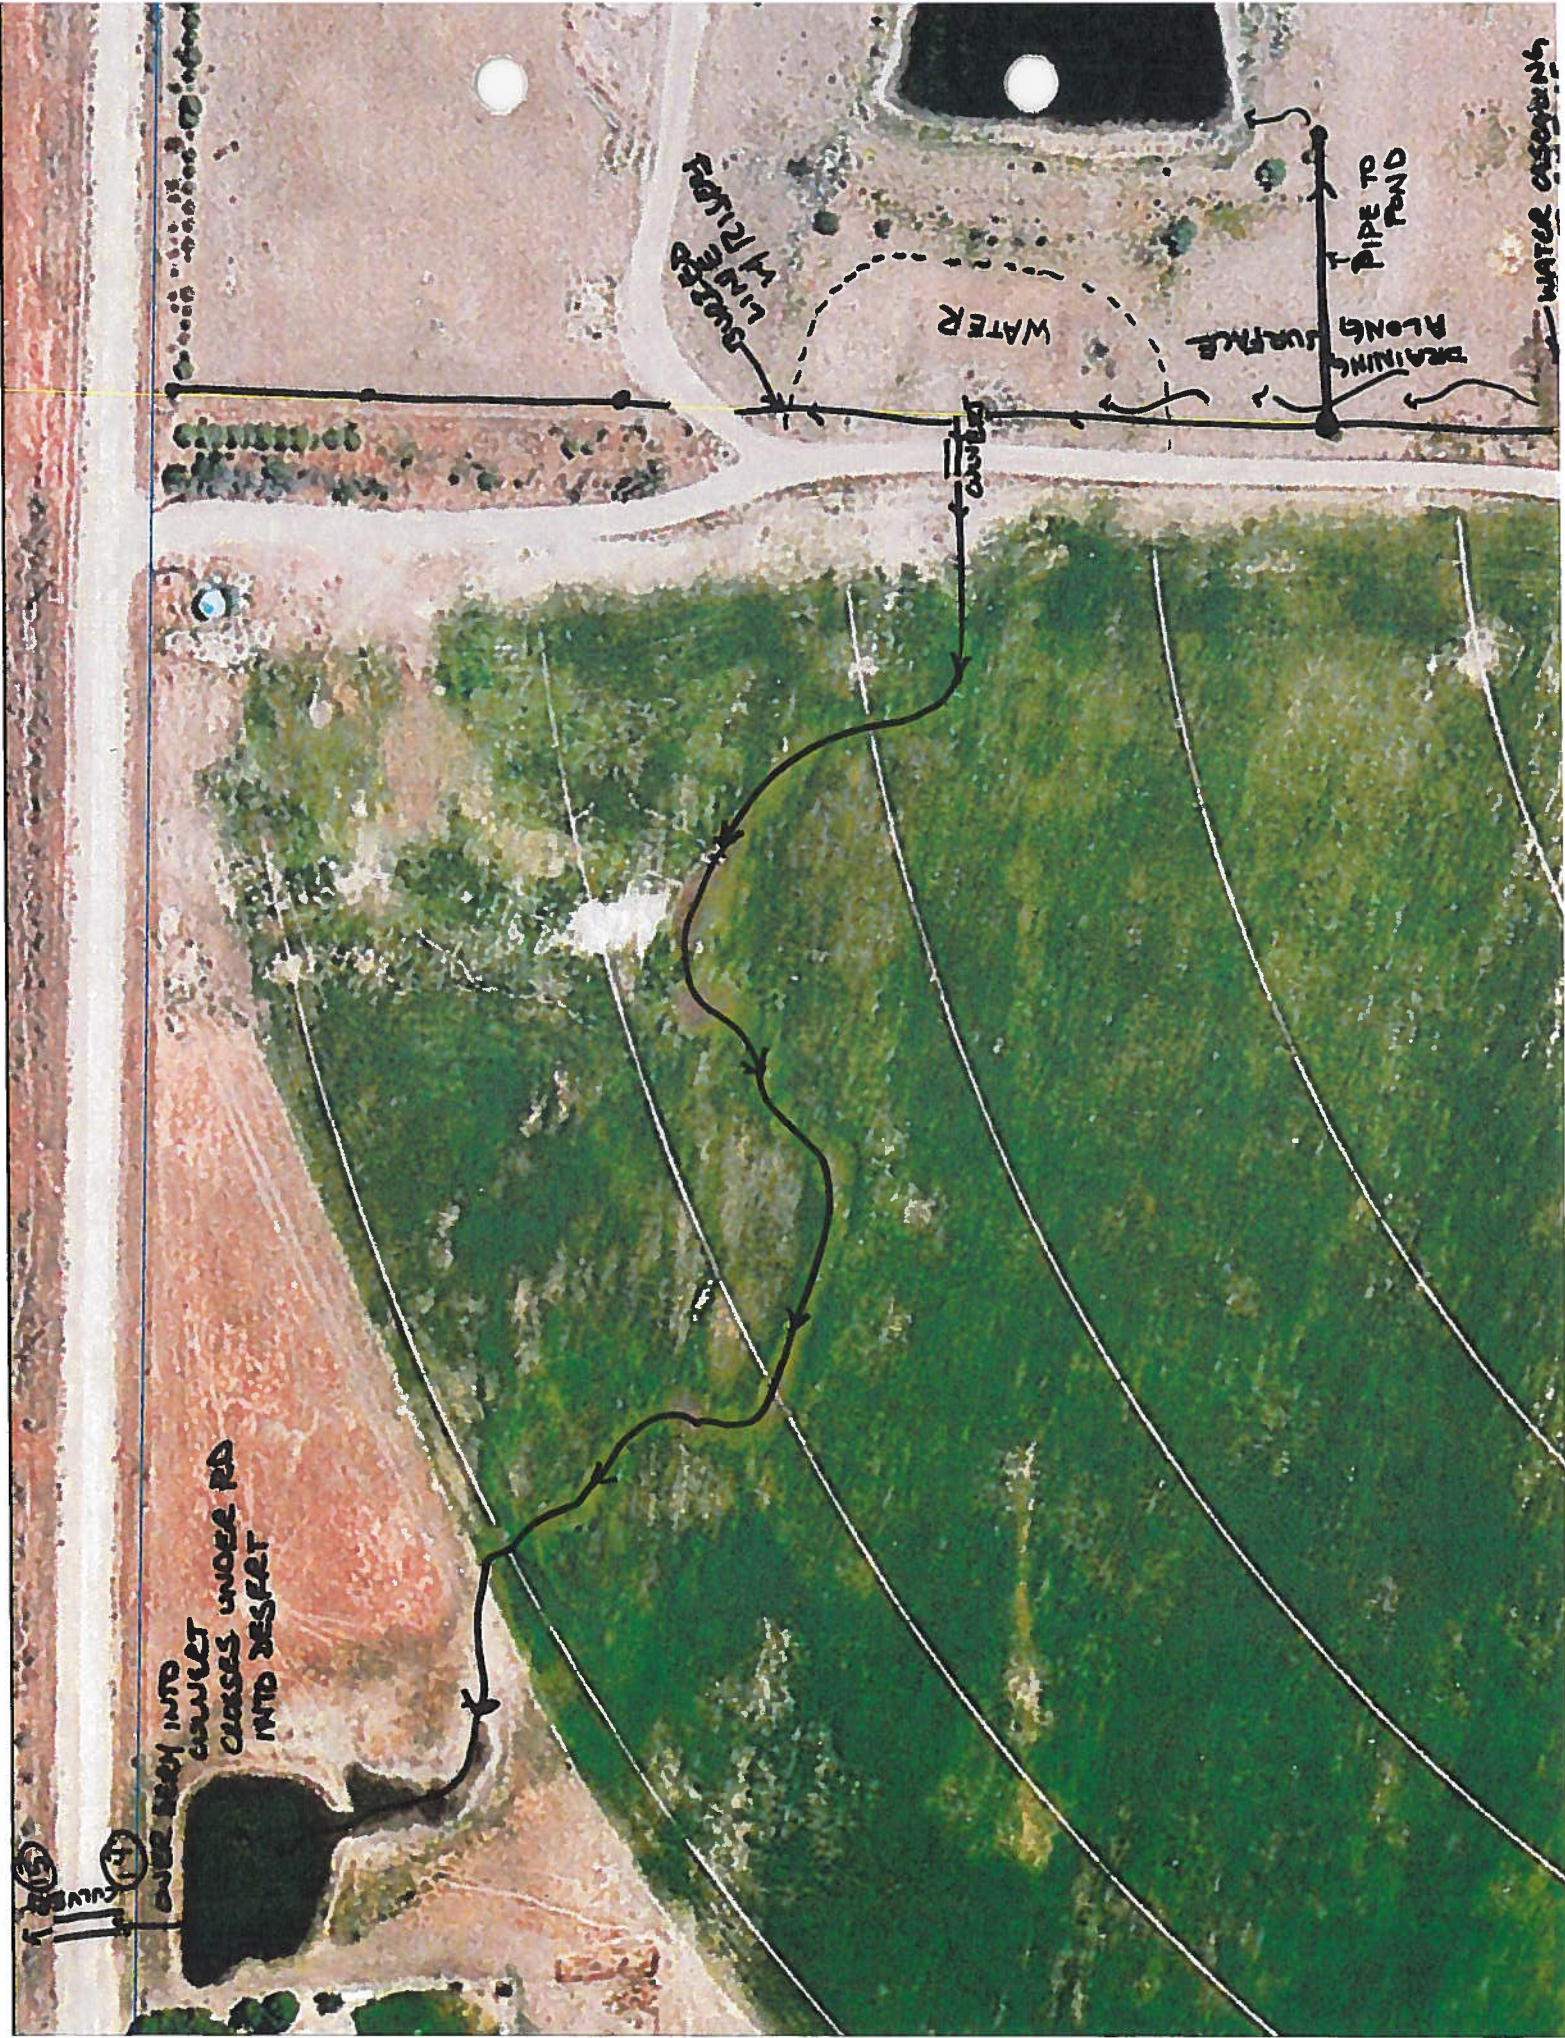
- Riser off this line had section of pipe being used to divert water from mainline to surface, which drains into series of ponds north of the gravel pit. See maps/diagrams and photos for details.

WATER

PIPE FROM  
RISER TO  
POND

- There are **no recorded water rights authorizing storage (ponds)** on the property, either filled with surface runoff OR ground water.
- See previous memo dated 4/19/2012 for additional conclusions and recommendations for further action.

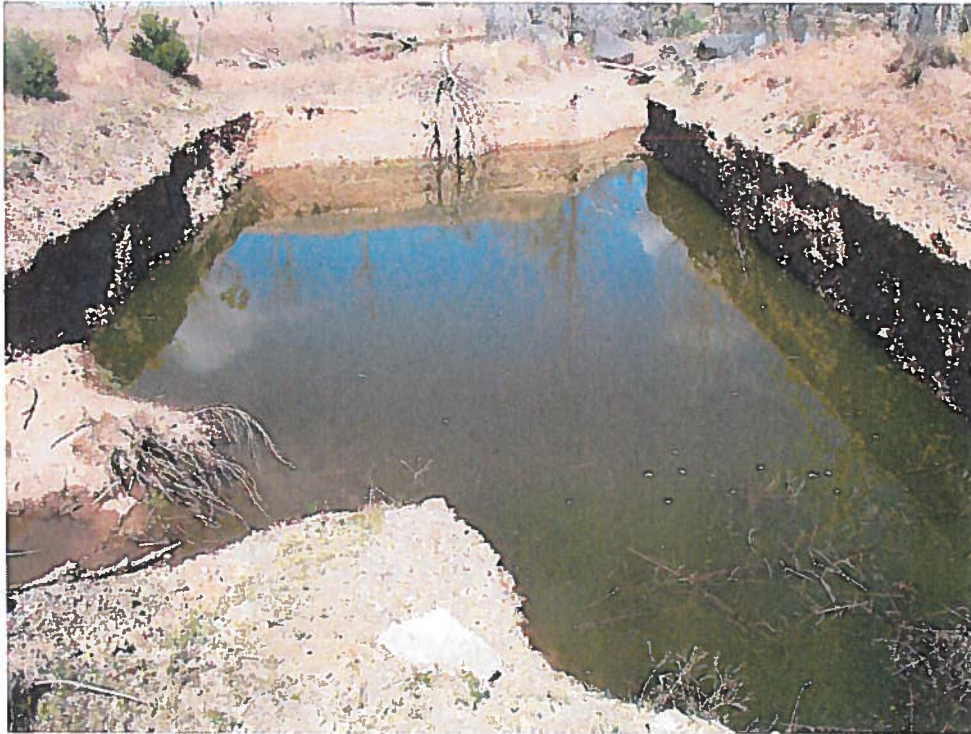
**SMT Investors/Scheff Complaint 6/6/2012:** Far SE pond in series of ponds north of gravel pit (facing west). Location 1 on map.

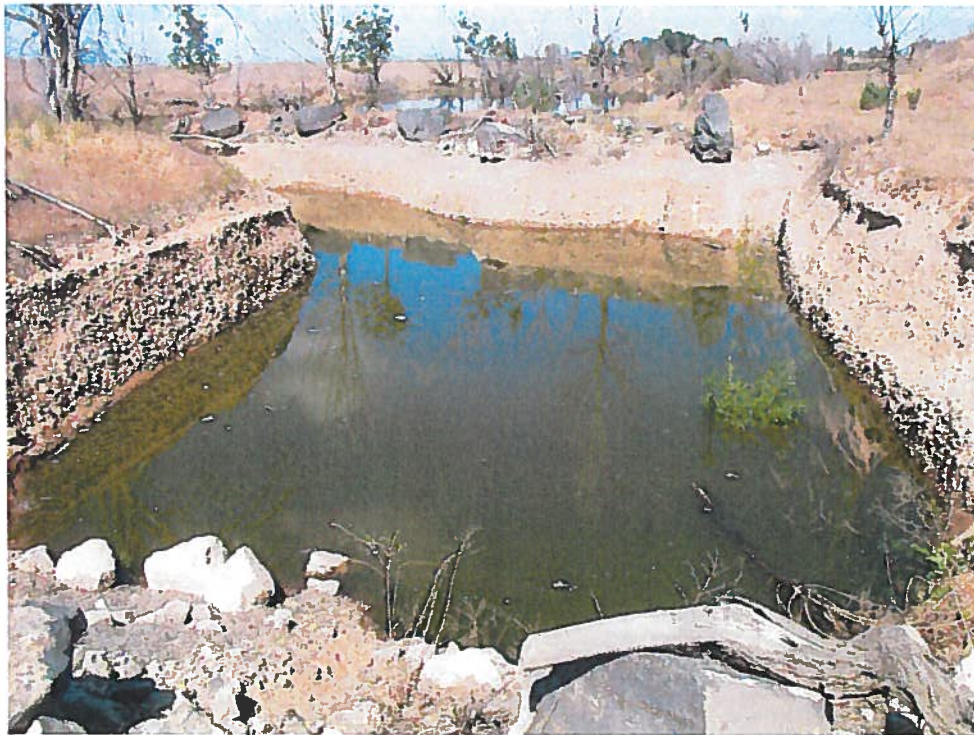
**SMT Investors/Scheff Complaint 6/6/2012:** Far NE pond in series of ponds (facing west). Location 2 on map.

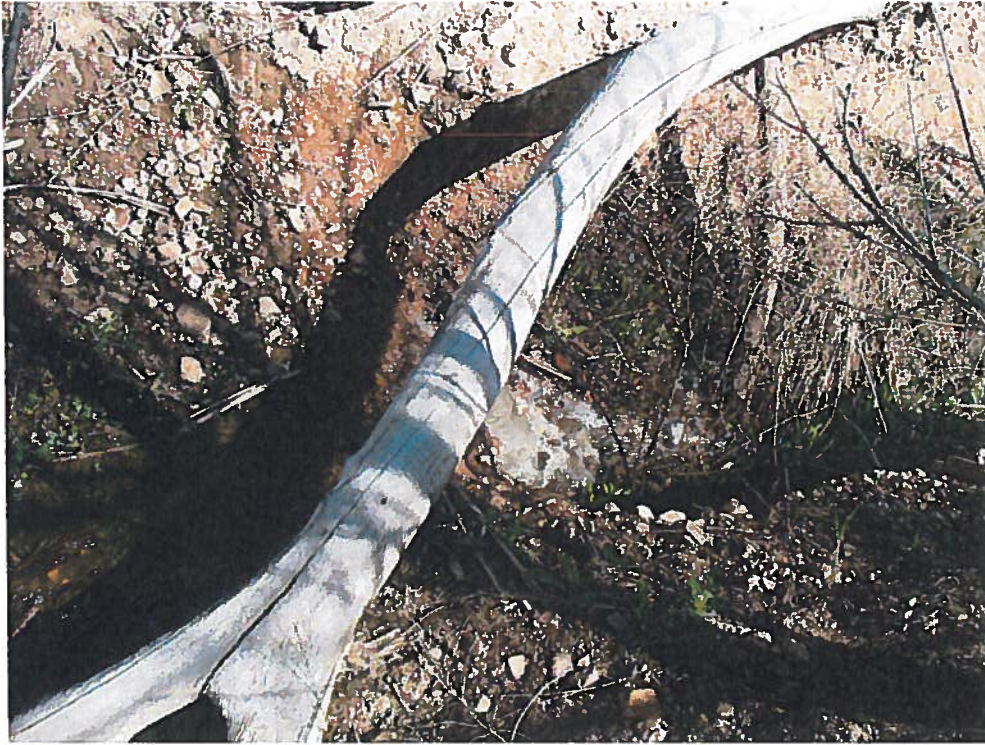
**SMT Investors/Scheff Complaint 6/6/2012:** Water flowing out of central pond into far SE pond in series of ponds (facing north). Location 3 on map.

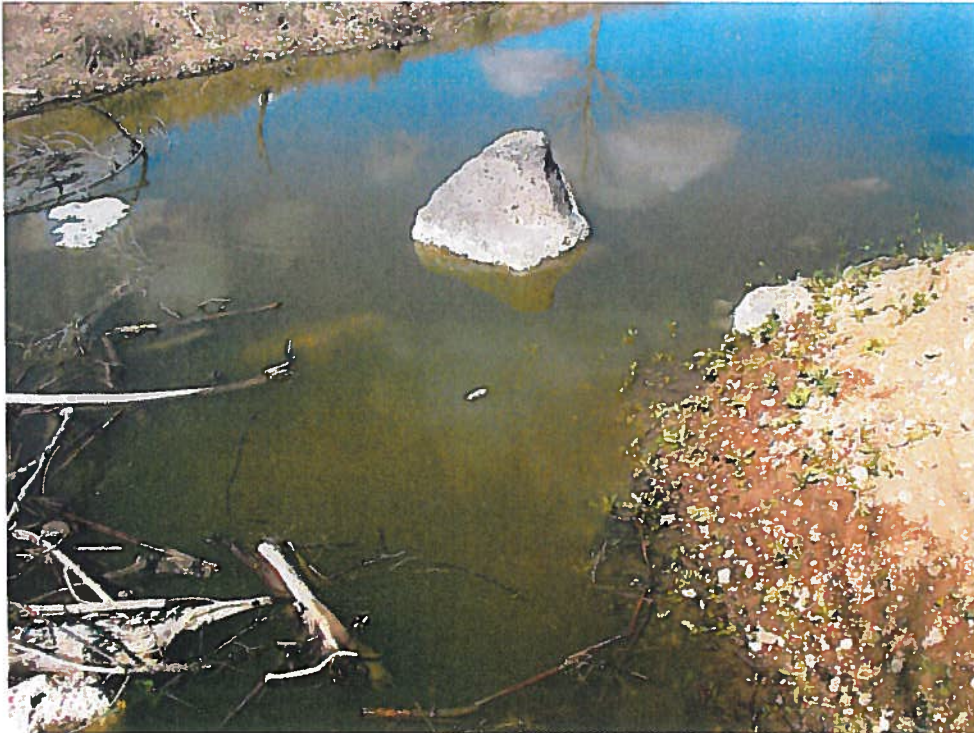
**SMT Investors/Scheff Complaint 6/6/2012:** Area water flowing out of central pond into far SE pond in series of ponds (facing north). Location 4 on map.

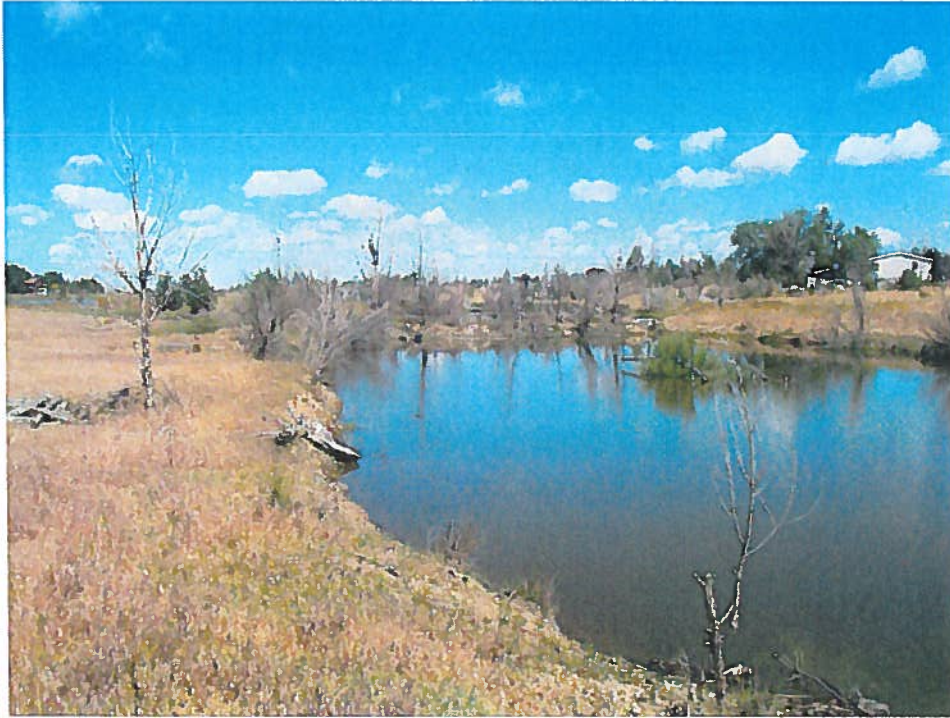
**SMT Investors/Scheff Complaint 6/6/2012:** Central pond in series of ponds (facing west). Location 5 on map.

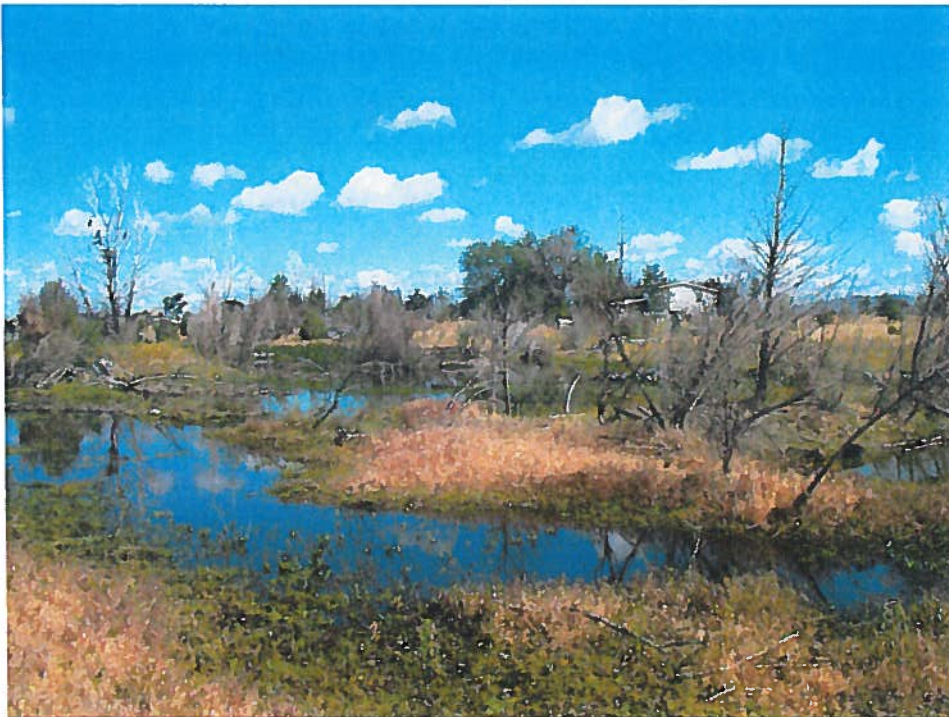
**SMT Investors/Scheff Complaint 6/6/2012:** Area between far west pond in series of ponds (facing north/northeast). Water moving from far west pond to central pond in this area. Location 6 on map.

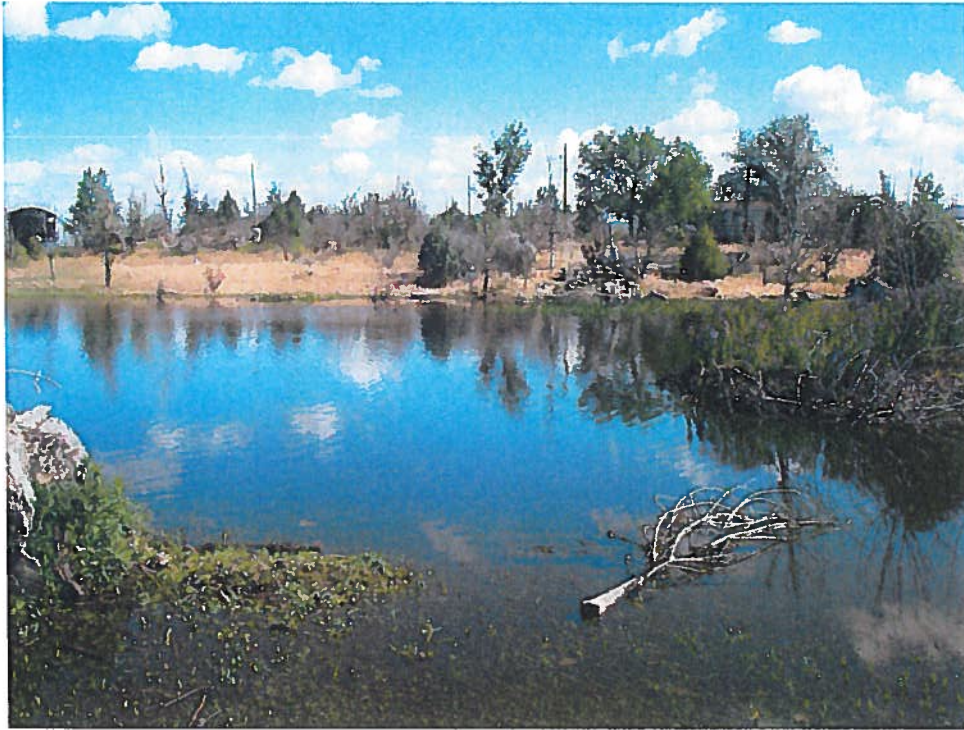
**SMT Investors/Scheff Complaint 6/6/2012:** Far west pond in series of ponds (facing north). Location 7 on map.

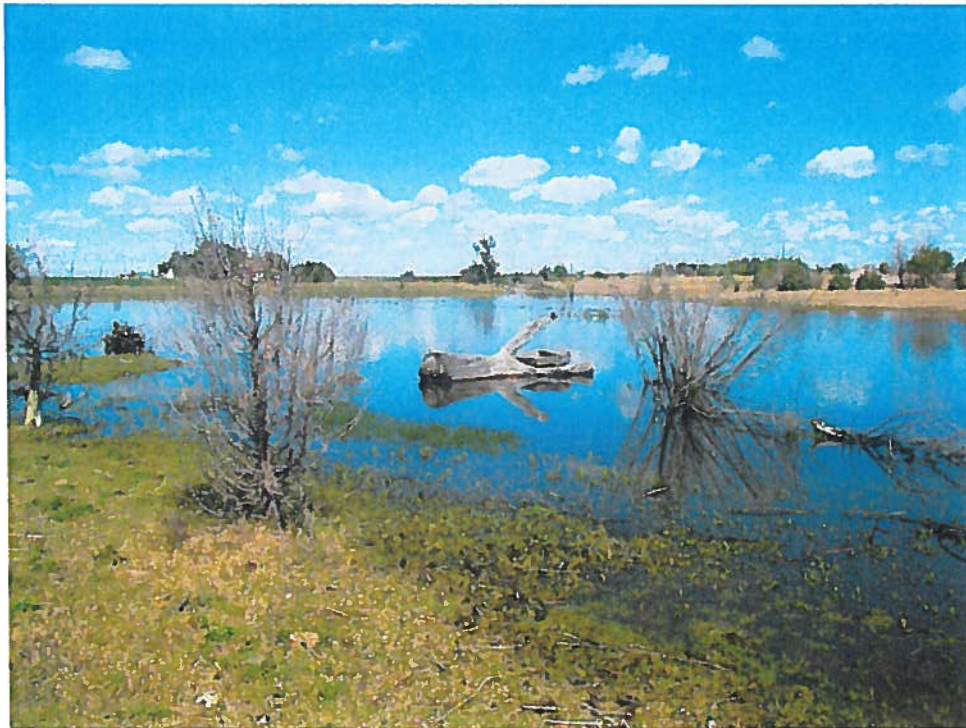
**SMT Investors/Scheff Complaint 6/6/2012:** Far west pond in series of ponds (facing west/northwest). Location 8 on map.

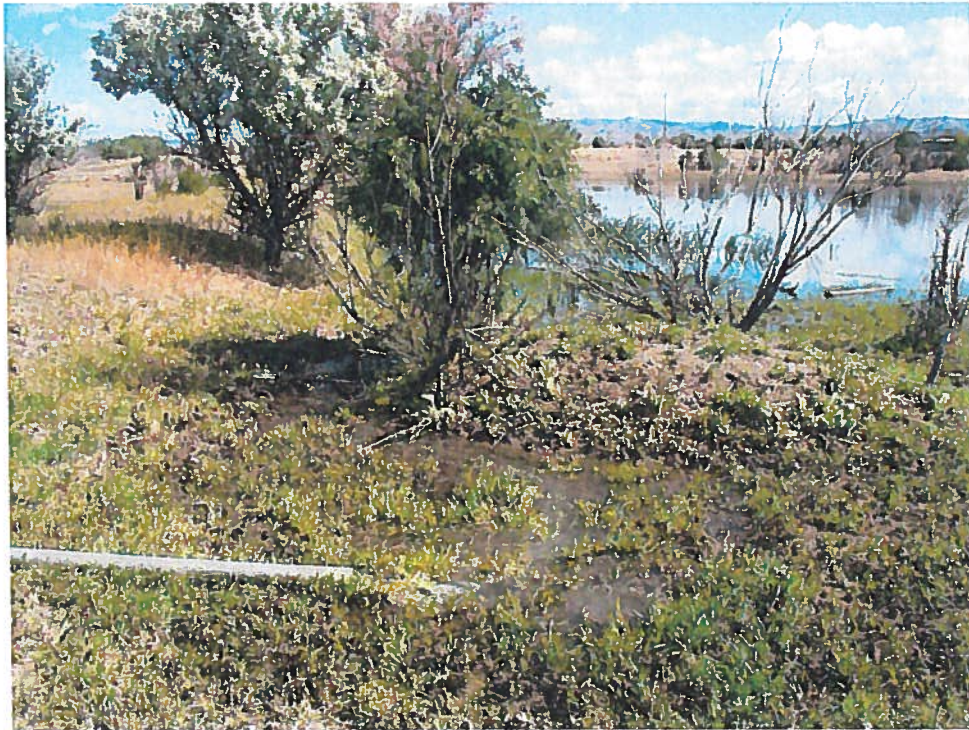
**SMT Investors/Scheff Complaint 6/6/2012:** Water draining from pipe into far west pond in series of ponds (facing north). Location 9 on map.

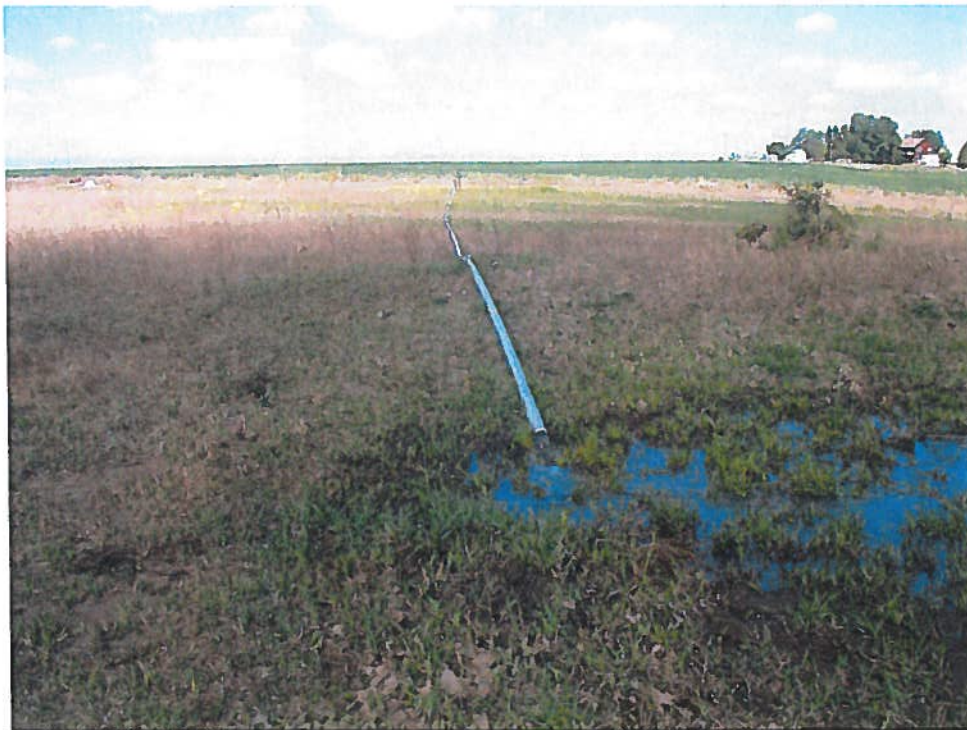
**SMT Investors/Scheff Complaint 6/6/2012:** Water draining from pipe into far west pond in series of ponds (facing west). Location 9 on map.

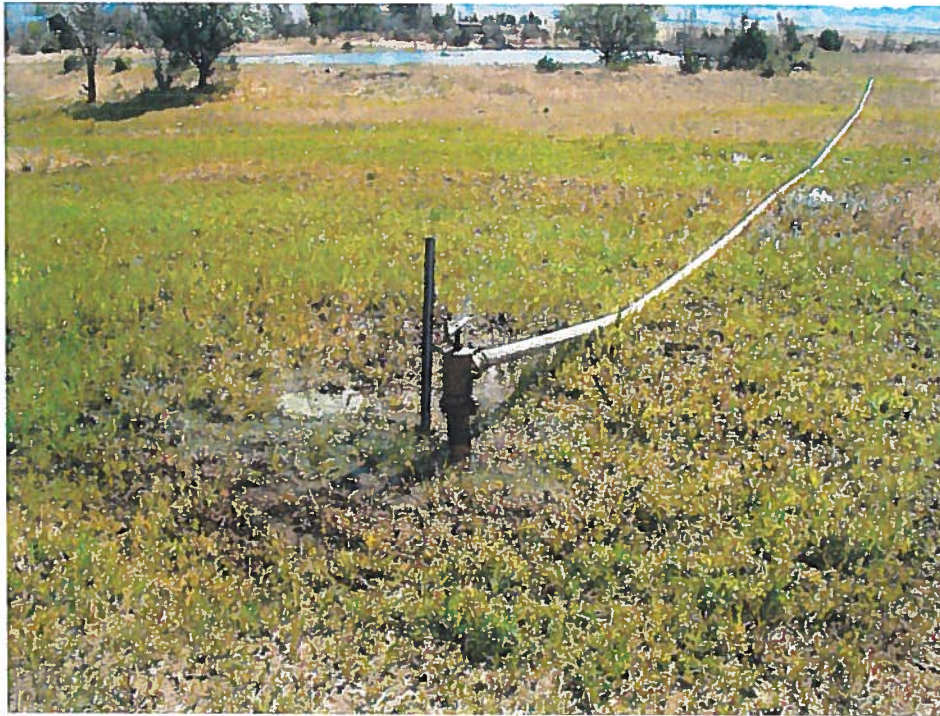
**SMT Investors/Scheff Complaint 6/6/2012:** Pipe connected to riser off mainline from well draining into far west pond in series of ponds (facing east). Location **10** on map.

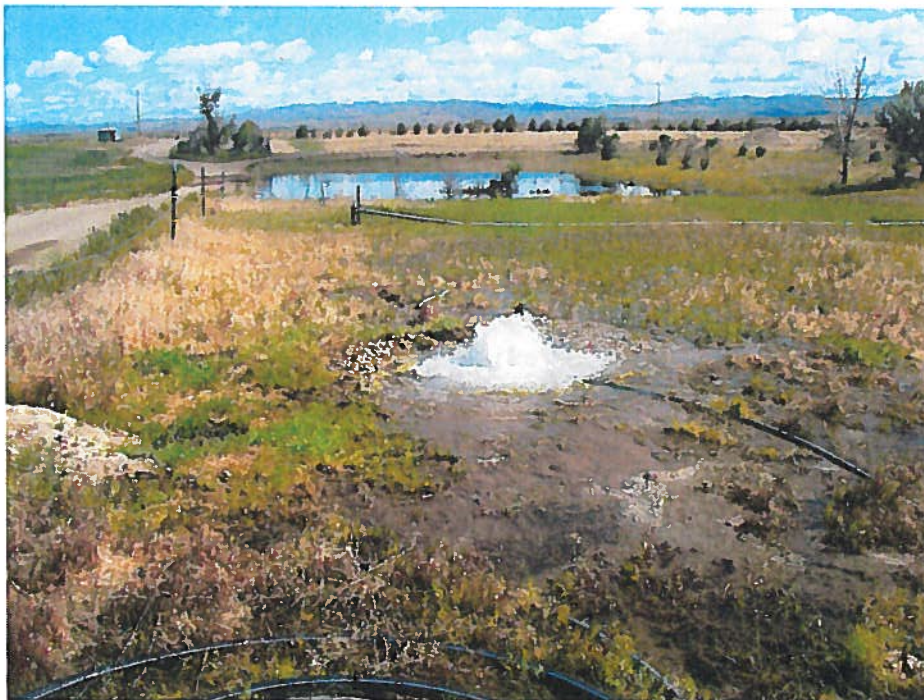
- Water assumingly coming from mainline just upstream of one riser was draining onto surface at far west edge of ponds also.
  - Water draining from surface across gravel road into northwestern portion of fields into pond adjacent to Scheff property. Water draining from this pond through culvert under Martha Ave into desert north of Martha Ave.

**SMT Investors/Scheff Complaint 6/6/2012:** Water flowing onto surface draining to the north eventually across the road and into pond adjacent to Scheff property (facing north). Location **11** on map.

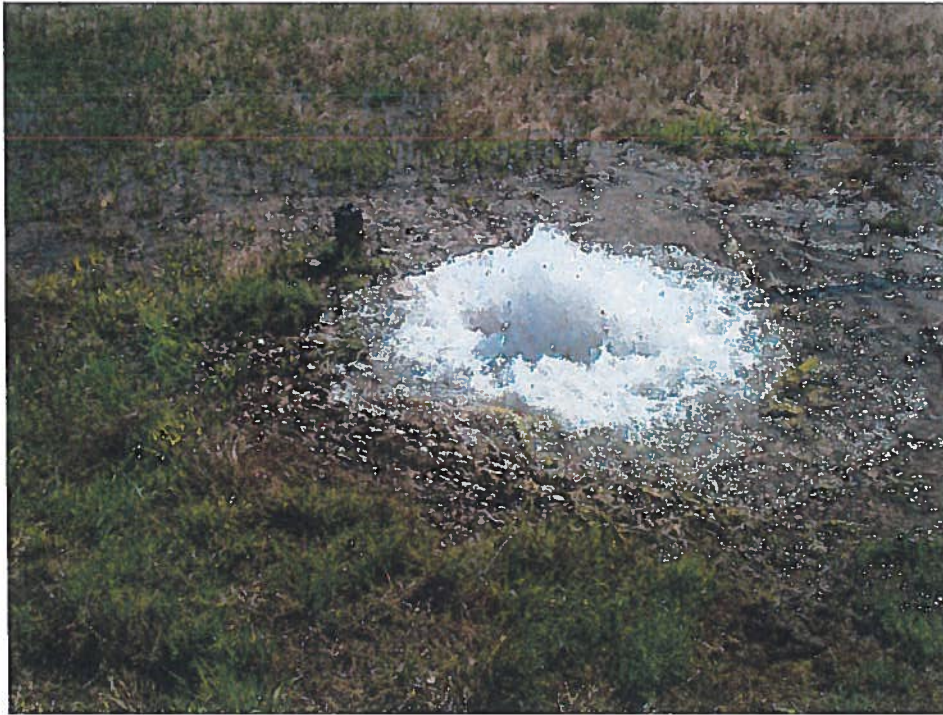
**SMT Investors/Scheff Complaint 6/6/2012:** Close up of water flowing onto surface pictured above. Location **12** on map.

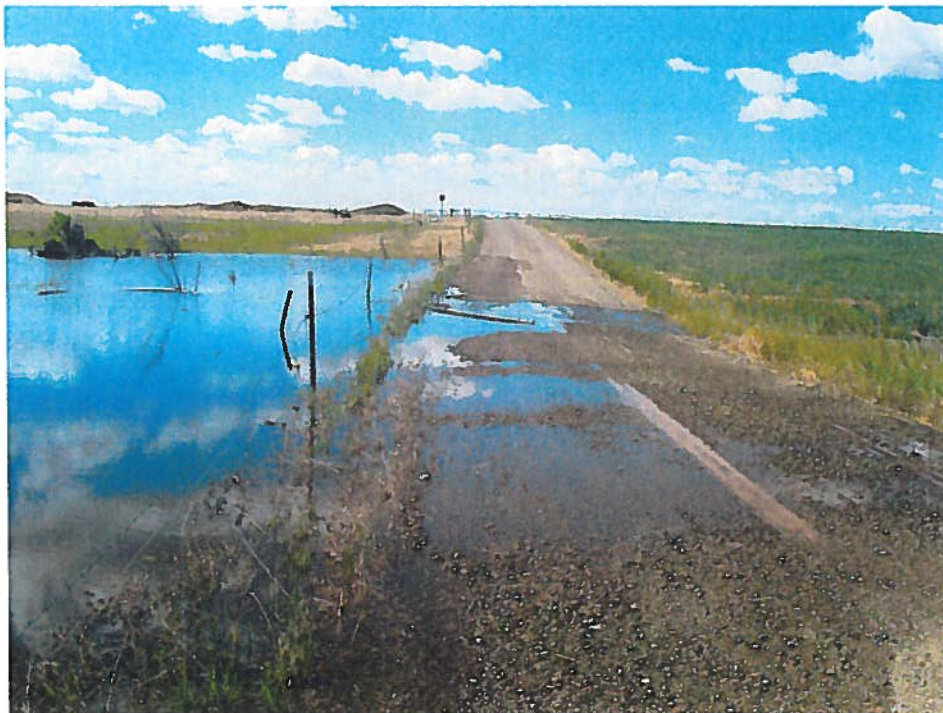
**SMT Investors/Scheff Complaint 6/6/2012:** Water flowing across the road from far west pond in series of ponds (facing south). Water flows across road into field and eventually into pond adjacent to Scheff property. Location **13** on map.

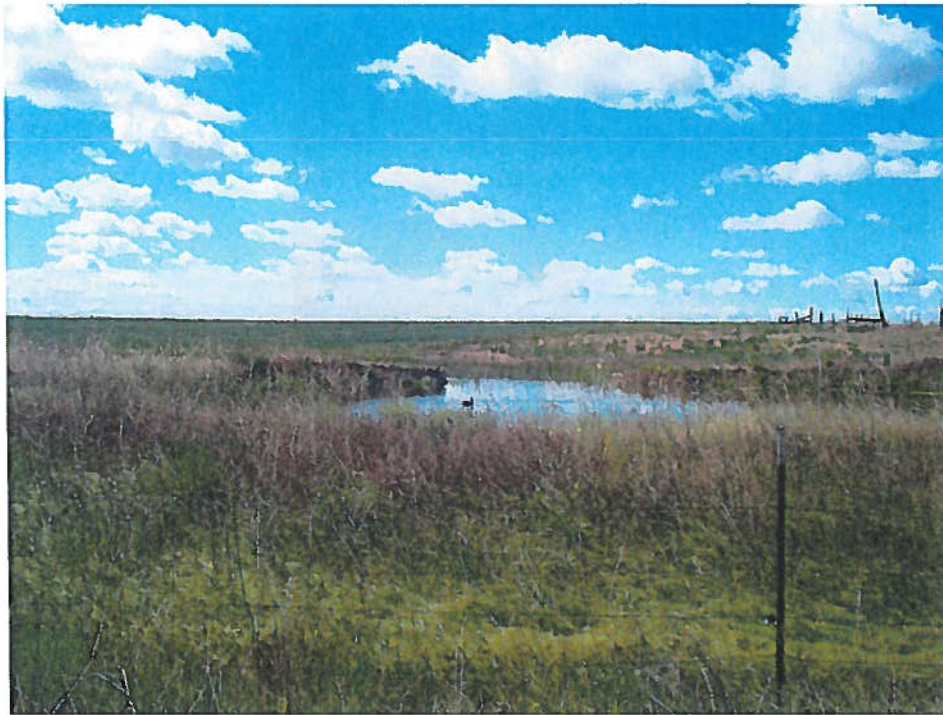
**SMT Investors/Scheff Complaint 6/6/2012:** Pond adjacent to Scheff property (facing south). Location **14** on map.

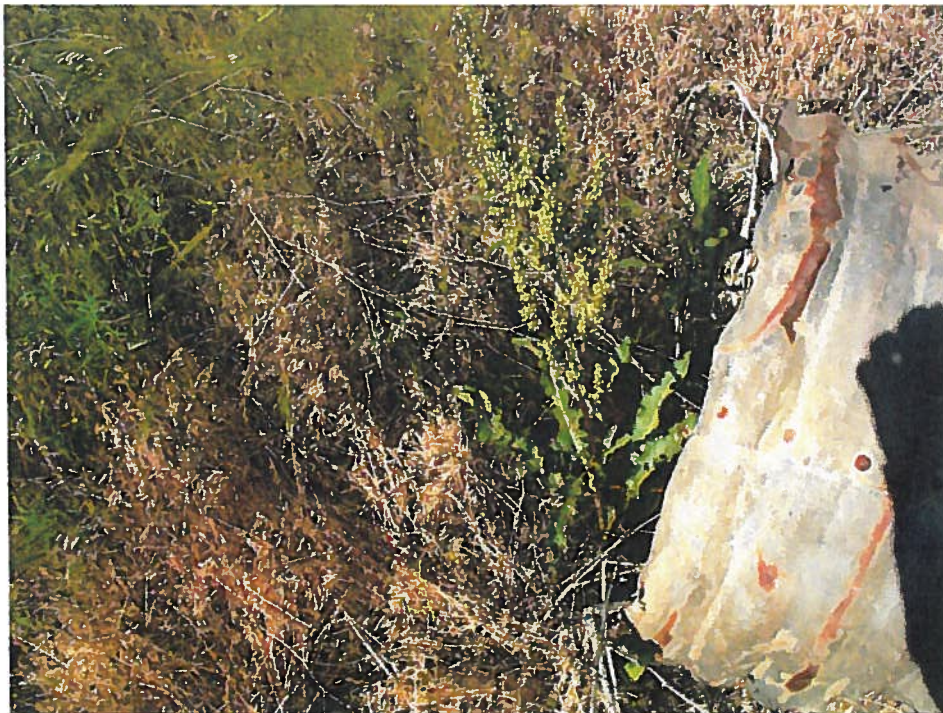
**SMT Investors/Scheff Complaint 6/6/2012:** Water draining from pond adjacent to Scheff property into south end of culvert under Martha Ave. Location **14** on map.

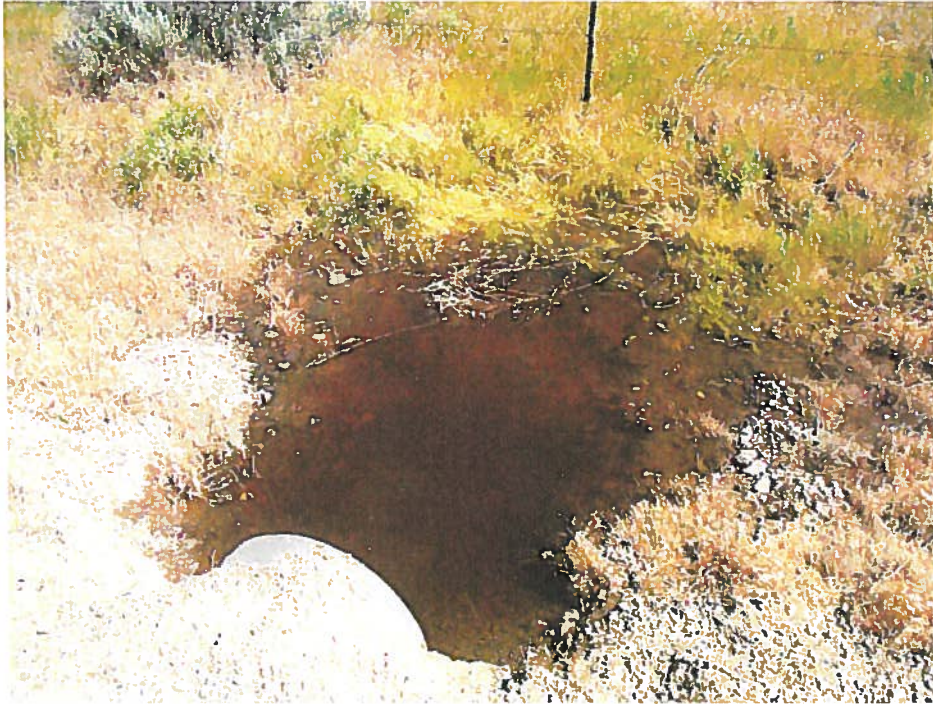
**SMT Investors/Scheff Complaint 6/6/2012:** Water draining out into desert from north end of culvert under Martha Ave (facing north/northwest). Water draining through culvert from pond adjacent to Scheff property. Location **15** on map.
