STATE OF IDAHO  
DEPARTMENT OF WATER RESOURCES  
**BENEFICIAL USE FIELD REPORT**

Permit No: 67-14383

Exam Date: 8/2/2012

**PLACE OF USE:** WILDLIFE STORAGE

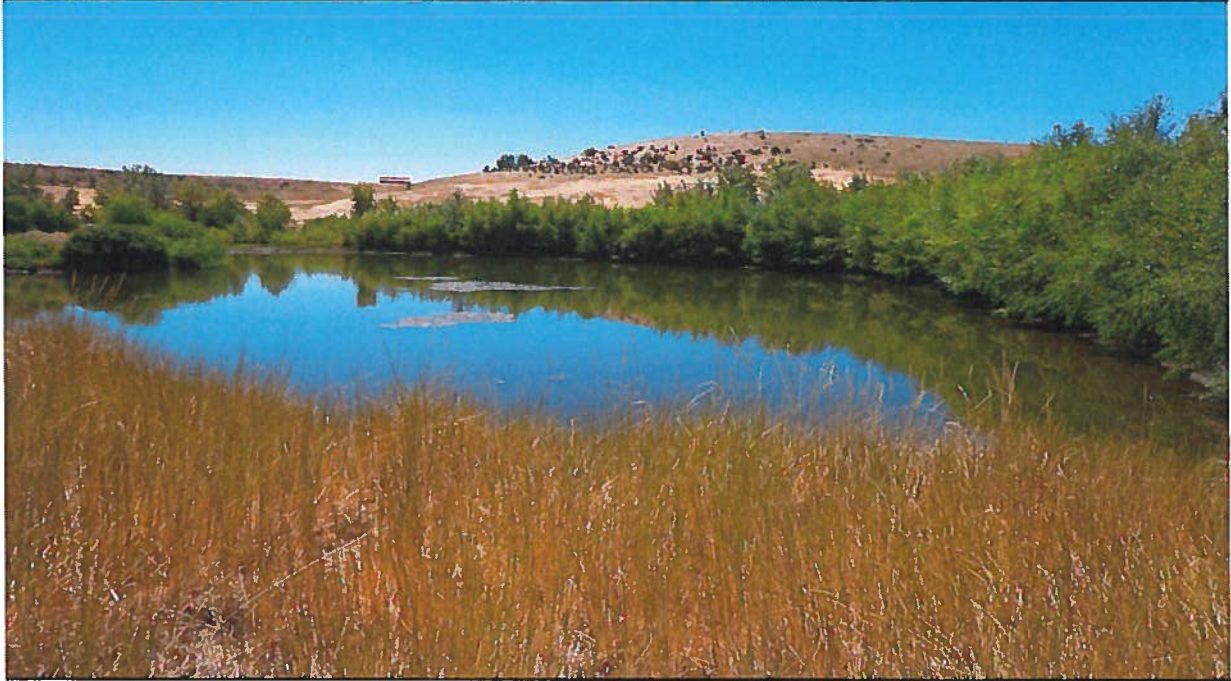
Point of Diversion/Place of Use: View southeasterly of wildlife storage pond. Dam with a thick cover of trees and brush is shown on the south and west end of the pond.

A 1 ½ acre wildlife storage pond, with a small island, was constructed near an unnamed stream. A 9-foot high dam with a spillway impounds water for wildlife. Since the right holder is not permitted to divert water from the unnamed stream to the wildlife storage pond, and there is no visible continuous source of water to the wildlife storage pond, it is concluded that the water supply to the pond is from a spring in the pond. Two runoff channels, which capture the springtime snow melt and storm water runoff, discharge into the wildlife storage pond. However, these channels are normally dry and are not active waterways in which to sustain the water level in the wildlife storage pond.

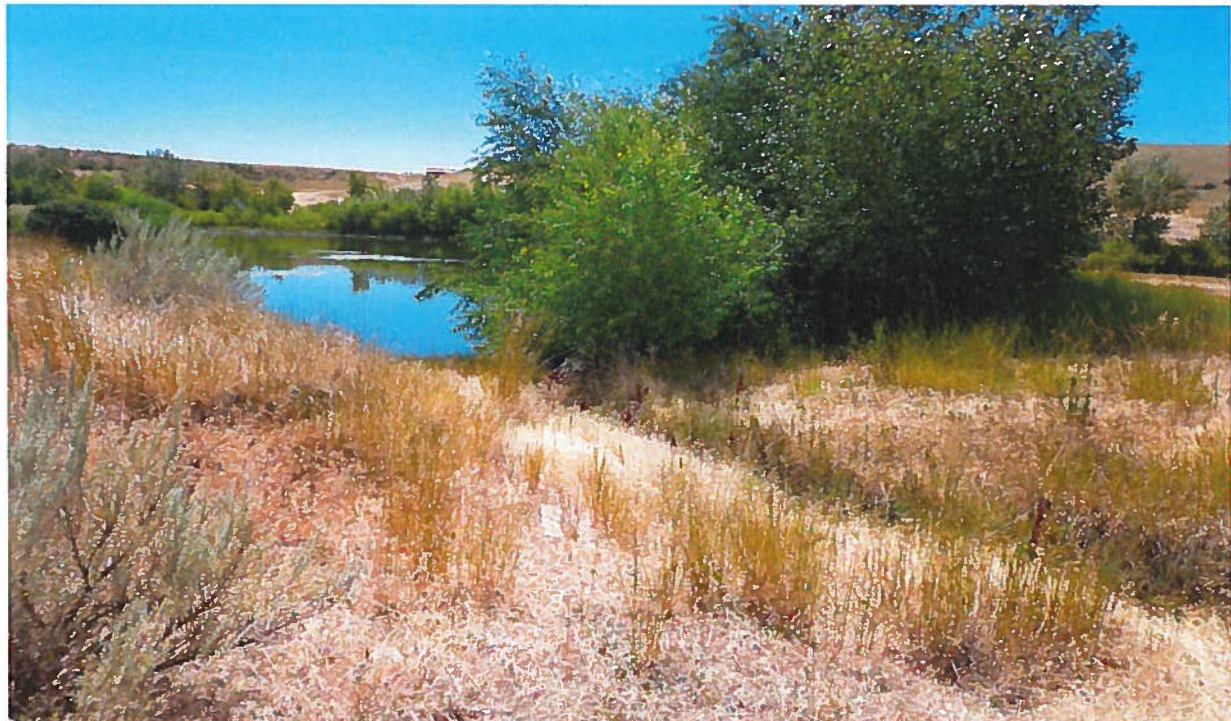
View southeasterly of wildlife storage pond and spillway. Spillway turns southwesterly and discharges to an unnamed stream.

CONDITION NO.4 – Permit holder shall construct a channel from the bottom of the spillway to the unnamed stream. The original permit holder constructed a spillway channel to the unnamed stream. Therefore, the permit holder is in compliance with Condition of Approval No.4.

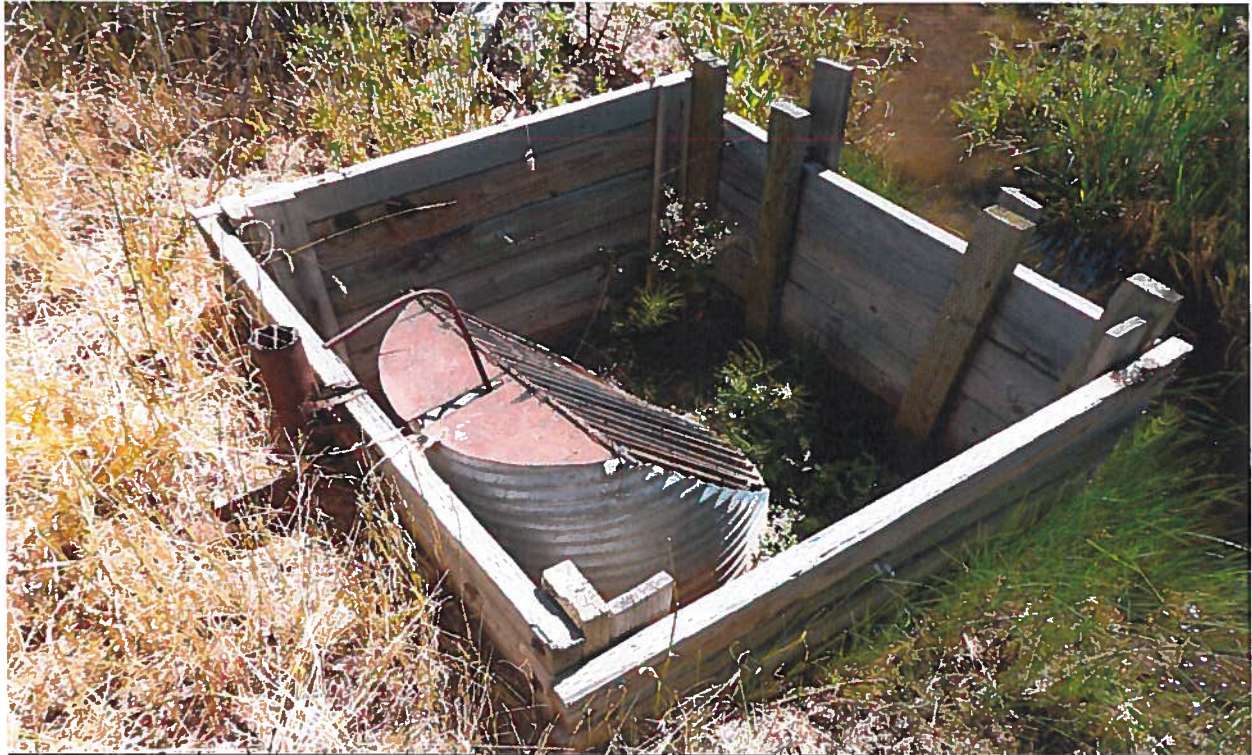
Point of Diversion (Abandoned): View southwesterly of abandoned headgate and collection structure on the unnamed stream. The original right holder used the unnamed stream as a supplemental source of water for the wildlife storage pond. The new right holder, which purchased the property in 2005, has never used the diversion structure for diverting water to the pond. The right holder indicated that a pipeline, which parallels the unnamed stream, was connected to the abandoned pipeline to the wildlife storage pond. The pipeline bypasses the wildlife storage pond to provide water to a downstream property owner.

CONDITION'S NO. 3 & NO.7 – No water shall be diverted to the reservoir from the unnamed stream located south of the impoundment. The original permit holder filled in the excavated open channel from the unnamed stream to the wildlife storage pond. Therefore, permit holder is in compliance with Conditions of Approval No.3 & No.7.

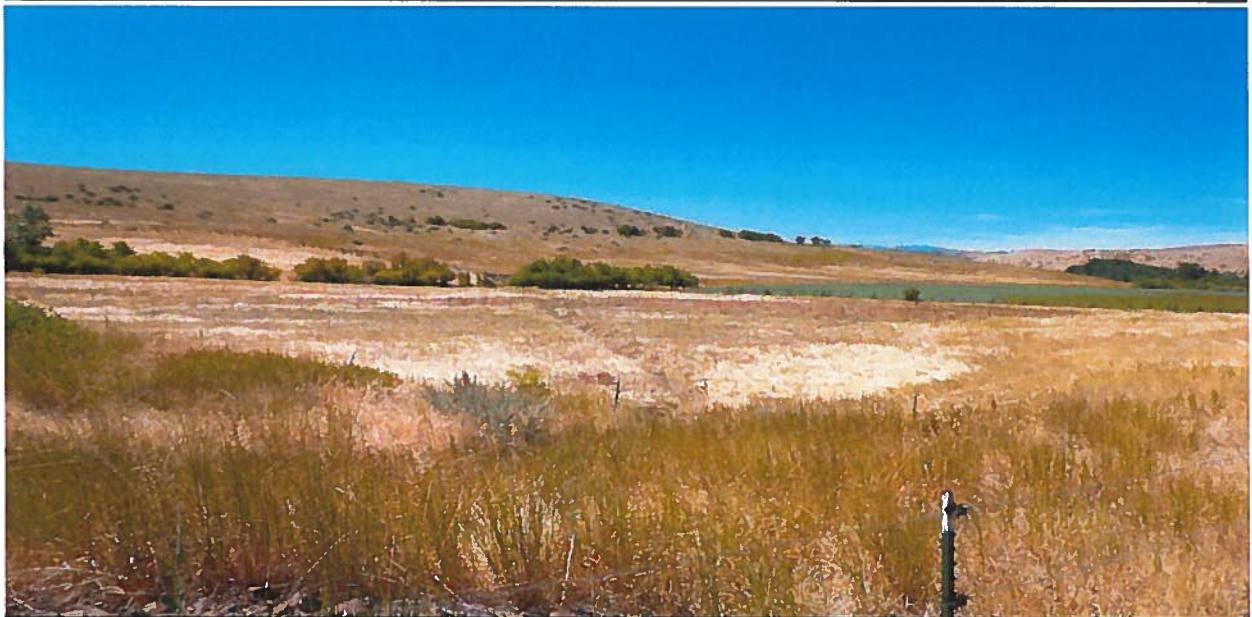
View southwesterly of wildlife storage pond spillway directed toward unnamed stream.
