STATE OF IDAHO  
DEPARTMENT OF WATER RESOURCES  
**BENEFICIAL USE FIELD REPORT**

Permit No: 63-31376

Exam Date: 9/19/2012

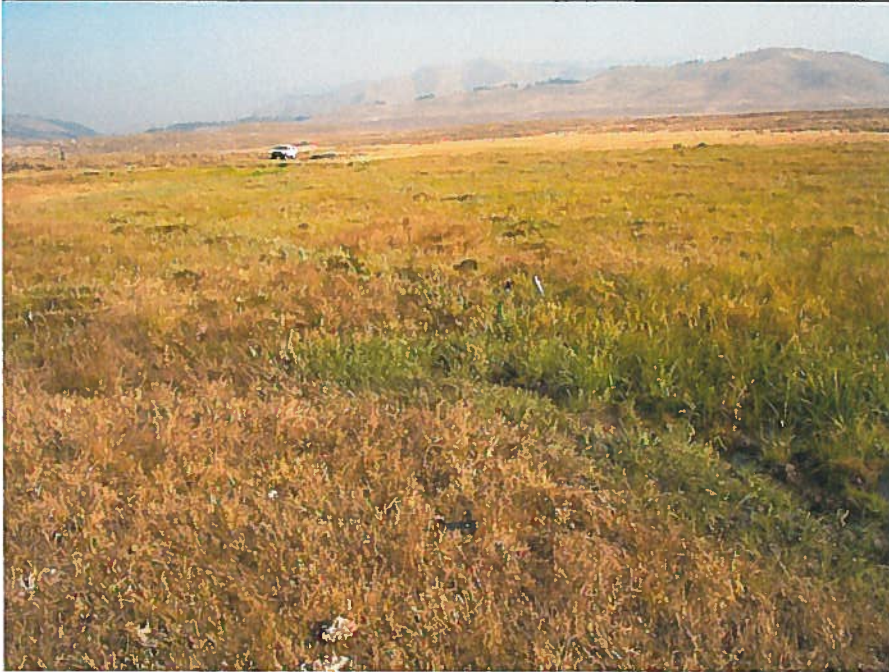
Photo 1

You are looking north in this photo. This spot is the beginning of a buried collection line (4") that runs across this spring seep area toward the stocktank that is near the jeep.

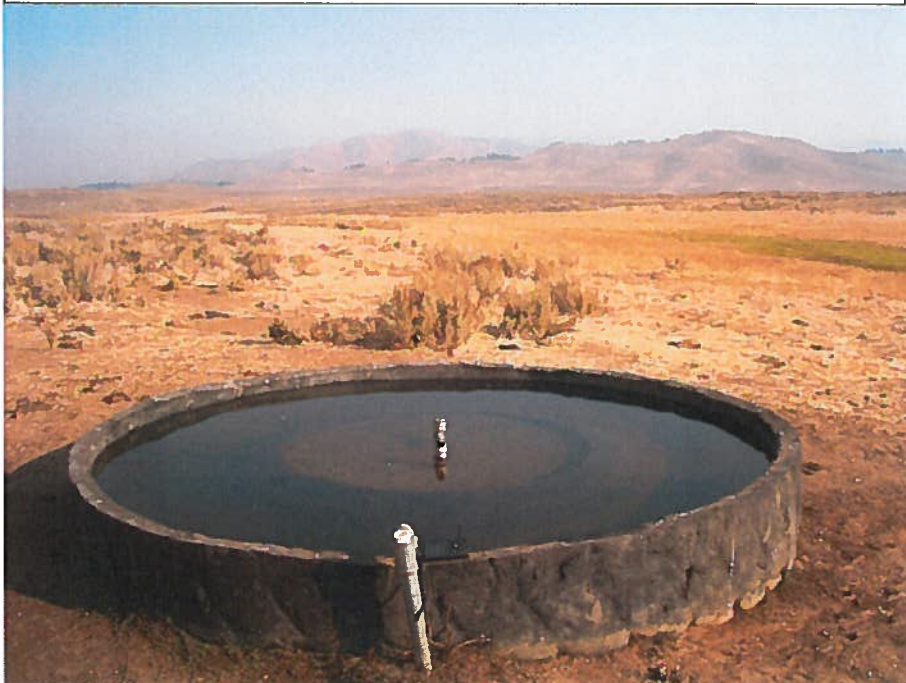
Photo 2

This photo is also looking north at the uke stocktank. The overflow line is in the center of the tank.
