STATE OF IDAHO  
DEPARTMENT OF WATER RESOURCES  
**BENEFICIAL USE FIELD REPORT**

Permit No: 63-31344

Exam Date: 9/19/2012

# 63-31344 LICENSING PLACE OF USE

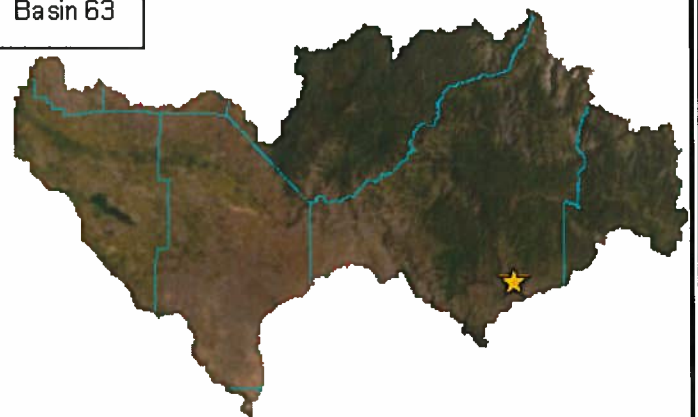
- Found point of diversion
- Found place of use
- Township lines
- Section lines
- Quarter/quarter lines

GIS PLACE OF USE PRESENTATION  
2011 AERIAL PHOTOGRAPHY  
BY KELLY K CHRISTENSEN

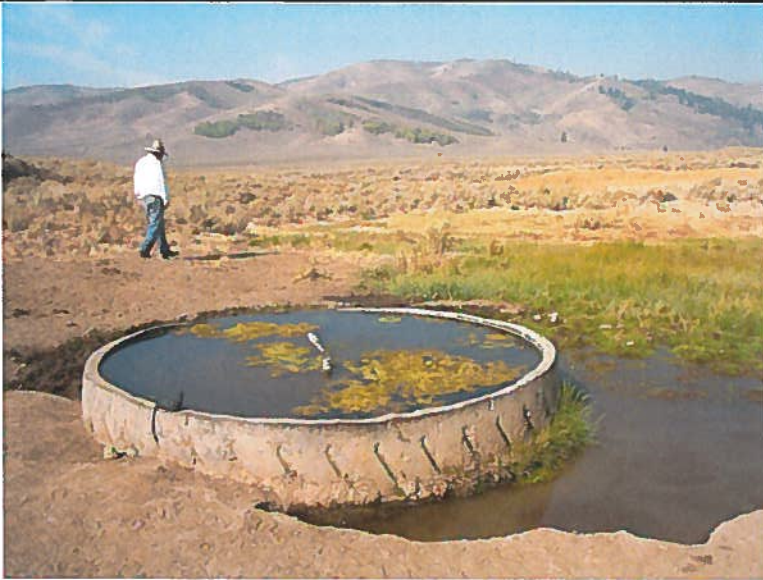
Photo 1

You are looking west in this photo across the stocktank. The west side of the uke tire tank settled slightly making that area slightly lower than the overflow pipe installed in the center of the trough.

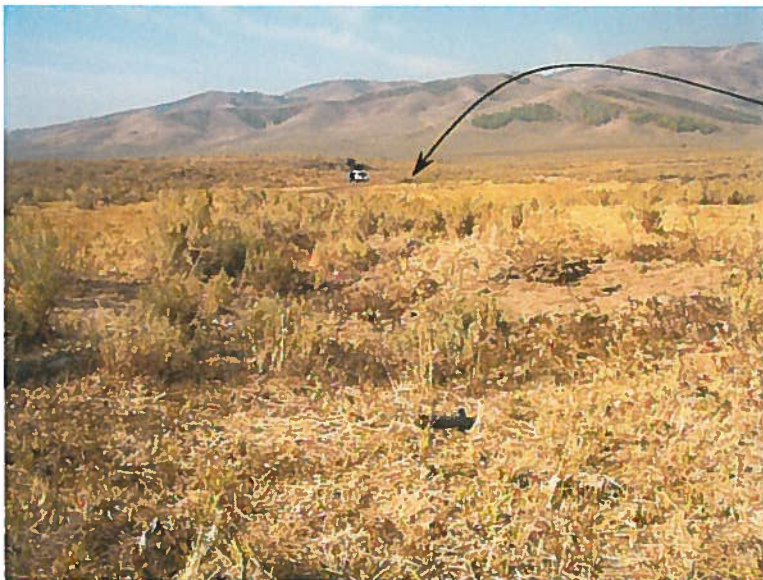
Photo 2

Stocktank

You are looking west in this photo toward the tank which is just to the right of the jeep. This is the approximate beginning of the spring development. As there is no longer any water coming to the surface above the stocktank physical characteristics of original development is not obvious. Between this point and the stocktank there is some indication of the pipeline route. This is the best estimate of the POD.

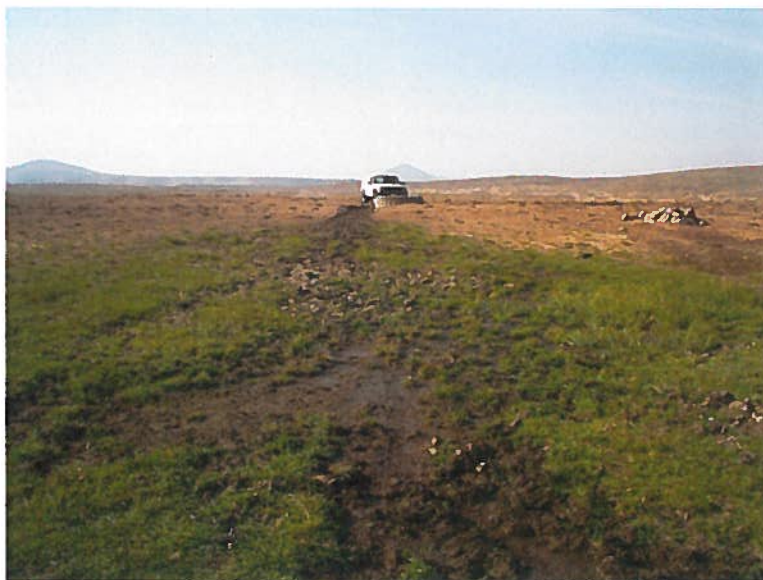
Photo 3

You are looking east southeast in this photo which shows the overflow from the stocktank.
