STATE OF IDAHO  
DEPARTMENT OF WATER RESOURCES  
**BENEFICIAL USE FIELD REPORT**

Permit No: 13-7492

3. **SOURCE**  
SPRING

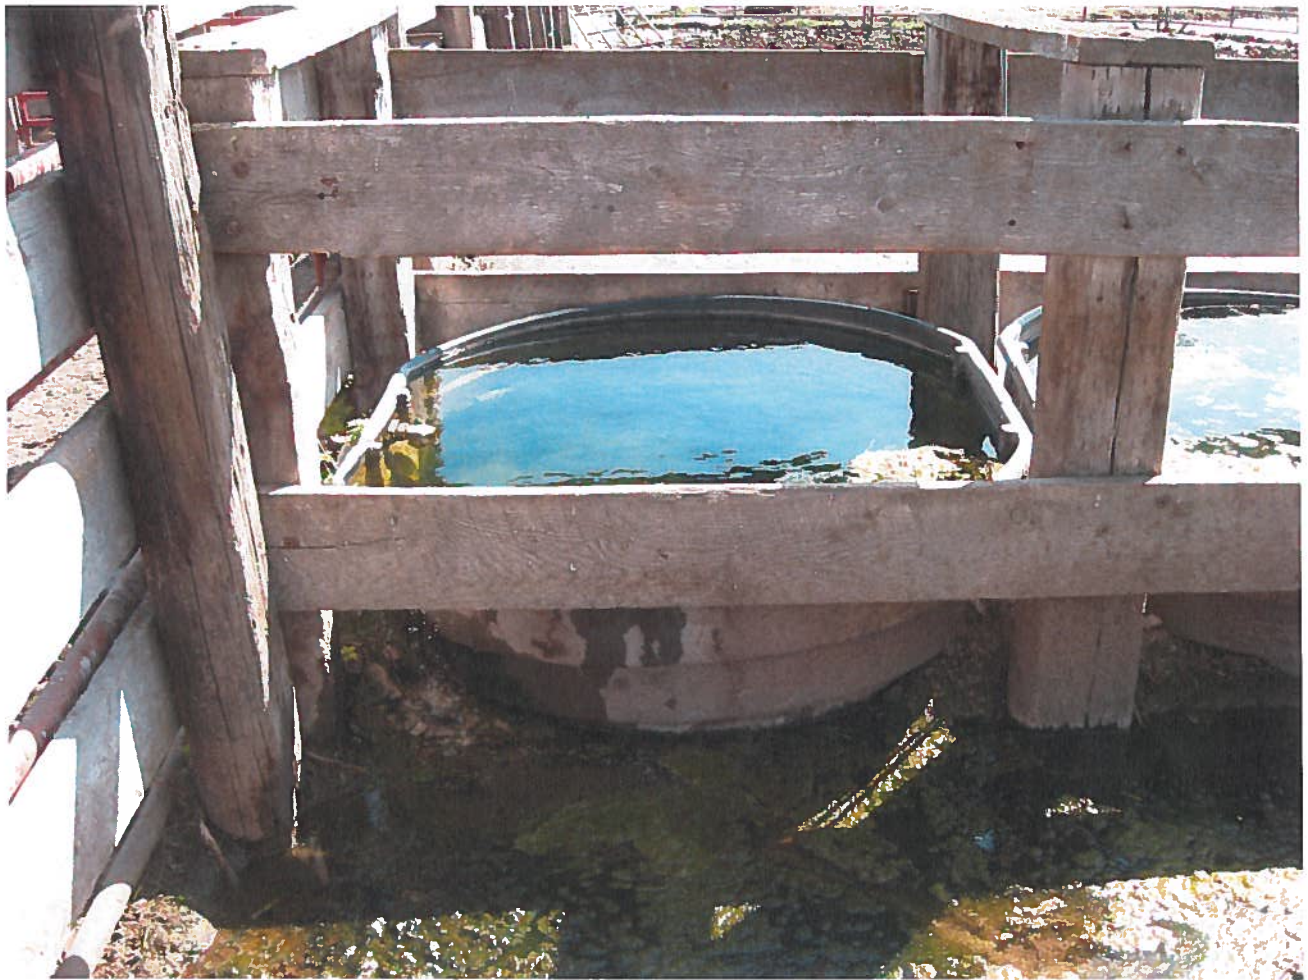
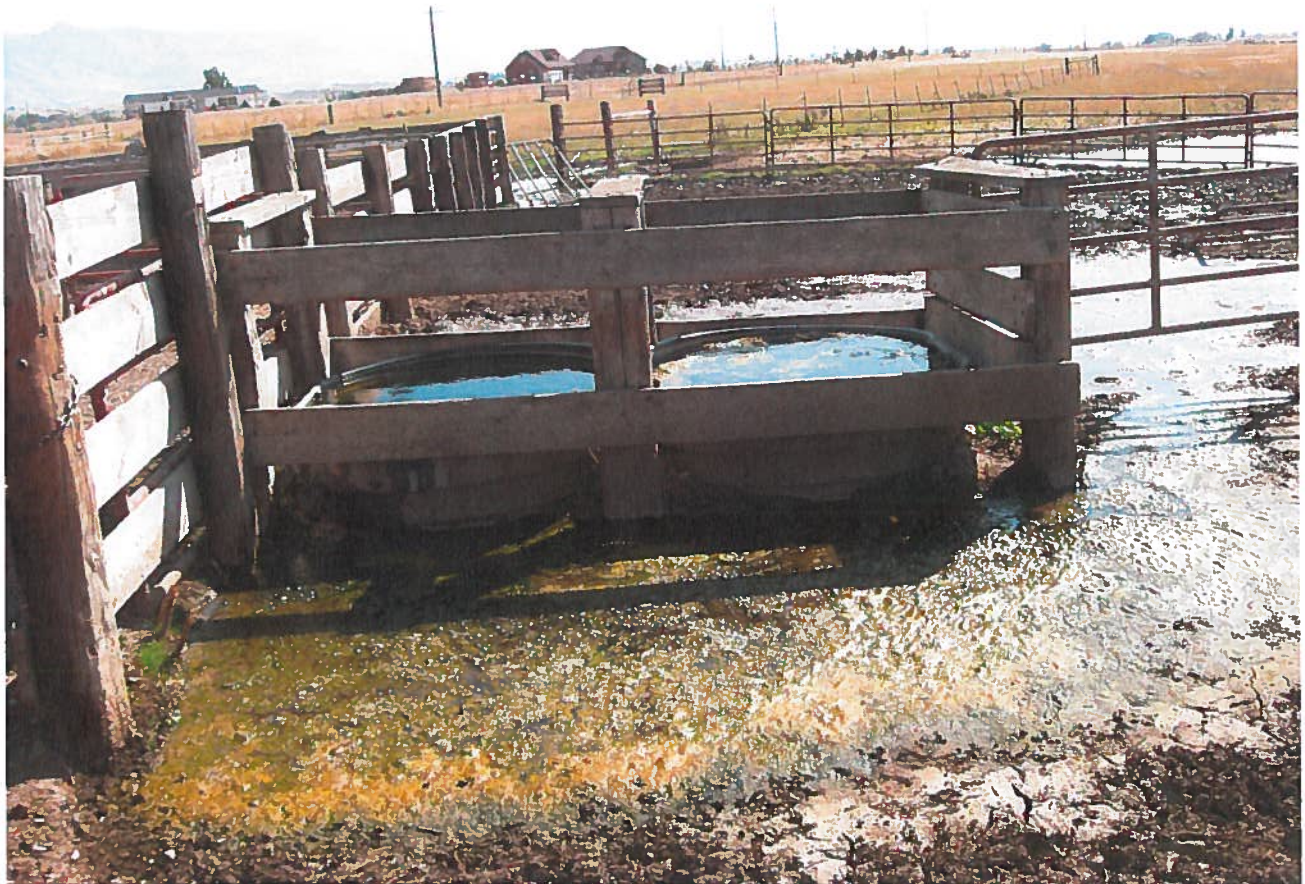
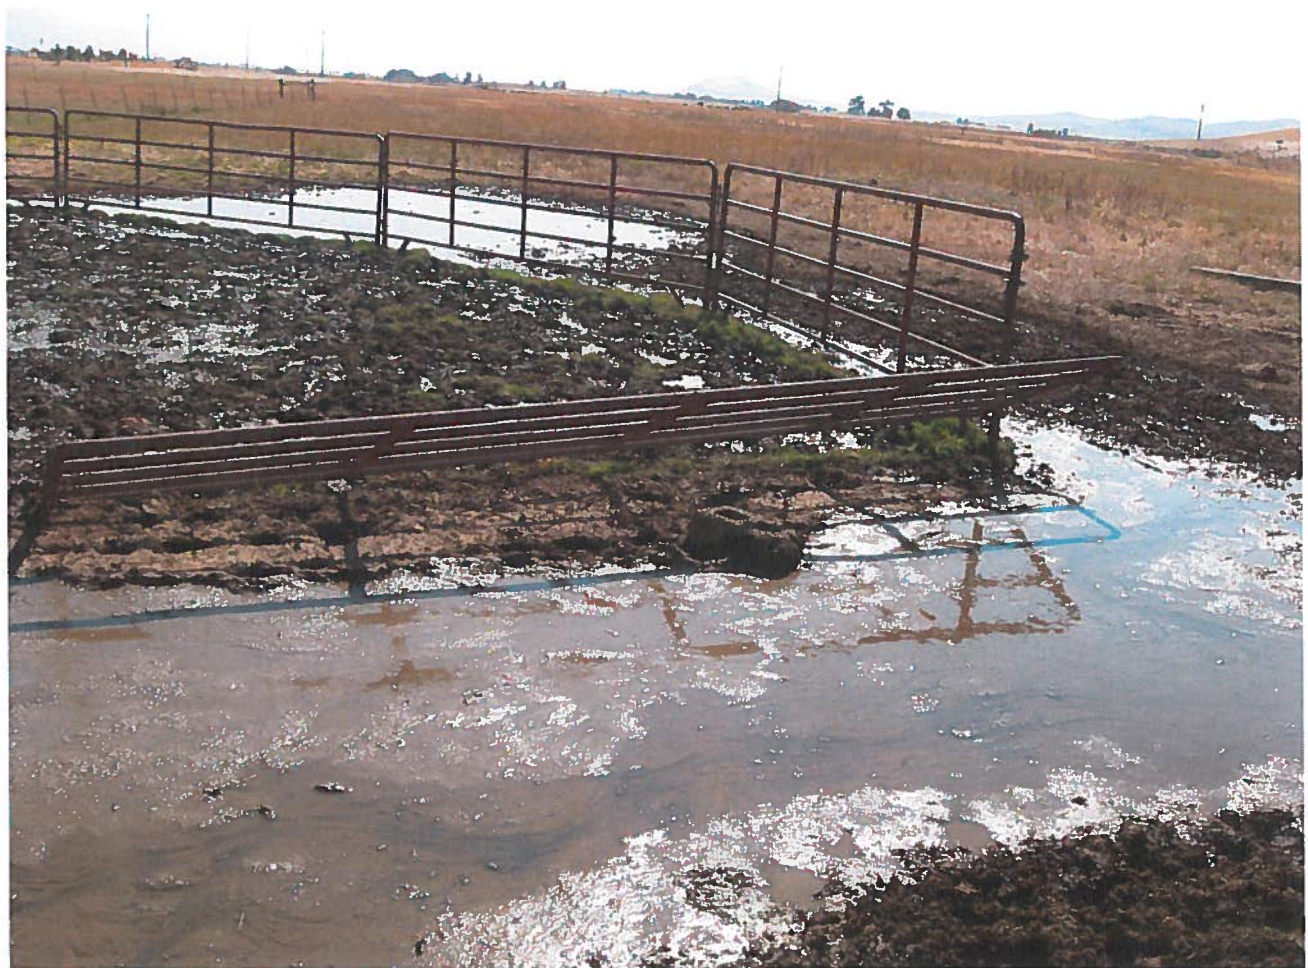
Spring water used to fill multiple stock troughs. No shutoff system installed or working on the troughs, so the water overflows creating a shallow pond in the corral area. Other troughs located in the SESE of Section 7, visible from aerial photography. Could not locate spring box. Parts of the hillside covered with thick vegetation, 5 feet tall. Evidence confirms spring development.
