STATE OF IDAHO  
DEPARTMENT OF WATER RESOURCES  
**BENEFICIAL USE FIELD REPORT**

Permit No: 63-33375

Exam Date: 5/9/2012

# 63-33375 LICENSING PLACE OF USE

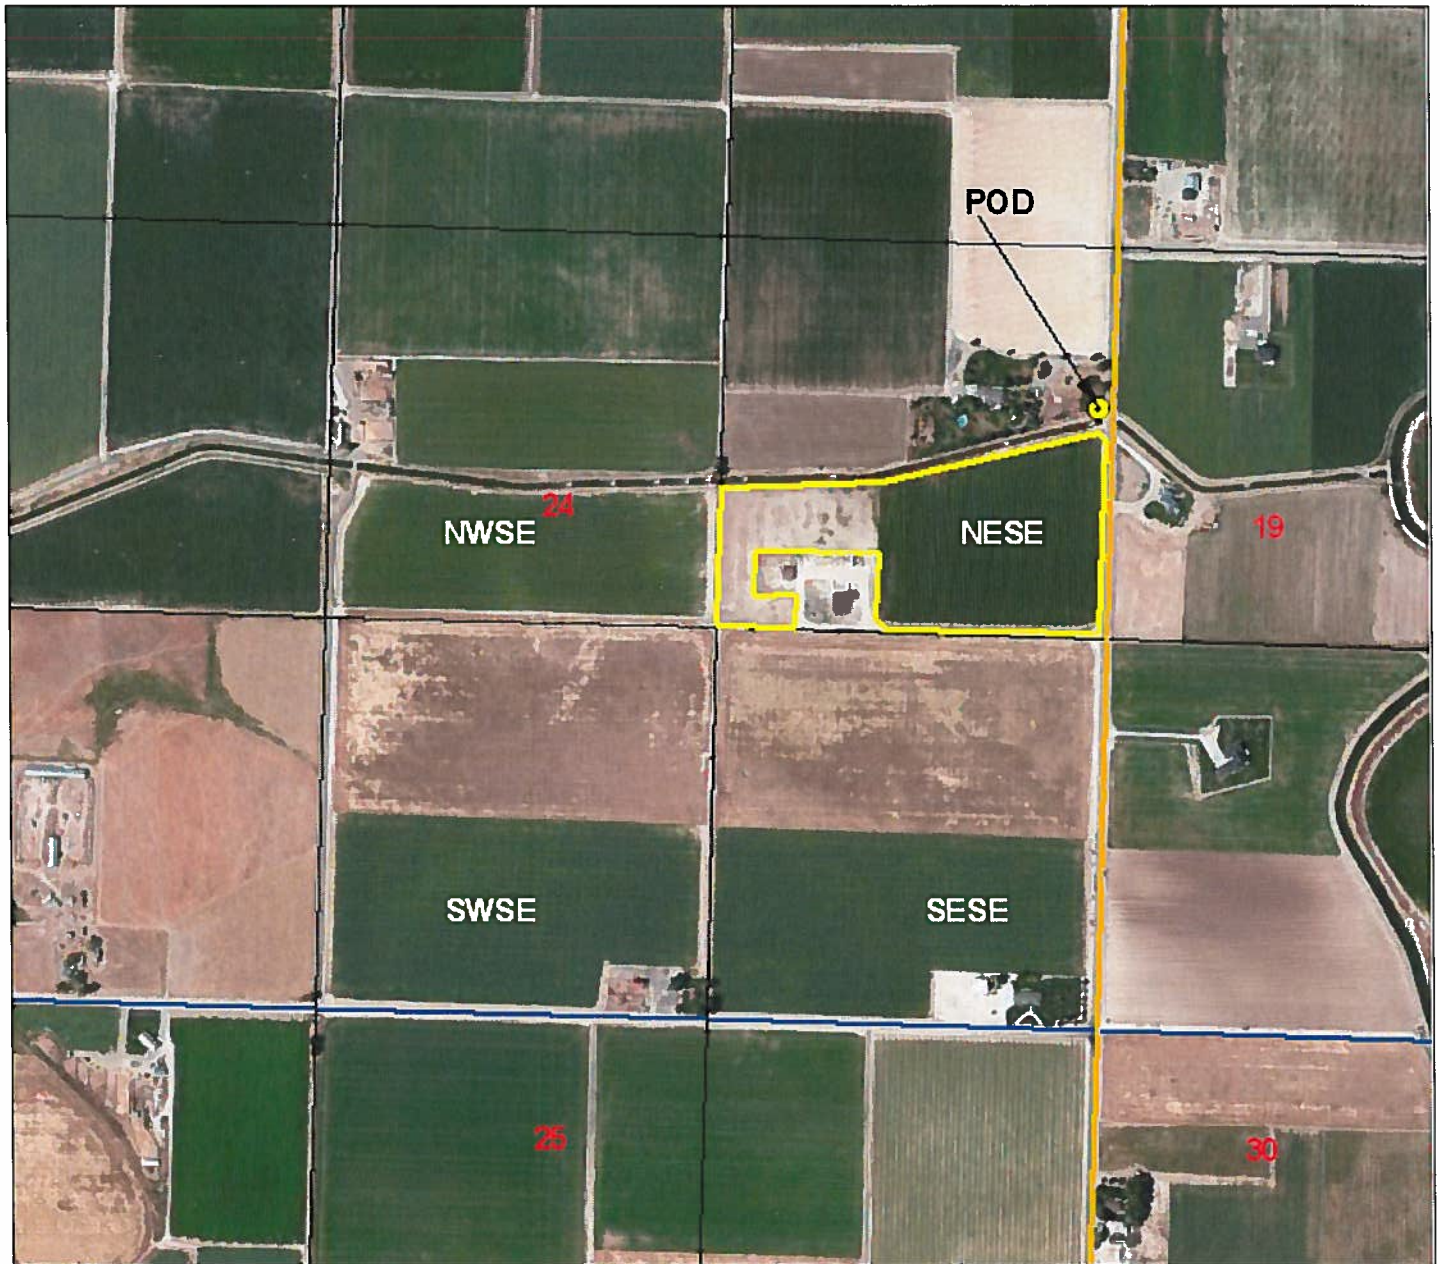
PLACE OF USE  
TWP 01N, RNG 2W Sec 24  
Data Entry on July 16, 2012

- Found point of diversion
- Found place of use
- Township lines
- Section lines
- Quarter/quarter lines

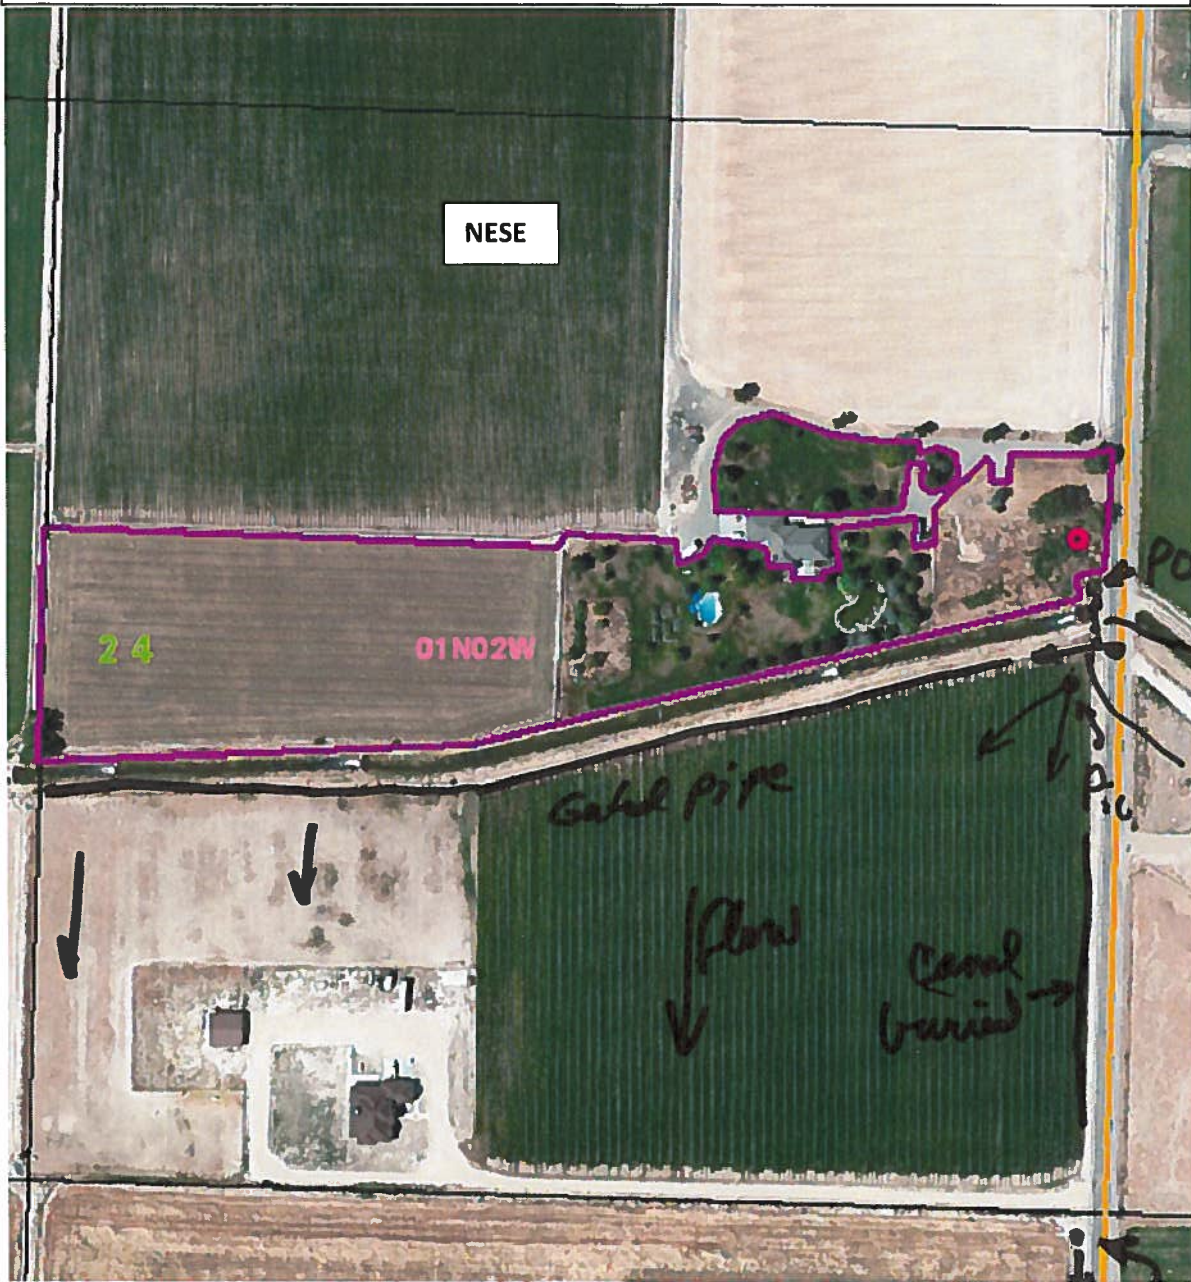
2011 AERIAL PHOTO

Field notes Exam 5-9-12

TWP 1N, RNG 2W, Sec 24

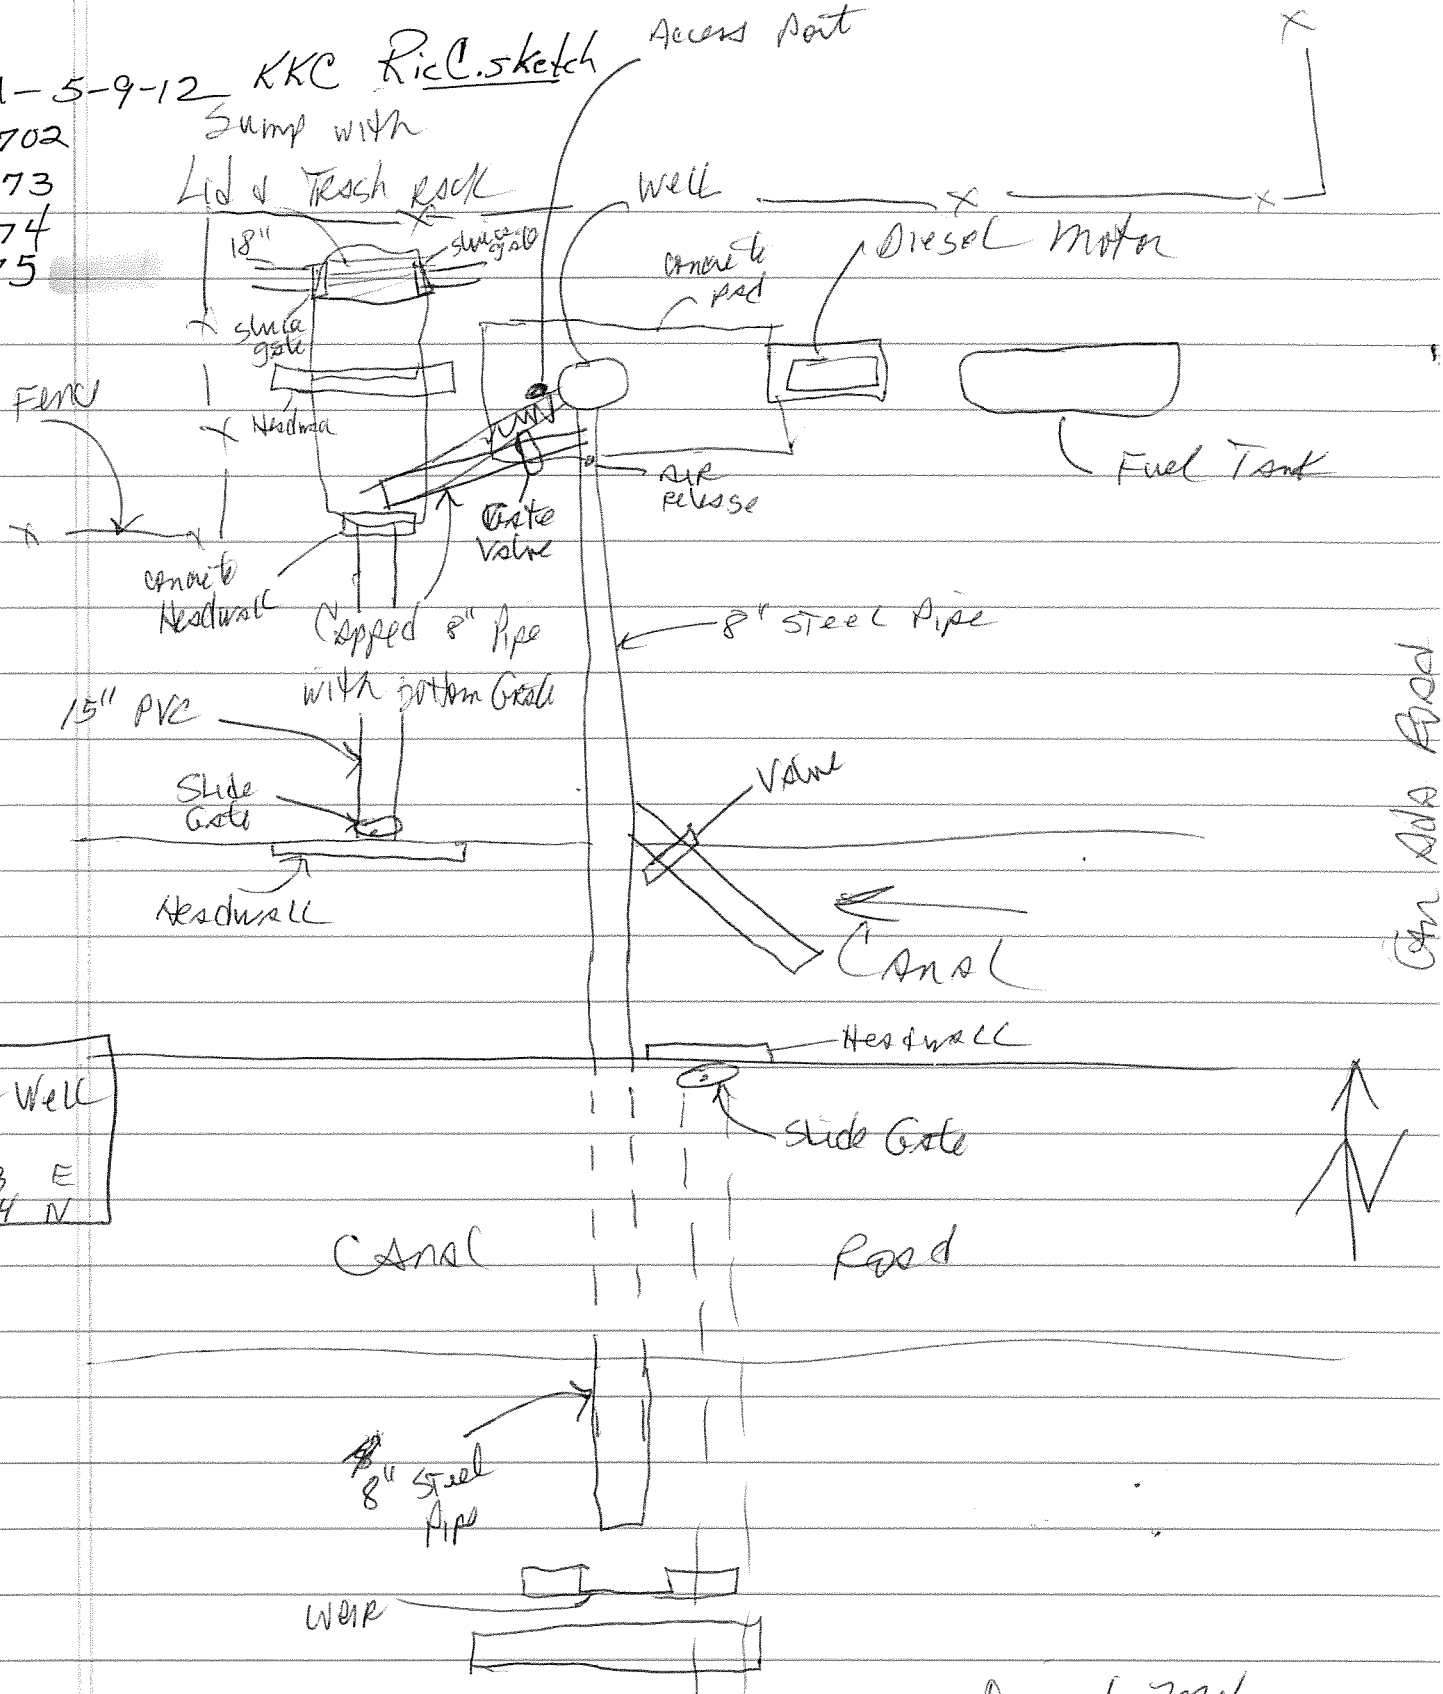
EXAM - 5-9-12 KKC Ric. sketch

POD  
1 Pri  
of POD  
1 Pri look  
w. Gated  
Pipe Eye  
for 33375

Canal  
open cement  
ditch

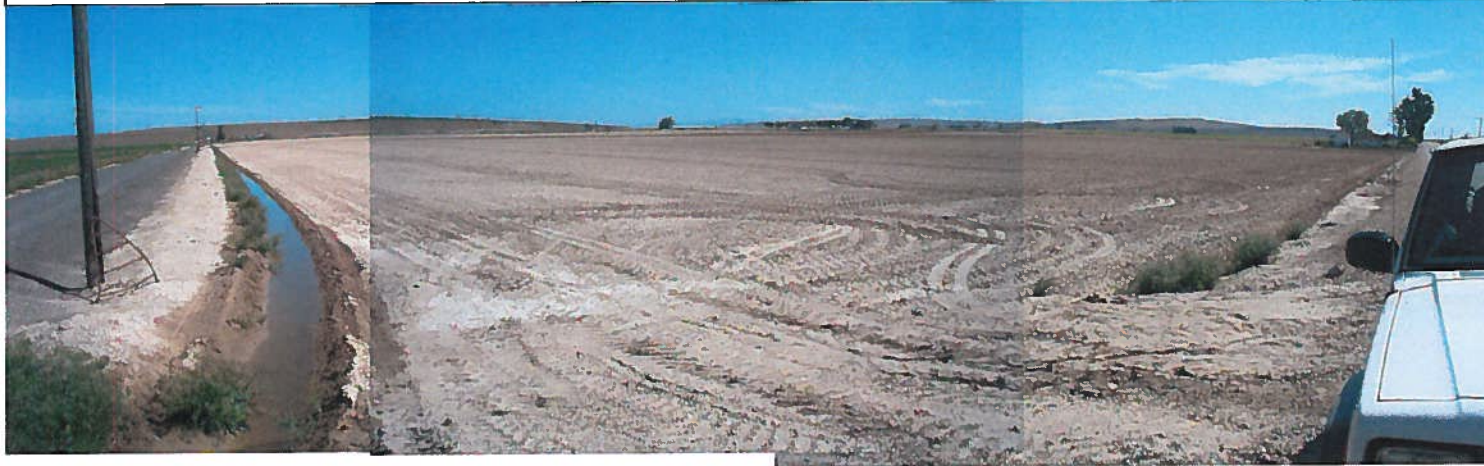
### Photo set 1

You are looking north on the left to east on the right. The foreground portion of the field is the POU for 63-33373. That right is farmed in conjunction with 63-11702 which is the background portion of the field.

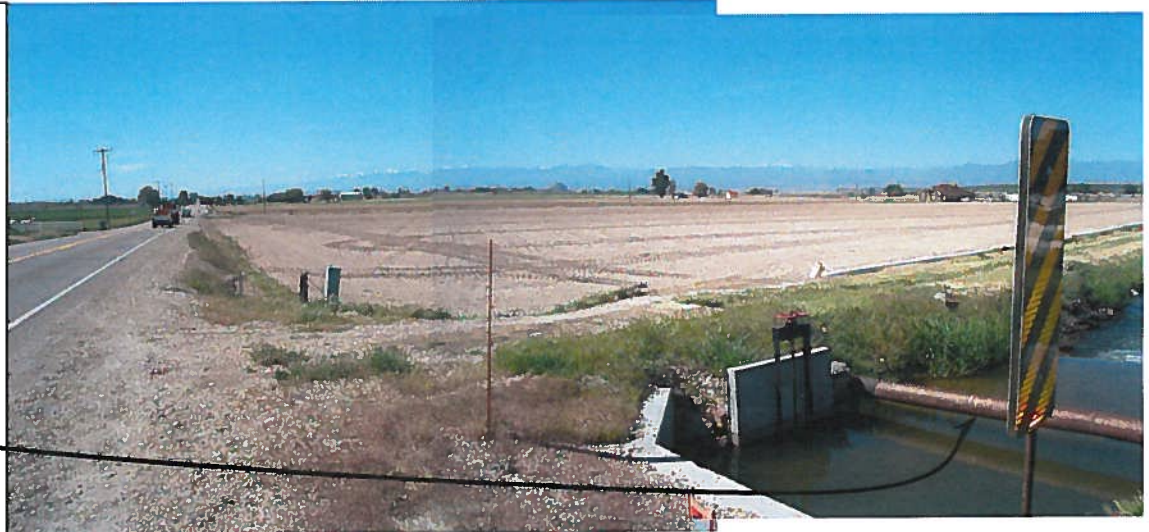
### Photo set 2

You are looking south on the left to southwest on the right. Shown is the Can Ada road. The field shown is the POU for 63-33375.

The photo location is just south of the POD which is in the southeast corner of the ground associated with 63-33374.

Pipeline from well crossing the canal.

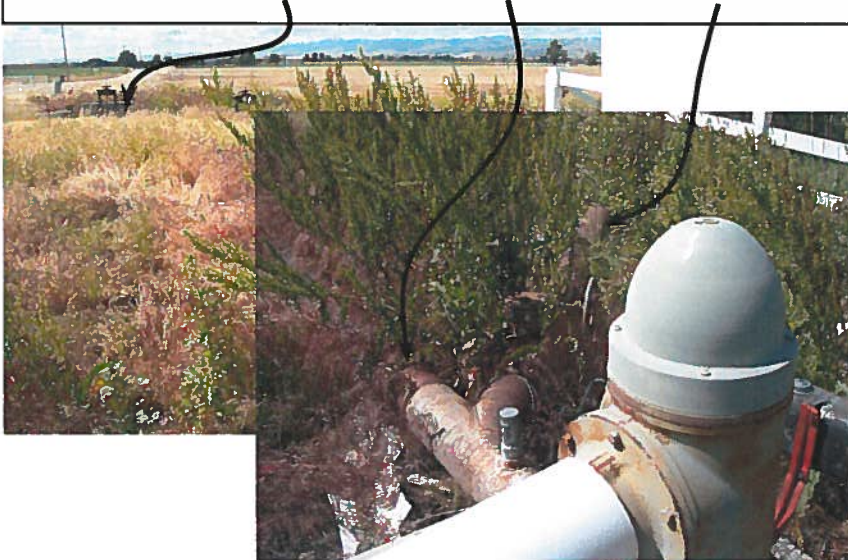
Photo Set 1

This photo set is looking south and shows the delivery pipe system that delivers water across the canal to irrigate ground to the south and west or to dump water into the delivery system carrying water to the north. That headgate was identified as # 104 on the weir structure. South discharge point south pipeline north pipeline

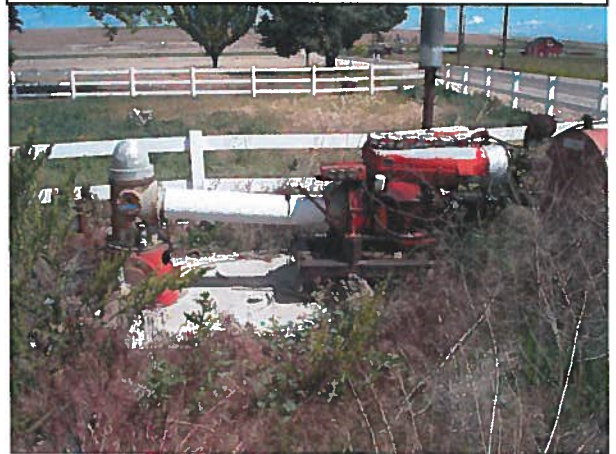
Photo 2

This photo is looking north at the well and diesel motor used to drive the well.

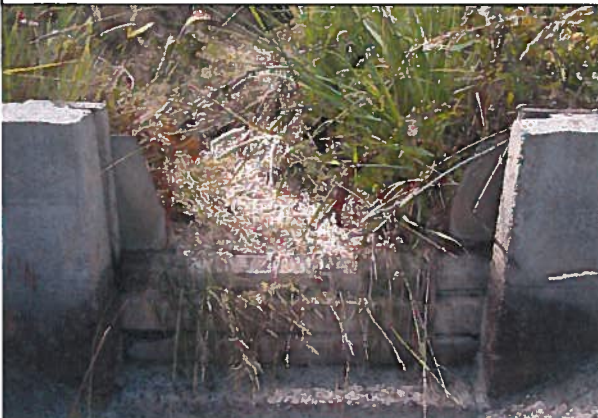
Photo 3

This shows the 2 ft cipolletti weir leading to the north ditch. You are looking south at the weir. The weir is in fair shape if the brush would be cleaned out. It may leak around the bottom some though.

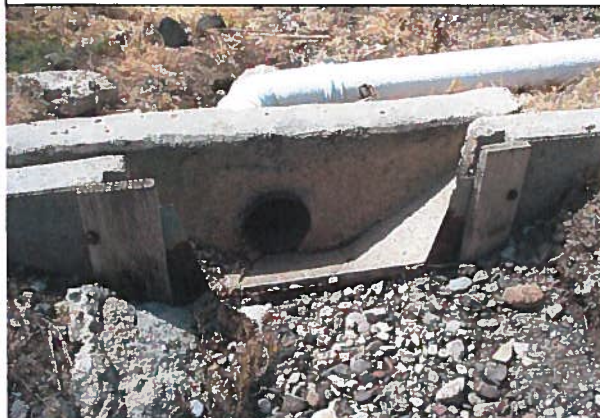
Photo 4

This shows the 2 ft cipolletti weir leading to the south ditch. You are looking south at the weir. The weir is in poor shape. it was made out of three sections of metal which have separated from each other by as much as an inch on the left. It has also pulled away from the backing board on the bottom creating an effective crest of two plus inches.

I recommend that the measurement and reporting conditions be modified to reflect condition 01M. The permit identified a water bearing zone of 200 to 350 ft. The well log did not identify water bearing zones but did identify fractured rock and gravel at 165 thru 185 ft followed with sandy clay from 185 ft thru 210 ft. A number of narrow sand zones were identified from that point to 362 ft. As this area is roughly 16 miles south southwest of the Boise Front Management area therefore the water bearing zone is not applicable.

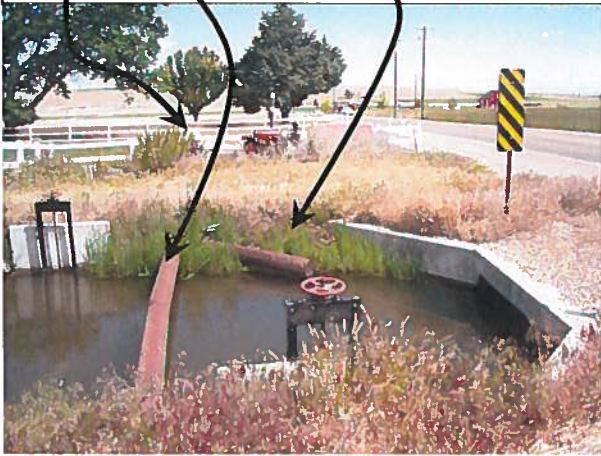
Photo 5

This shows the pipe system coming from the well. The left line crosses the canal to dump into the farm ditch system just above the south weir. The pipe to the right allows water to be dumped into the main canal as exchange water

Well

West pipe

East Pipe
