STATE OF IDAHO  
DEPARTMENT OF WATER RESOURCES  
**BENEFICIAL USE FIELD REPORT**

Permit No: 63-33373

Exam Date: 5/9/2012

63-33373 LICENSING PLACE OF USE

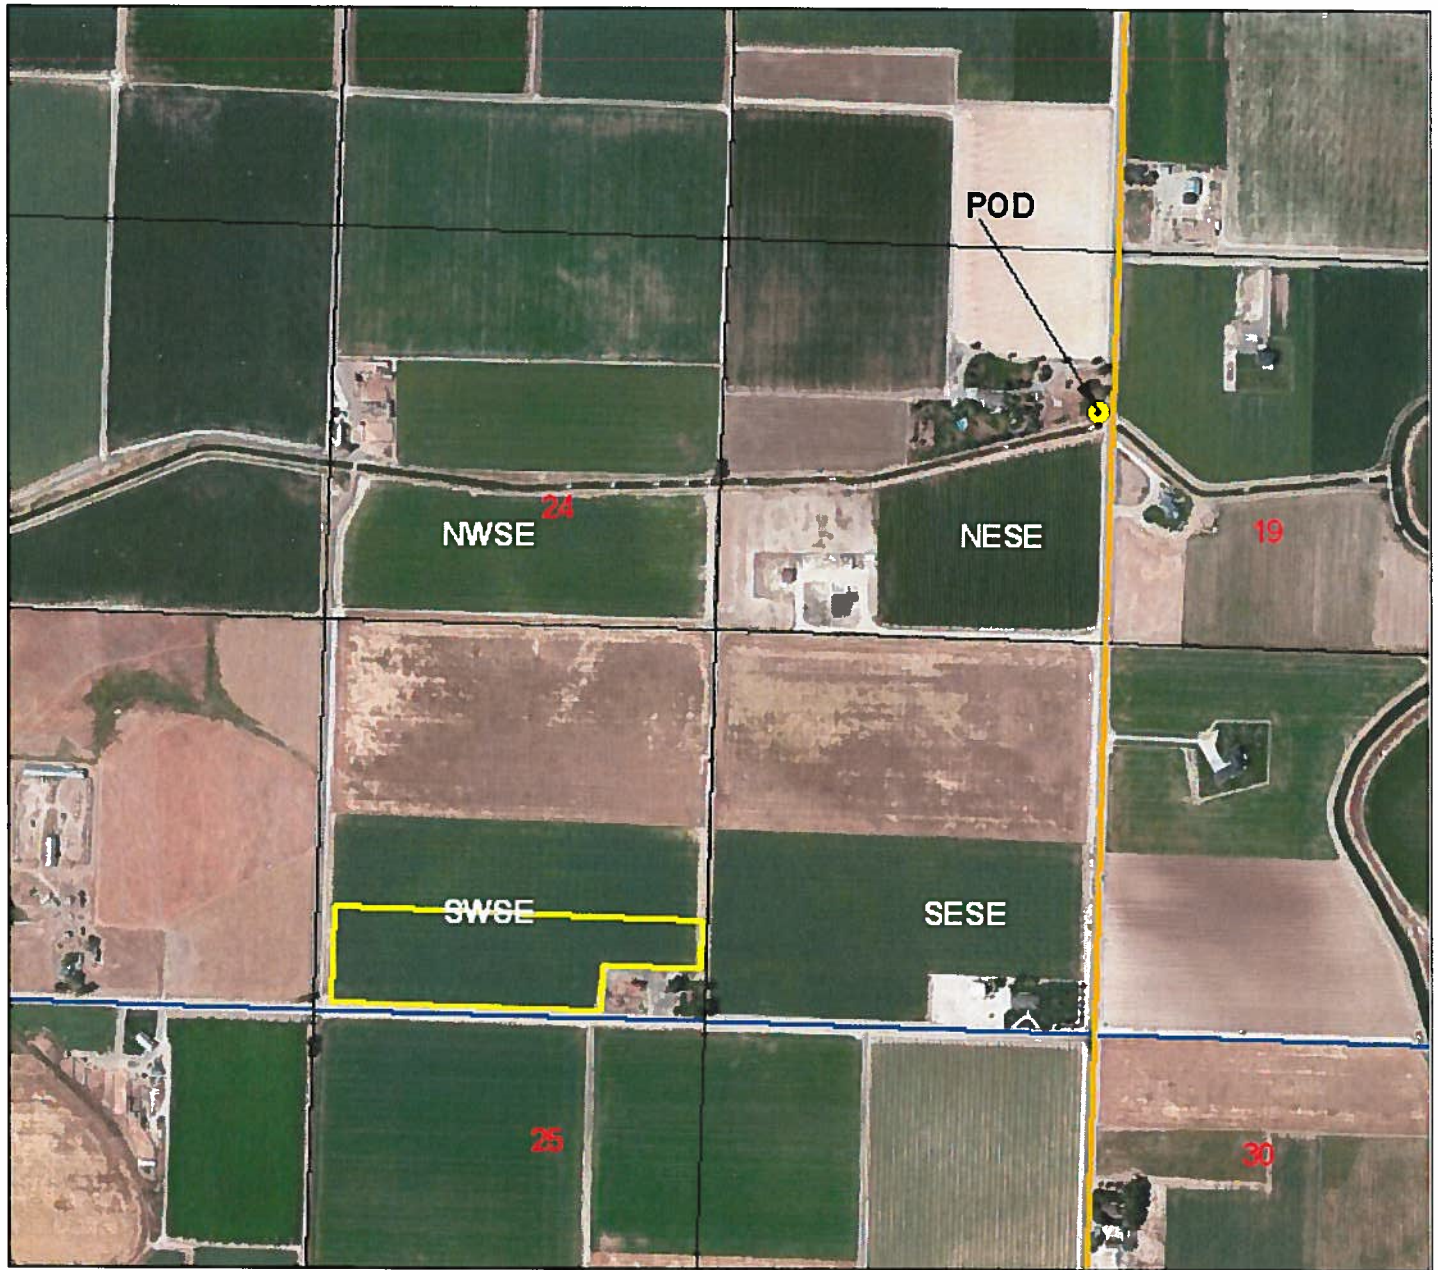
PLACE OF USE  
TWP 01N, RNG 2W Sec 24  
Data Entry on July 16, 2012

- Found point of diversion
- Found place of use
- Township lines
- Section lines
- Quarter/quarter lines

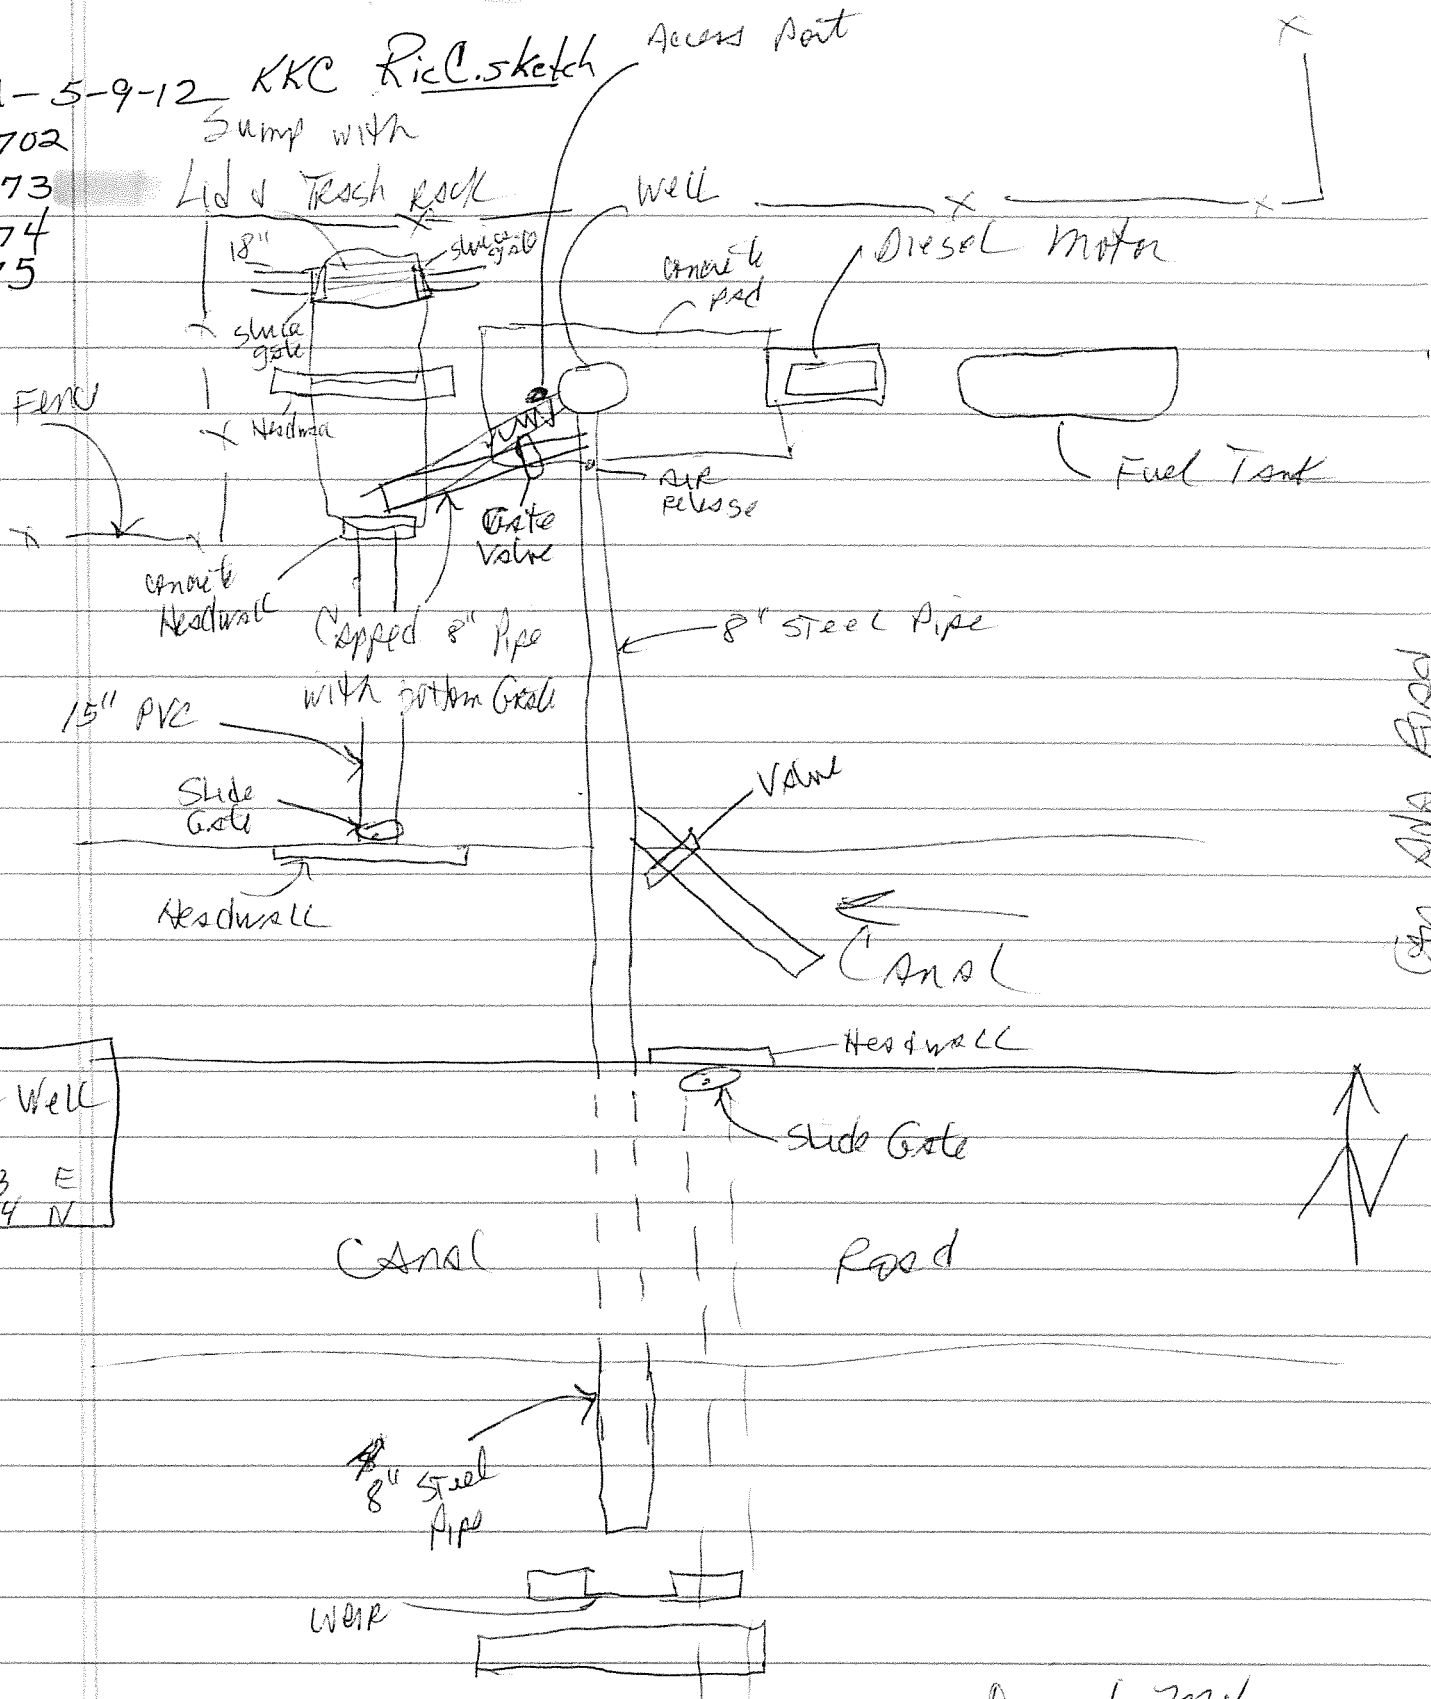
EXAM-5-9-12 KKC RicC sketch

Well Pumps

Johnson

Serial # 138538 H110

BHP 110 @ 1760 rpm - Vertical shaft

Diesel Motor

BF6L 913

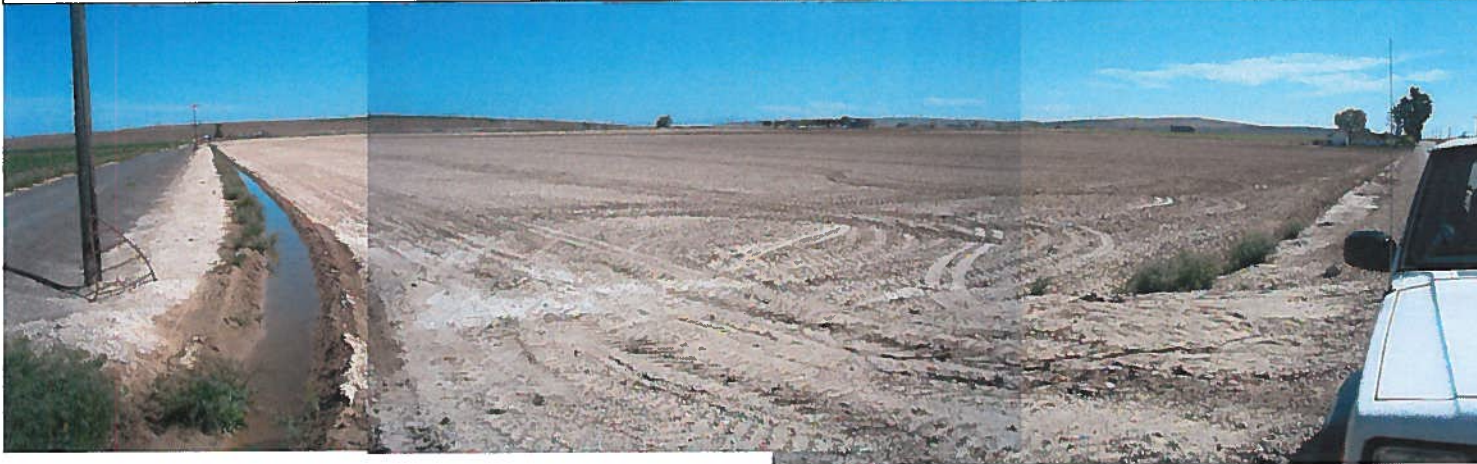
### Photo set 1

You are looking north on the left to east on the right. The foreground portion of the field is the POU for 63-33373. That right is farmed in conjunction with 63-11702 which is the background portion of the field.

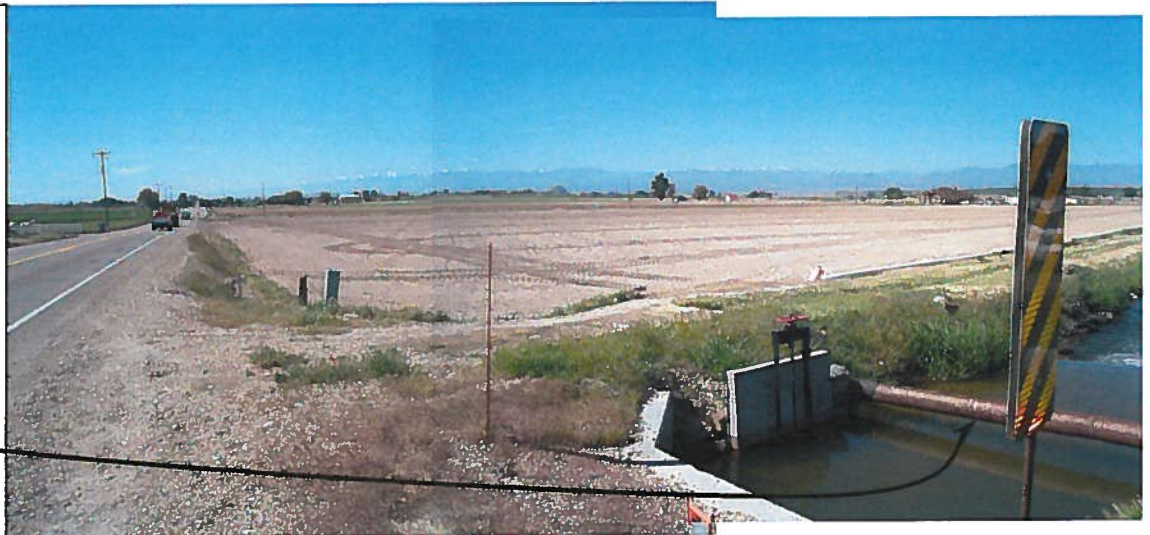
### Photo set 2

You are looking south on the left to southwest on the right. Shown is the Can Ada road. The field shown is the POU for 63-33375.

The photo location is just south of the POD which is in the southeast corner of the ground associated with 63-33374.

Pipeline from well crossing the canal.

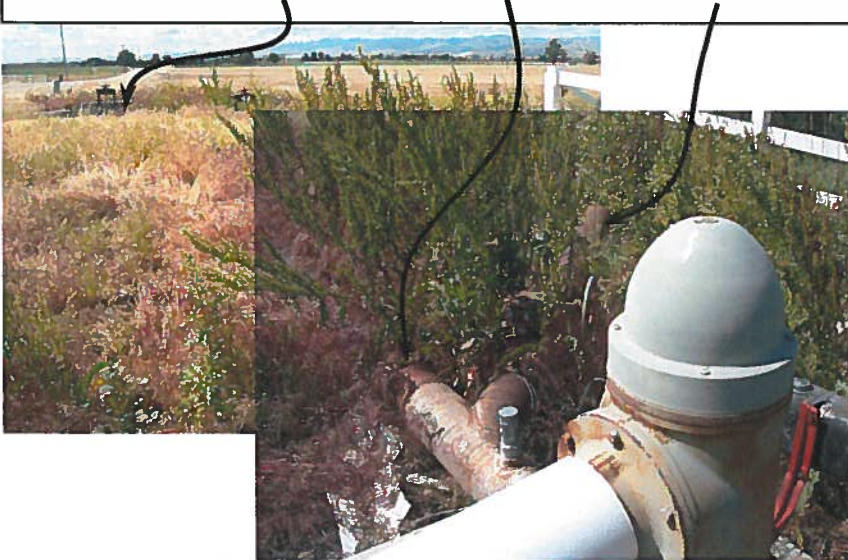
Photo Set 1

This photo set is looking south and shows the delivery pipe system that delivers water across the canal to irrigate ground to the south and west or to dump water into the delivery system carrying water to the north. That headgate was identified as # 104 on the weir structure. South discharge point south pipeline north pipeline

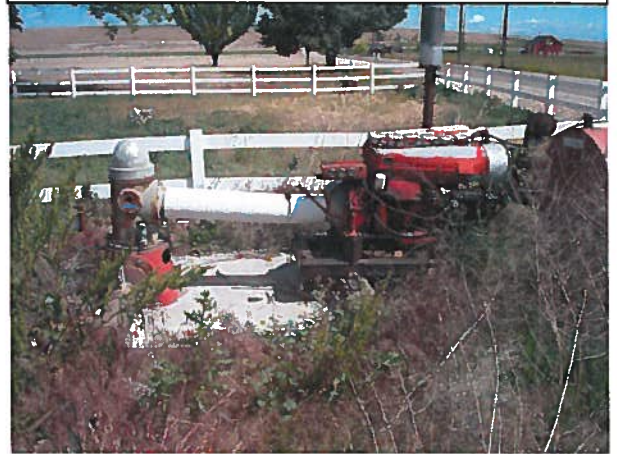
Photo 2

This photo is looking north at the well and diesel motor used to drive the well.

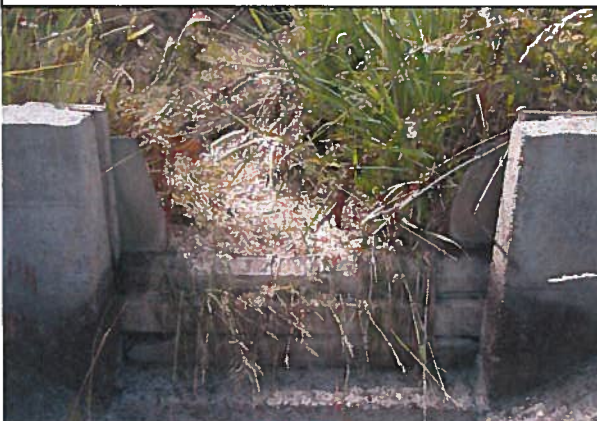
Photo 3

This shows the 2 ft cipolletti weir leading to the north ditch. You are looking south at the weir. The weir is in fair shape if the brush would be cleaned out. It may leak around the bottom some though.

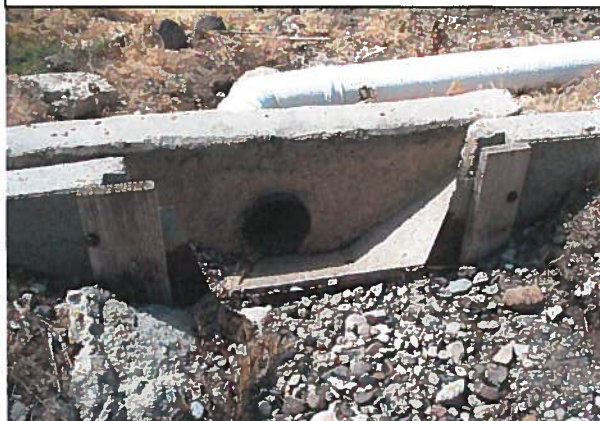
Photo 4

This shows the 2 ft cipolletti weir leading to the south ditch. You are looking south at the weir. The weir is in poor shape. it was made out of three sections of metal which have separated from each other by as much as an inch on the left. It has also pulled away from the backing board on the bottom creating an effective crest of two plus inches.

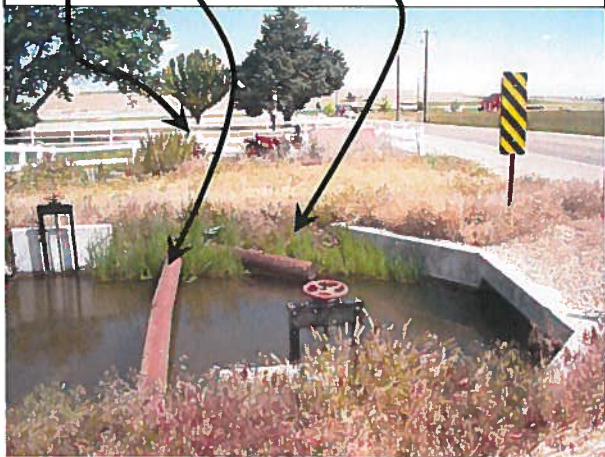
Photo 5

This shows the pipe system coming from the well. The left line crosses the canal to dump into the farm ditch system just above the south weir. The pipe to the right allows water to be dumped into the main canal as exchange water

Well   West pipe   East Pipe
