**APPLICATION TO SELL OR LEASE A WATER RIGHT  
TO THE WATER SUPPLY BANK**Name of Seller/Lessor Foster Land and Cattle Phone \_\_\_\_\_Mailing address PO Box 40, Ririe, ID 83443 Email \_\_\_\_\_**A. DESCRIPTION OF WATER RIGHT, OR PORTION THEREOF, OFFERED TO THE BANK**If the entire right is for sale or lease, check here ☐, list the water right number, and skip to Part B.

# REPORT

## ON-SITE INSPECTION OF THE SECTION 11, T04N, R35E

Conducted on September 17, 2010

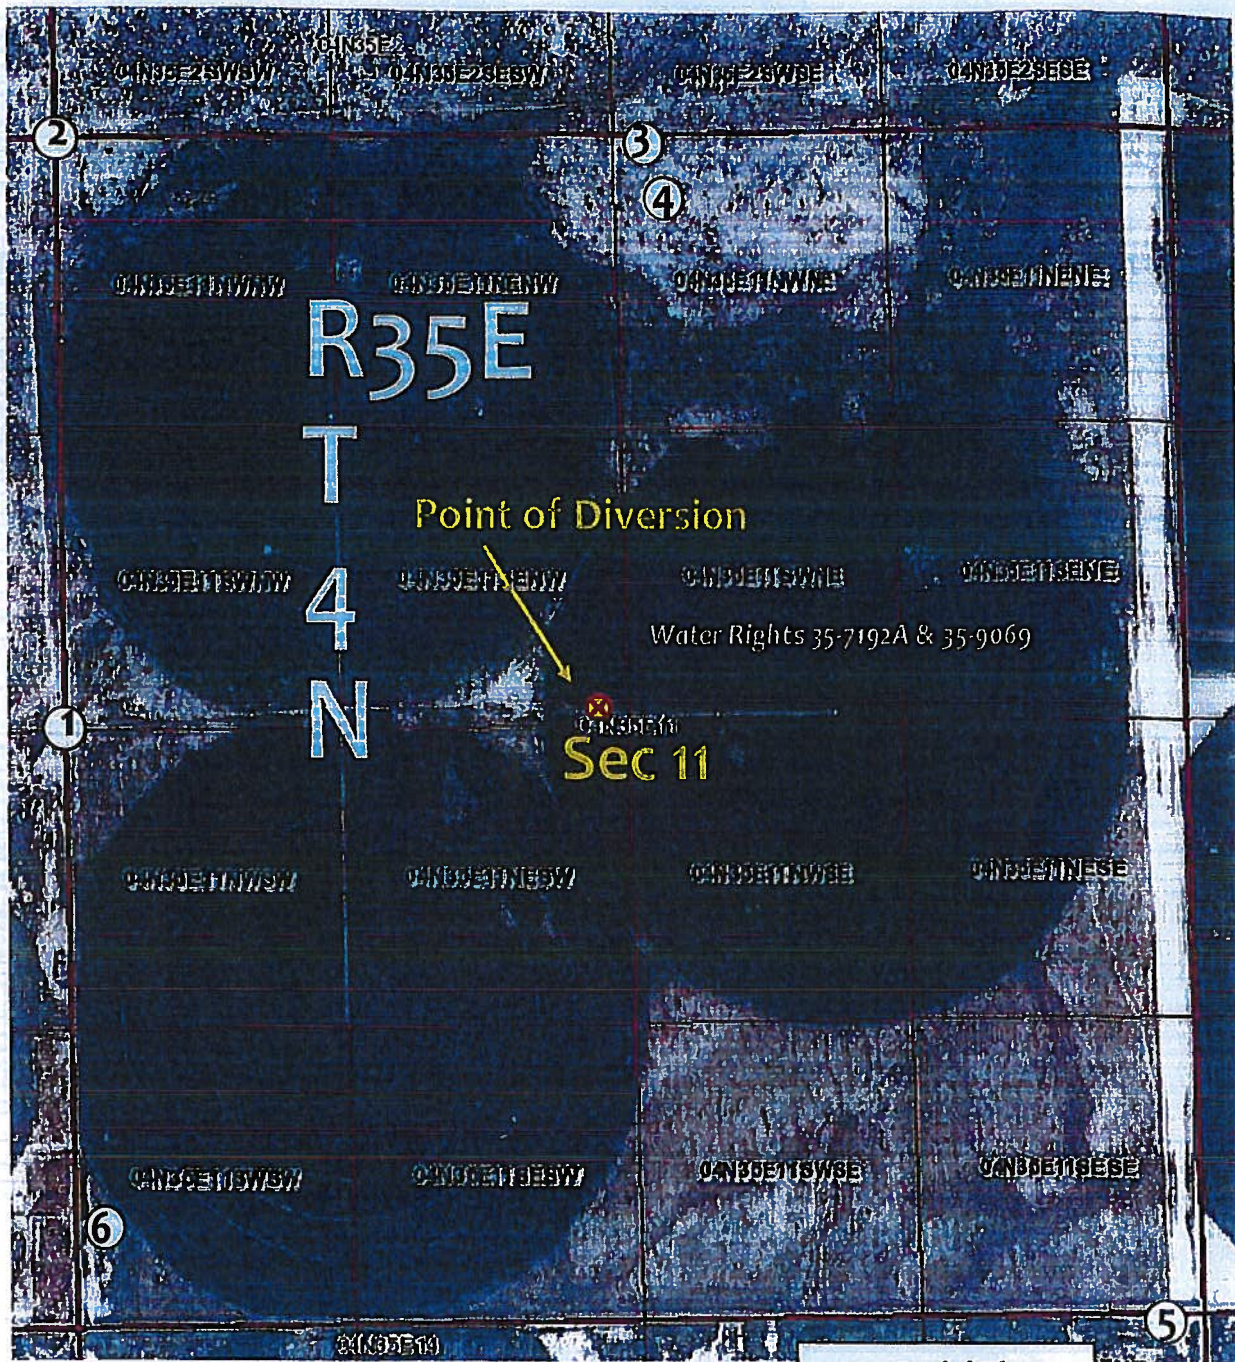
### PHOTO LOCATIONS: Sec 11, T4N, R35E

These site locations are indicated on the 2009 aerial photo in "Attached A". Photos taken at these Site Locations document the inspection. Numerous photos were taken, only relevant and clear photos are included with this report.

The 2009 aerial photo in "Attachment A" appears to indicate that the corners, with a few exceptions, in Section 11, T04N, R35E, were, are, or have been irrigated. The irrigation of Section 11, T04N, R35E, is authorized under water rights 35-7192A and 35-9069 which in combination are authorized to divert 6.02 cfs and irrigate 636 acres (See "Attachment A").

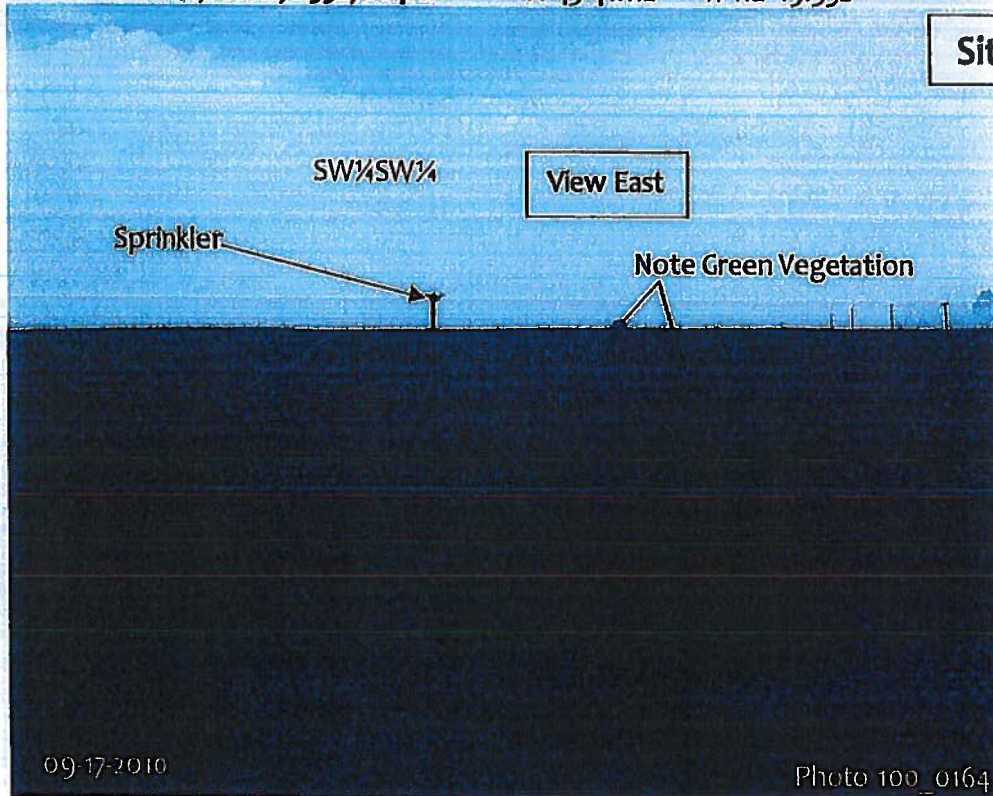
Site Location #6

Irrigation was occurring in the SW corner of the SW $\frac{1}{4}$ SW $\frac{1}{4}$  Section 11, as seen in Photo #100\_164.
