STATE OF IDAHO  
DEPARTMENT OF WATER RESOURCES  
**BENEFICIAL USE FIELD REPORT**

Permit No: 63-11726

Exam Date: 1/30/2012

## FIELD EXAM PHOTOS

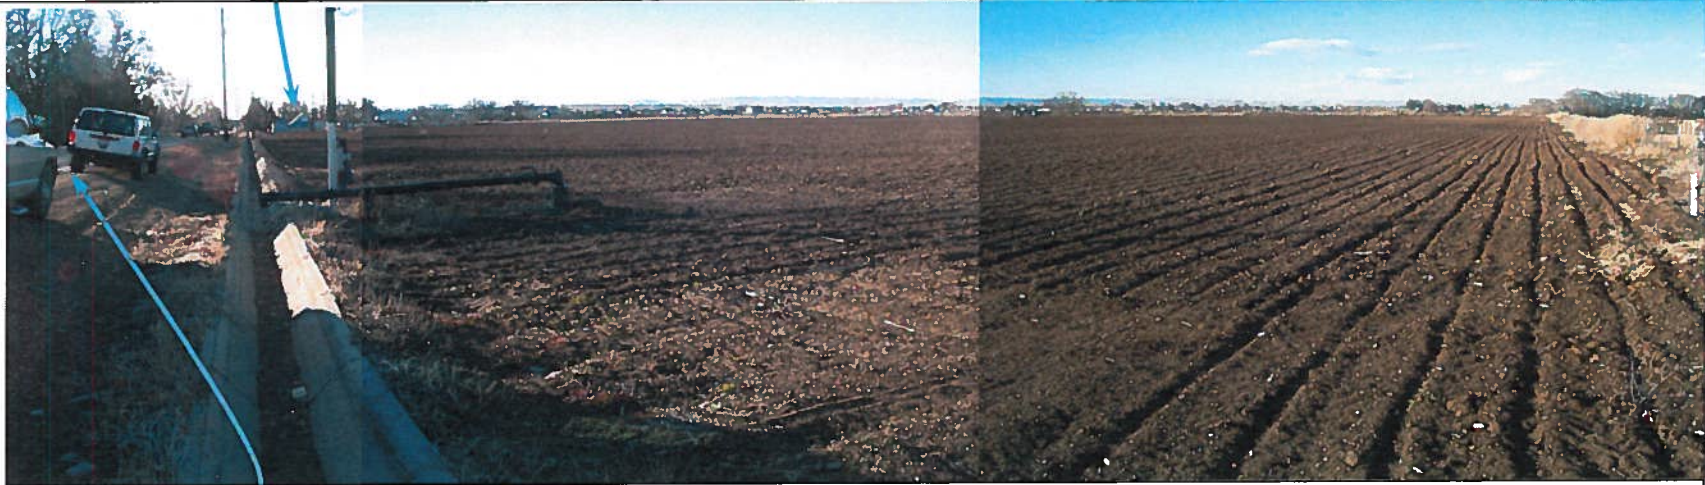
Can-Ada Rd

You are looking south on the left to west on the right. The photo location is at the northeast corner of the POU currently owned by Welton Stanley. Irrigation flow is from the east to the west in the field and north to the south in the ditch system. The cement ditch ends at the far farmstead and is tied into gated pipe. One line continues south paralleling the Can-Ada Rd and the other log legs around the farmstead on the north and then turning south.

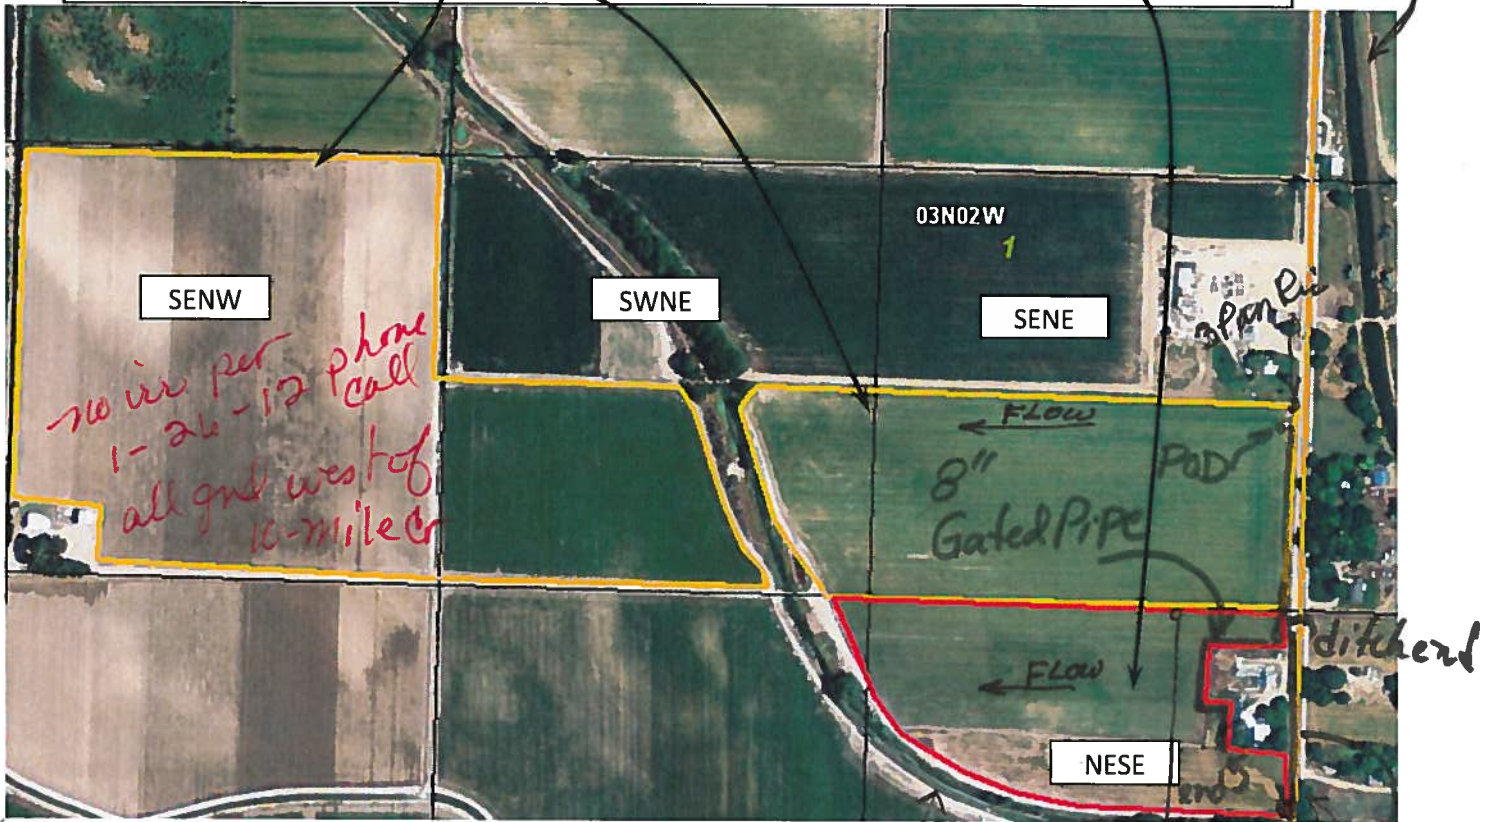
## FIELD EXAM MAP

Phyllis's Canal

Ten-mile Cr

GPS 2297241  
#6 138397  
2297671  
1382539  
± 4'

1/2 mi 3pm  
to Cherry Ln Can Add Rd  
134 mi 2-mi  
to Garrity  
Exit.  
10" Gated Pipe
