STATE OF IDAHO  
DEPARTMENT OF WATER RESOURCES  
**BENEFICIAL USE FIELD REPORT**

Permit No: 43-7328  
Exam Date: 6/10/2011

# Permit 43-7328

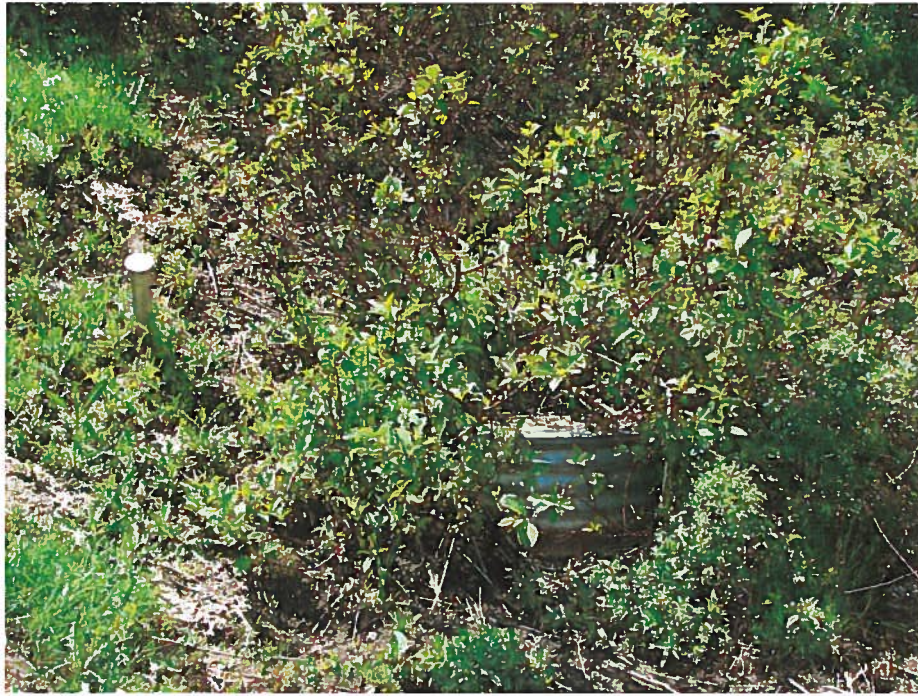
Existing system consists of a headbox at the spring that supplies water through a 1.5" polyethylene pipe over an approximate distance of 96' with an elevation drop of 10' to two storage tanks. The cylindrical storage tanks are both 4' in diameter x 6' tall and were filled to capacity. Water is delivered from the storage tanks to two troughs. The west trough is at a distance of approximately 41' from the tanks, with an elevation drop of 8', while the east trough is approximately 2375' (0.45 miles) from the tanks with an elevation drop of 395'. Both troughs were of similar design and dimensions (13.25' L x 2' W x 1.75' D). The water level in both troughs is regulated by a single float valve. On the day of the exam the east trough was empty, while the west trough was full. The headbox was completely overgrown by woody vegetation preventing access to potential water flow and possible flow measurement. The Hazen Williams Full Pipe Flow Calculation was utilized to obtain a potential rate of diversion.

Figure 1: Headbox at spring and survey marker (field spring 8)

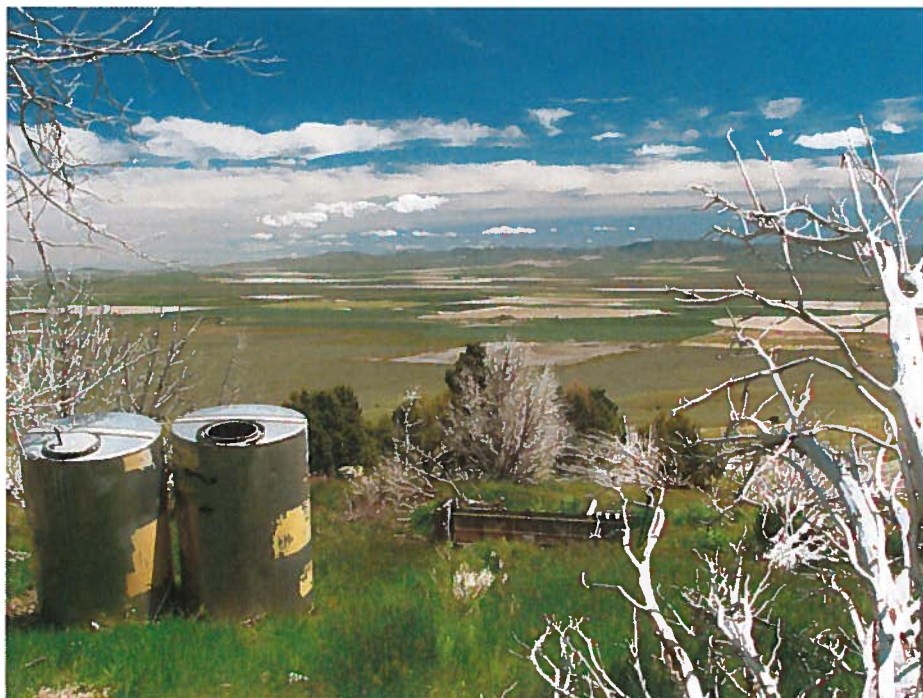
Figure 2: Storage Tanks and west trough

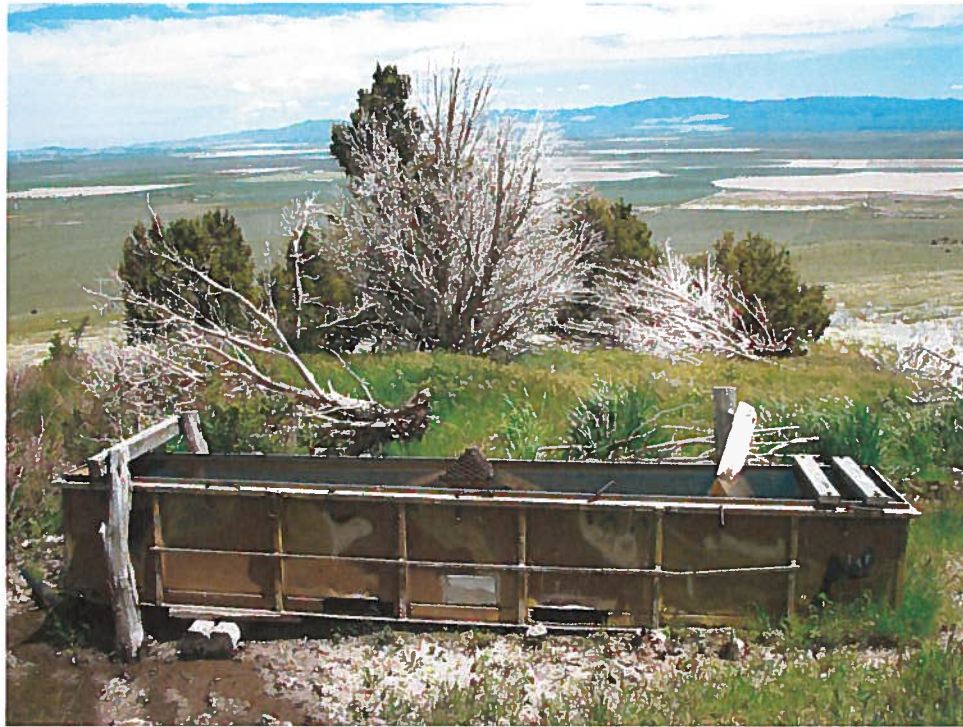
No cattle were present at either trough on the day of the exam. I did flush several chukars at the west trough, but saw no other obvious signs of wildlife in the area. According to Jeremy Bisson, BLM Wildlife Biologist, the area is utilized by as many as 800 head of mule deer. I estimate use based on 30 deer potentially utilizing the trough on a daily basis. Steve Davis, BLM Hydrologist, stated the site is utilized by 875 range cattle.

Figure 3: West trough

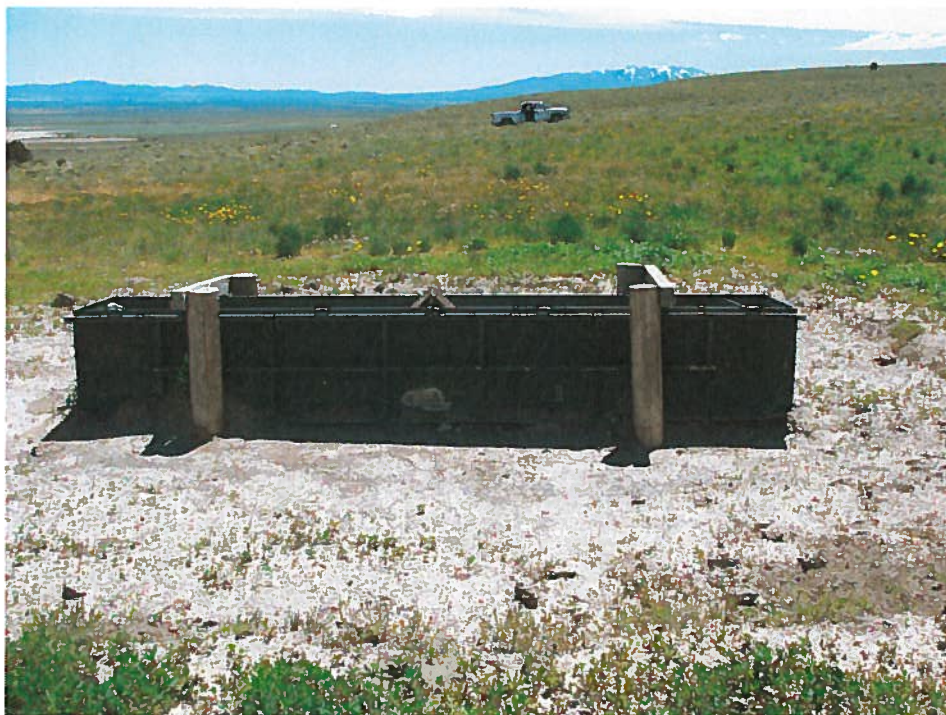
Figure 4: East trough
