STATE OF IDAHO  
DEPARTMENT OF WATER RESOURCES  
**BENEFICIAL USE FIELD REPORT**

Permit No: 43-7327

Exam Date: 6/10/2011

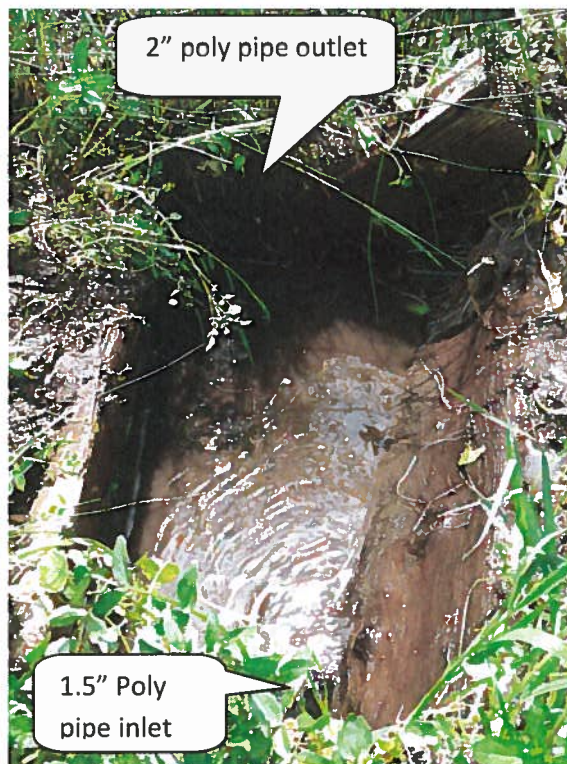
Existing system consists of a small wood headbox (2' L x 1' W x 6" D) that supplies water through a 2" polyethylene pipe over an approximate distance of 2085' to two troughs placed end to end. Each trough measures 10' L x 5.17' W x 1.3' D. The water level in the

Figure 2: Headbox after removal of vegetation.

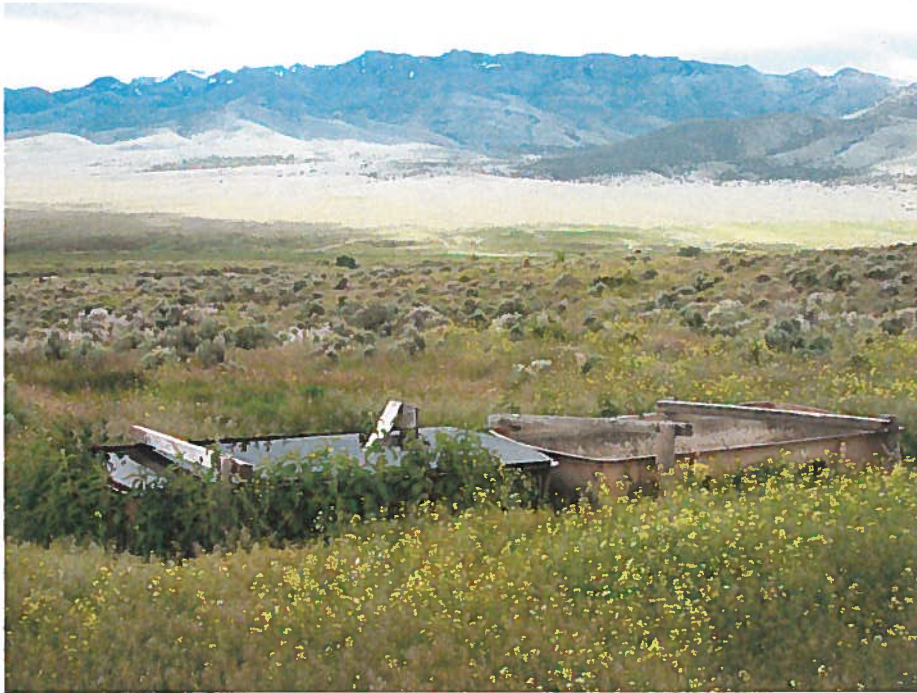
troughs are regulated by a single float valve on the west end of the trough closest to the spring. The west trough was filled to capacity, while the east trough was almost empty as the connector pipe appeared to be clogged with algae and sediment. Headbox contained water but no measurable flow was present, therefore the Hazen Williams Full Pipe Flow Calculation was utilized to obtain a potential rate of diversion.

Figure 3: View of troughs looking south towards the Jim Sage Mountains.

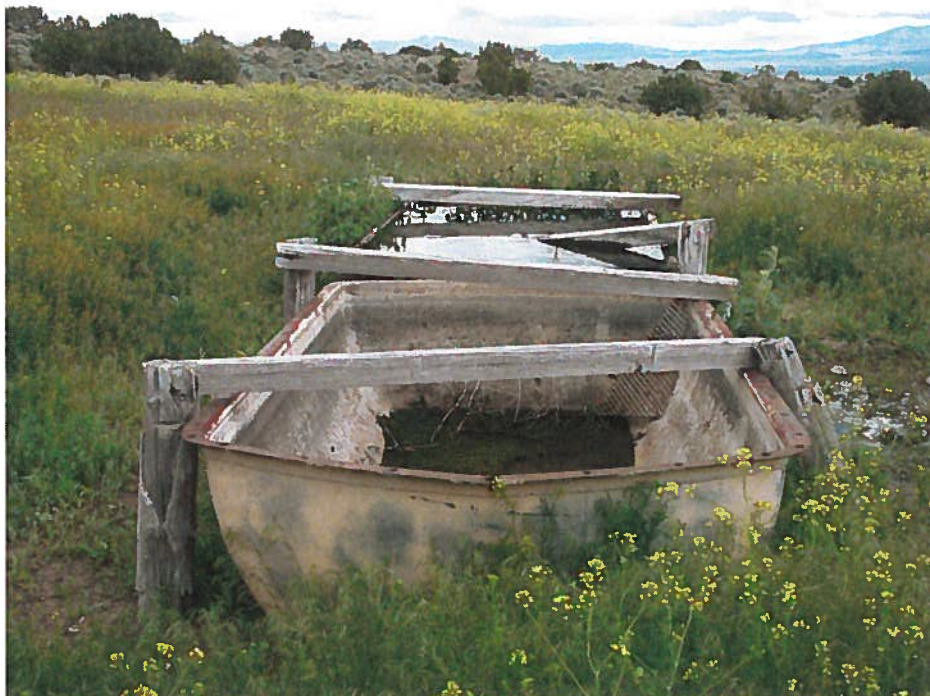
Figure 4: View of troughs looking west.
