## IDAHO DEPARTMENT OF WATER RESOURCES

### WELL INSPECTION FORM

1. DRILLING PERMIT NO: NONE OTHER APPLICABLE NO: 47-08147
2. OWNER: MARILYN & VERLYN BROOK Phone: (208) 734-1845  
Address: 3169 E 3500 N, Twin Falls, Idaho 83301

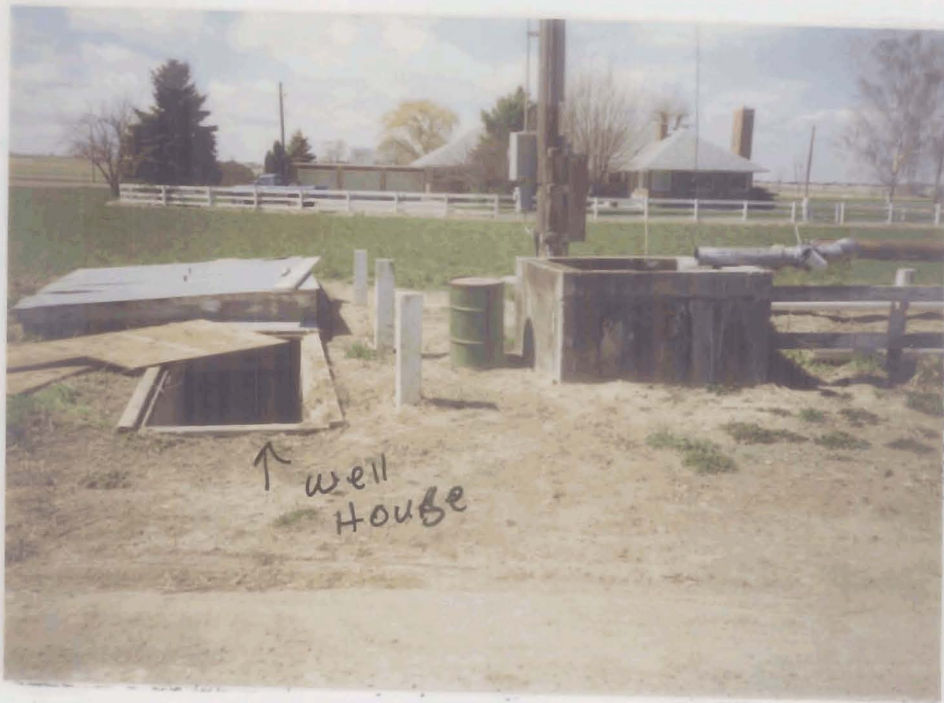
This is a photo of the well house  
for well #1

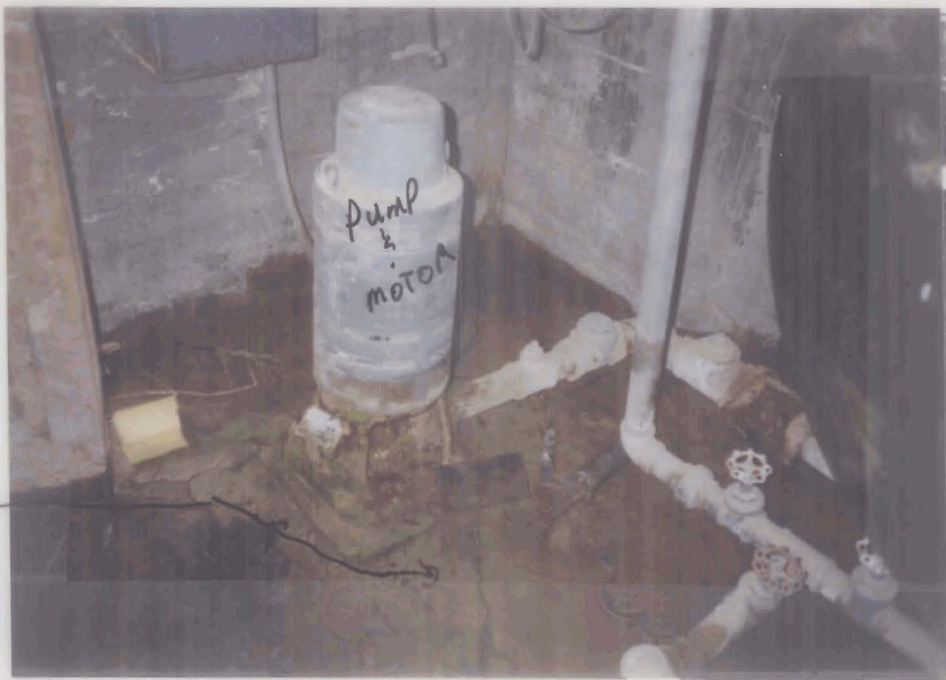
5. WELL CONSTRUCTION:  
Casing Diameter 6 inches Water tight cap? ☐ Yes ☒ No Access Port: ☐ Yes ☒ No  
Casing  $\geq$  12 inches above ground? ☐ Yes ☒ No - Describe TURBINE MOTOR.  
Depth of Casing UNKNOWN ft. Method Drilled UNKNOWN  
Condition of Well Casing: ☐ Good ☒ Fair ☐ Poor Describe There was a LOT OF CORROSION.  
Control Valve? ☒ Yes ☐ No Pressure Gauge: ☐ Yes ☒ No  
Condition of Piping and Valving Fair - There was a great deal OF CORROSION  
Auger to a depth of 0 ft. Evidence of Annular Seal ☐ Yes ☒ No  
Are there obvious construction problems that may be a source for contamination or waste of water?  
☒ Yes ☐ No (Describe in Remarks and Attach Photo - On Reverse)

9. REMARKS: There were 2 things I was concerned  
about. First, there was a great deal of corrosion on  
the pump and piping. Second, the floor was  
beginning to frost heave, leaving cracks in  
the cement floor of the well house.

Frost  
Heaves  
in  
Floor

← 3500 gal  
PRESSURE  
TANK

This is the well and pump for  
well #1
