State of Idaho  
Department of Fish and Game  
Boise, Idaho

**MEMORANDUM**

**RE:** Sterling WMA water rights

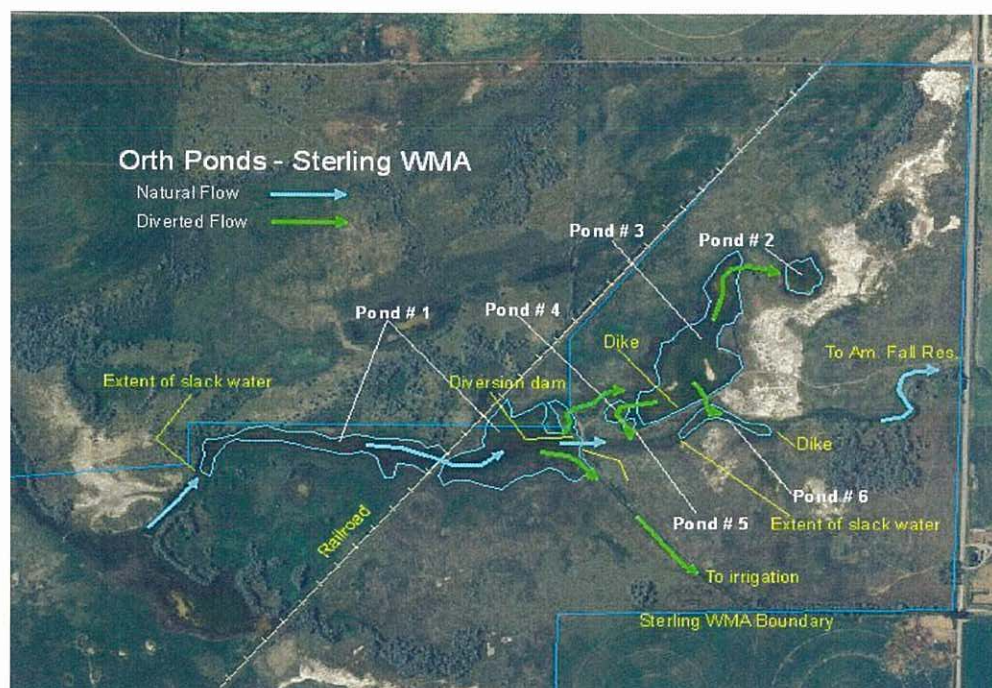
Figure 3. Orth Ponds with flows and structures, Sterling WMA

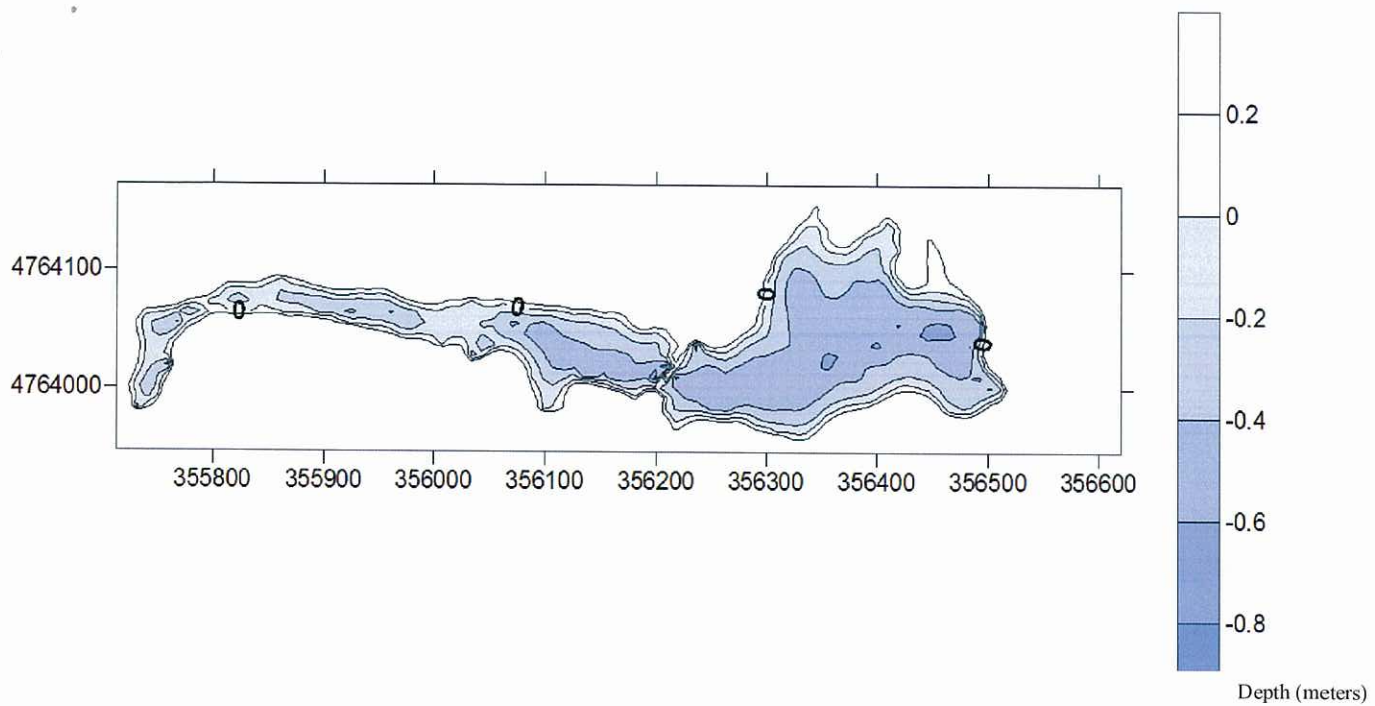
#### **Pond #1**

**Pond #1** is formed by a dam within the natural drain. The dam was originally constructed in the early 1900s to provide diversion to an irrigation ditch which in turn serves neighboring properties to the south and east. In the late 1980s, the Department negotiated with the downstream neighbor to modify this dam and allow use of excess water through and beyond the irrigation season in Pond #1 as well as Ponds #2 thru #6. Depth measurements were taken with a sonar device and analyzed with Surfer 8.0 software to create a bathymetric map and calculate a volume estimate.

Maximum depth measured on 17 May was less than 1 meter, with the in pond staff gauge reading at 2.6. As associated water rights indicate, up until recently we believed this drain handled only natural flows from upstream springs and runoff. This drain can be used to deliver Aberdeen Springfield Canal water, ultimately to the same diversion ditch delivering the natural flows. There are three outlets. The modified dam construction includes an emergency spillway.

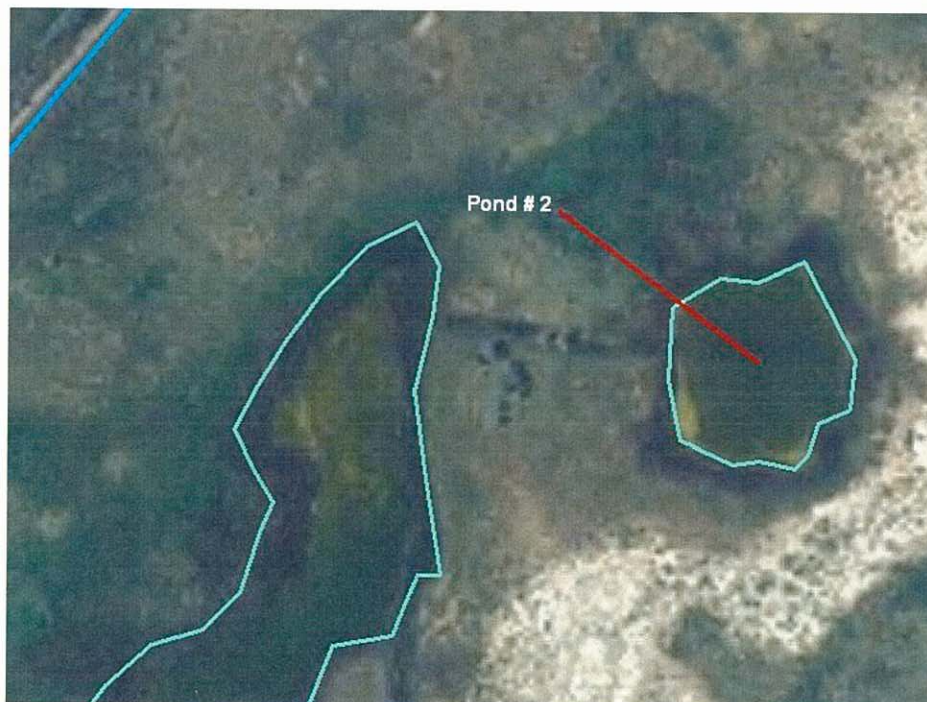
## Pond # 2

**Pond # 2** is connected to Pond #3 by a manmade ditch, but fills naturally in the spring apparently from surface water sources just to the north. Older photos and maps (1966) indicate

this pond occurred at least intermittently before the dike and ditch work was completed in the late 1980s. In fact, on 11 March, 2010, Paul Wackenhut witnessed flow out of Pond #2 through the manmade ditch into Pond #3. This pond is intended to be augmented by the diversion with flow from west to east. On 17 May, 2010, fifty two depth measurements were made from a boat with a tape measure within the open water of the Pond #2. (Depth measurements for Ponds #2, #4, #5, and #6 are from within open water only, while the surface area used in the volume calculation attempted to capture all inundated areas based on interpretation of aerial photography coupled with ground truthing. Depth measurements did not include shallows with emergent vegetation so average depths are likely overestimated.)

**Average depth was estimated to be 1.4 feet, N=52 (Depths from open water only-See above)**

**Total Surface Area = 1.05 acres**

**Maximum Volume Estimate = 1.47 acre-feet**
