State of Idaho  
Department of Fish and Game  
Boise, Idaho

**MEMORANDUM**

**DATE:** June 15, 2010  
**TO:** Jeff Peppersack  
**FROM:** Paul Wackenhut and Walt Poole  
**RE:** Sterling WMA water rights

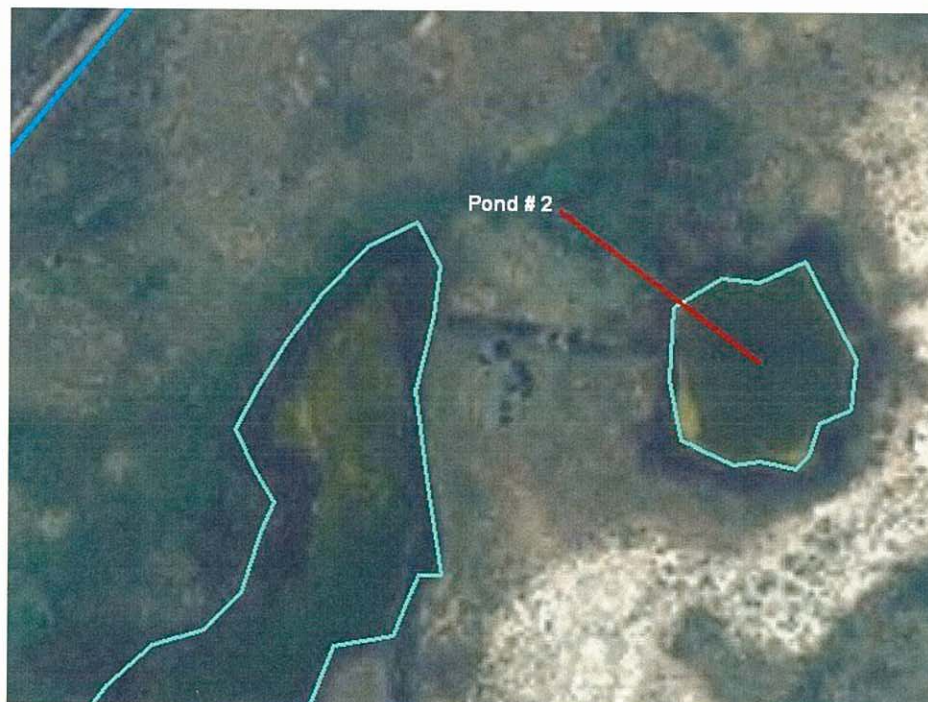
## Pond # 2

**Pond # 2** is connected to Pond #3 by a manmade ditch, but fills naturally in the spring apparently from surface water sources just to the north. Older photos and maps (1966) indicate

this pond occurred at least intermittently before the dike and ditch work was completed in the late 1980s. In fact, on 11 March, 2010, Paul Wackenhut witnessed flow out of Pond #2 through the manmade ditch into Pond #3. This pond is intended to be augmented by the diversion with flow from west to east. On 17 May, 2010, fifty two depth measurements were made from a boat with a tape measure within the open water of the Pond #2. (Depth measurements for Ponds #2, #4, #5, and #6 are from within open water only, while the surface area used in the volume calculation attempted to capture all inundated areas based on interpretation of aerial photography coupled with ground truthing. Depth measurements did not include shallows with emergent vegetation so average depths are likely overestimated.)

**Average depth was estimated to be 1.4 feet, N=52 (Depths from open water only-See above)**

**Total Surface Area = 1.05 acres**

**Maximum Volume Estimate = 1.47 acre-feet**
