State of Idaho  
Department of Fish and Game  
Boise, Idaho

**MEMORANDUM**

**RE:** Sterling WMA water rights

Entire + SUPPORT DATA  
memo - IN FILE # 35-8624

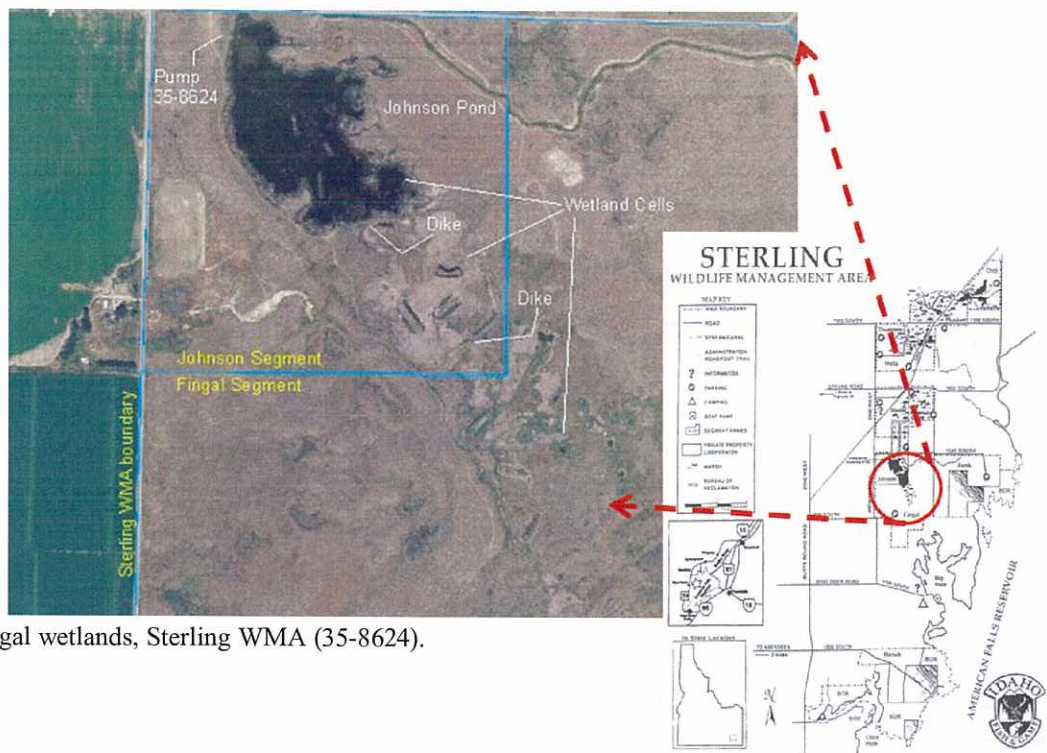
Figure 1. Johnson-Fingal wetlands, Sterling WMA (35-8624).

**Water Right No. 35-08624**, held by the State of Idaho IDFG, is a ground water diversion located in T 05S R31 E Sec 24. This source was intended to augment natural marshes in portions of the WMA known as the Johnson and Fingal Segments. Prior aerial photography (1966) indicates this entire basin was naturally inundated during periods of high water. The well and a series of two dikes were developed in the late 1980s in an effort to increase the amount of open water over additional months (Figure 1). It was suggested by engineering staff at the time that filling of the cells may be difficult due to porosity of suspected underlying lava formations. That concern has proven valid as only the uppermost cell appears to consistently hold higher than natural water levels. This cell lies completely within the Johnson Segment and is referred to as the Johnson Pond. The second cell, also within the Johnson segment also involves a low dike but only appears to influence water levels during periods of high runoff. The lowest cell is contained by natural topography and has no apparent surface water connection to the Snake River (American Falls Reservoir). Some work has been done in the lower cells (Fingal and Johnson Segments) through mechanical excavation and pothole blasting to increase areas of open water given the existing water table. The permitted year round rate of diversion is 1.01 cfs with

a volume of 731.2 acre feet. The actual estimated surface area of the upper pond is 29 acres. This pump is operated year round to provide maximum open water during drought and freezing conditions.

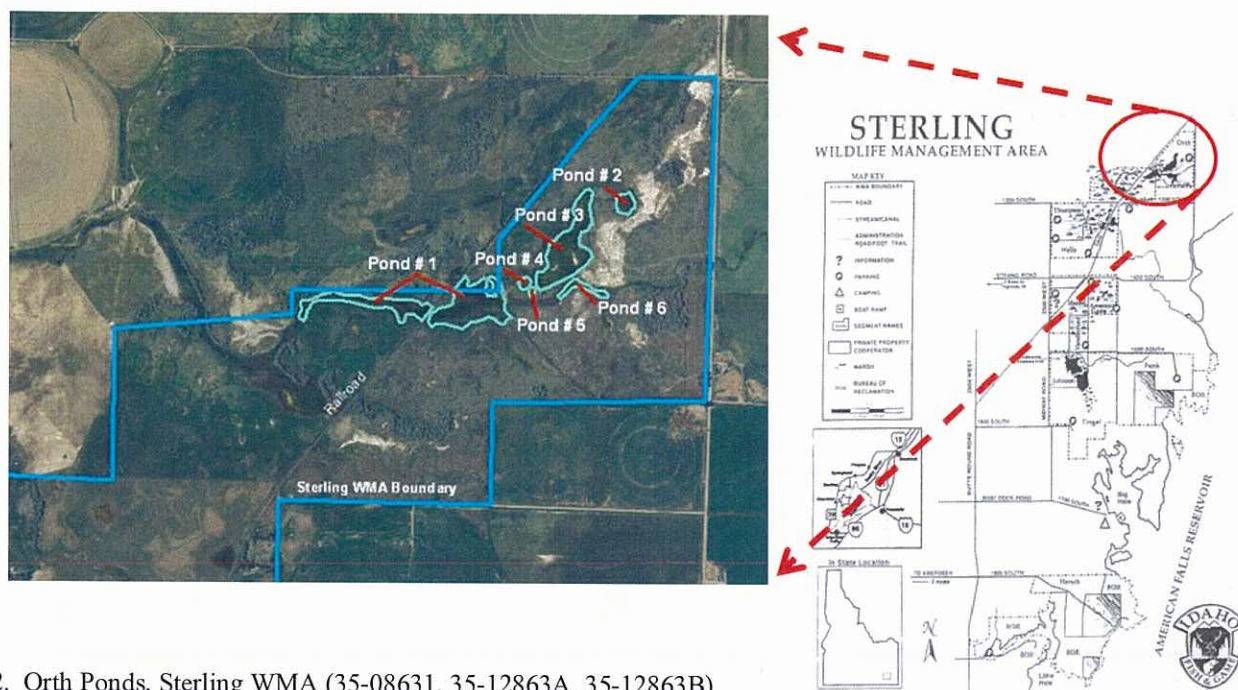
Figure 2. Orth Ponds, Sterling WMA (35-08631, 35-12863A, 35-12863B)

The Orth Ponds includes six interconnected bodies of water within the Orth and Plunkett Segments. Evidenced by historical aerial photos (1966), some of these ponds appear to have natural origin from numerous springs in the area. The original diversion works (Pond #1 dam) was to serve an offsite irrigation water right (35-2009) and was first completed in 1910. In 1971 IDFG acquired the property now referred to as the Orth Segment which included the location of Pond #1 dam. In 1981 BOR acquired the Plunkett Segment, which has been leased to and administered by IDFG since that time. This gave IDFG administrative authority over most of the property inundated by Orth Pond #1. In 1983 IDFG began plans to construct additional dikes that would create or augment Orth Ponds #2, #3, #4, #5 and #6 (Figure 2). In 1985 IDFG secured an easement agreement from John Hamilton allowing impoundment from Pond #1 on the southeast corner of the Hamilton property. That agreement states that the water level of Pond #1 would not change. The dam design includes a spillway limiting freeboard to not less than one foot. Original drawings suggest intended height of 7.5 feet from the base of the outlet stream to the top of the dam, or 6.5 feet for the effective dam height. Our recent observations suggest the final construction conforms with the original design. A photo included in the 4 May, 2010 Idaho Dept. of Water Resources internal memo seems to confirm this design and construction (assumes the measuring stick is anchored in the base of the outlet stream and the person on the dam is of average height). In 1985 work began to reconstruct the Pond #1 dam, which included provision for diversion into Ponds #2, #3, #4, and #5. Additional diking, ditching and minor berm work created Pond #3 and augmented Ponds #2, #4 and #5, all to the east of Pond #1.

The primary dike (Pond #3 and #5) includes two water level control structures and a spillway. A third dike in the natural drain immediately east of Pond #1 created Pond #6. Staff gauges are in place in Pond #1 and Pond #3. Flows from the natural drain and on site springs that feed the WMA wetlands return to American Falls Reservoir. Other than evaporation or seepage, the only consumptive water use is the neighbor's irrigation water diversion from the southeast end of Pond #1 dam.

**Water Right No. 35-08631**, held by IDFG, originally was intended to cover Pond #6. Upon completion of the 1980s development which included additional diversion and the creation or augmentation of Ponds #2, #3, #4 and #5, the 'place of use' was amended in 1994 to include ponds #2 thru #6 (An additional claim was filed in 1990, which split into water rights 35-12863A and 35-12863B in 2000, covers Ponds #1 thru #6). Points of diversion refer to both barriers within the natural drain. The 'beneficial use' for the year round storage (20AF) is 'wildlife storage'. Ponds #2 thru #5 receive natural flow from springs or via a diversion from Pond #1. Pond #6, impounded by a separate dike, receives inflow directly through the natural drain, and indirectly from Pond #3 and #5 after being diverted from Pond #1 (Figure 3). A field report from 1991 (pond numbering varies from that used here) concluded a total storage capacity of 74.8 AF. Since that time Pond #6 capacity has been reduced by lowering the spillway. This was done to address the neighbor's concern with backing water against the Pond #1 dam. Even allowing for this discrepancy, recent readings taken by IDFG personnel (see below) are well within the permitted 75 AF. Water levels would have to have been substantially higher in

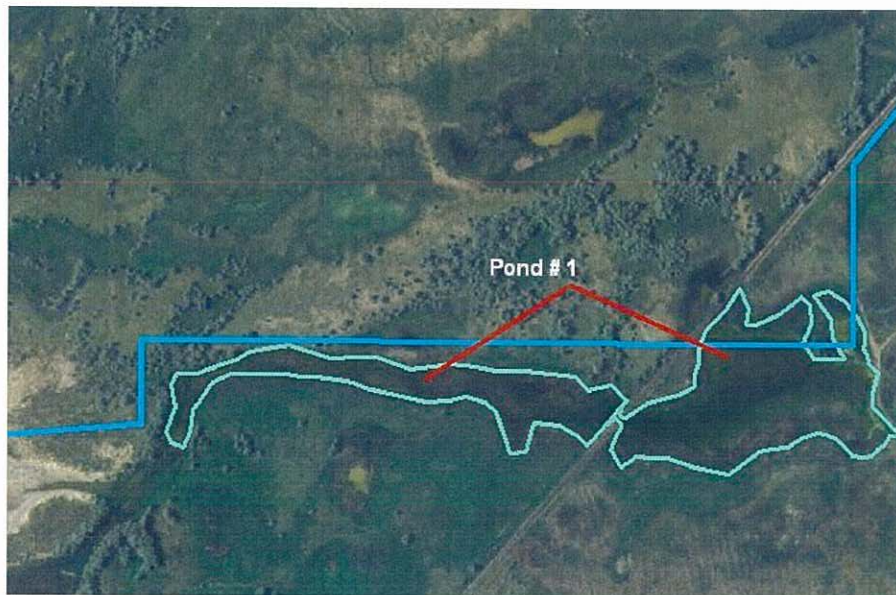
#### **Pond #1**

**Pond #1** is formed by a dam within the natural drain. The dam was originally constructed in the early 1900s to provide diversion to an irrigation ditch which in turn serves neighboring properties to the south and east. In the late 1980s, the Department negotiated with the downstream neighbor to modify this dam and allow use of excess water through and beyond the irrigation season in Pond #1 as well as Ponds #2 thru #6. Depth measurements were taken with a sonar device and analyzed with Surfer 8.0 software to create a bathymetric map and calculate a volume estimate.

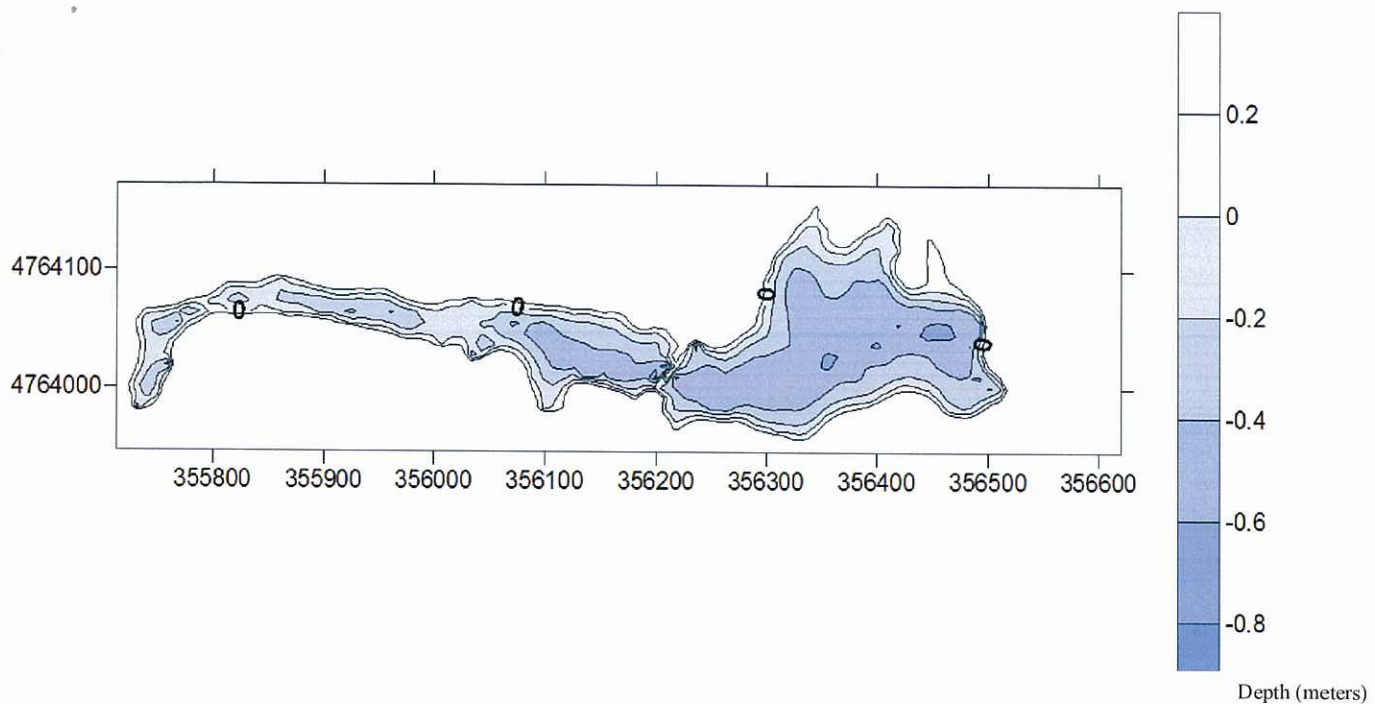
Maximum depth measured on 17 May was less than 1 meter, with the in pond staff gauge reading at 2.6. As associated water rights indicate, up until recently we believed this drain handled only natural flows from upstream springs and runoff. This drain can be used to deliver Aberdeen Springfield Canal water, ultimately to the same diversion ditch delivering the natural flows. There are three outlets. The modified dam construction includes an emergency spillway.

| | Surface Area (acres) | Maximum Volume Est. (acre-feet) |
|---|---|---|
| Pond # 1 (Orth Segment) | 12.88 | 12.13 |

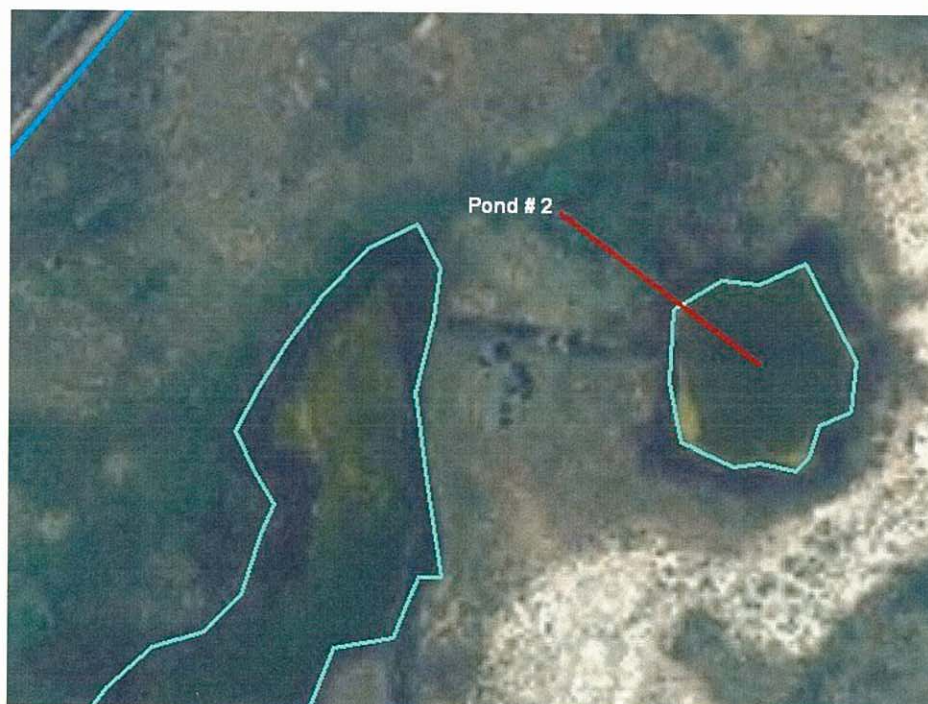
## Pond # 2

**Pond # 2** is connected to Pond #3 by a manmade ditch, but fills naturally in the spring apparently from surface water sources just to the north. Older photos and maps (1966) indicate

this pond occurred at least intermittently before the dike and ditch work was completed in the late 1980s. In fact, on 11 March, 2010, Paul Wackenhut witnessed flow out of Pond #2 through the manmade ditch into Pond #3. This pond is intended to be augmented by the diversion with flow from west to east. On 17 May, 2010, fifty two depth measurements were made from a boat with a tape measure within the open water of the Pond #2. (Depth measurements for Ponds #2, #4, #5, and #6 are from within open water only, while the surface area used in the volume calculation attempted to capture all inundated areas based on interpretation of aerial photography coupled with ground truthing. Depth measurements did not include shallows with emergent vegetation so average depths are likely overestimated.)

**Average depth was estimated to be 1.4 feet, N=52 (Depths from open water only-See above)**

**Total Surface Area = 1.05 acres**

**Maximum Volume Estimate = 1.47 acre-feet**

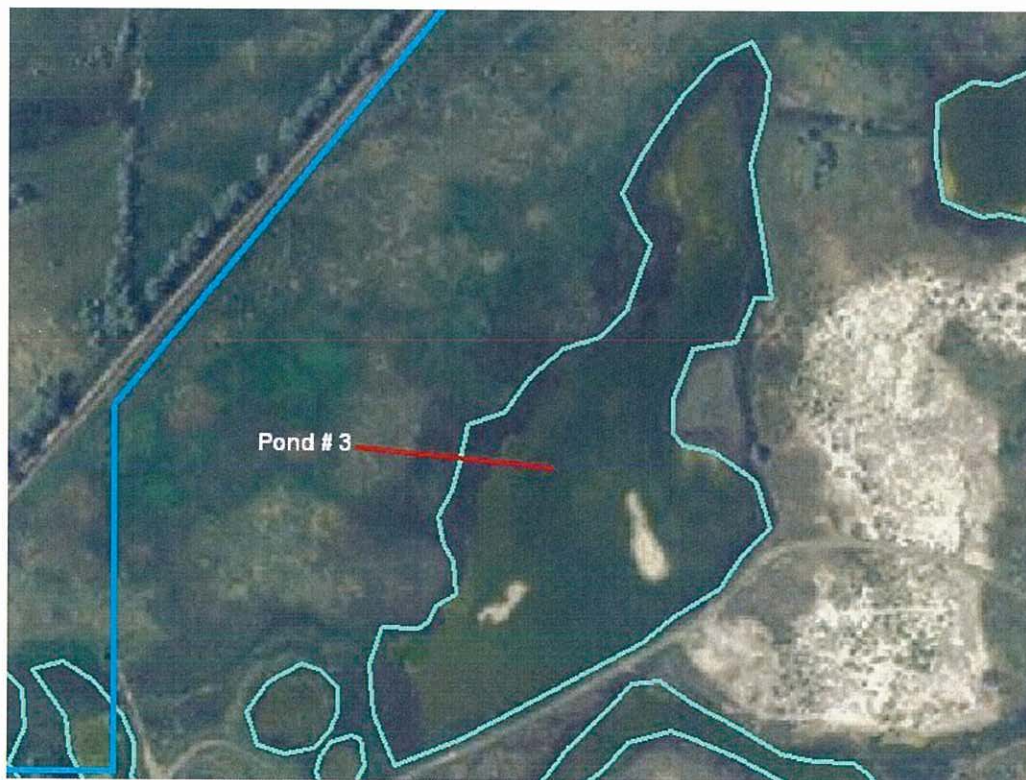
**Pond #3** is the first pond affected by the diversion ditch off of the Pond #1 dam north water level control structure. This pond appears to exist mainly as a result of the 1980s dike work although as with Pond #2, in the early part of the year some inflow appears to be natural. Depth measurements were taken with a sonar device and analyzed with Surfer 8.0 software to create a bathymetric map and calculate a volume estimate.

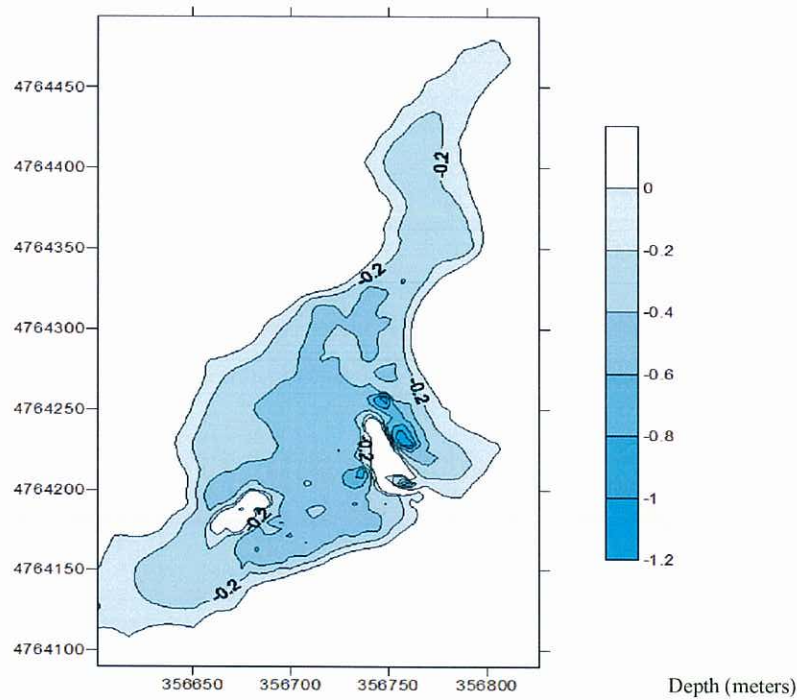
Maximum depth measured on 17 May, 2010, was less than 1.3 meters, with the in pond staff gauge reading at 2.0. As of 10 June, 2010 this pond had a slight outflow into Pond #6 with no inflow from the Pond # 1 diversion. The dike along the south edge of the pond includes one water level control structure and an emergency spillway emptying into the natural drainage.

**Total Surface Area = 8.23 acres**

**Maximum Volume Estimate = 6.659 acre-feet** (Software - Surfer 8.0, N=722 depth meas.)

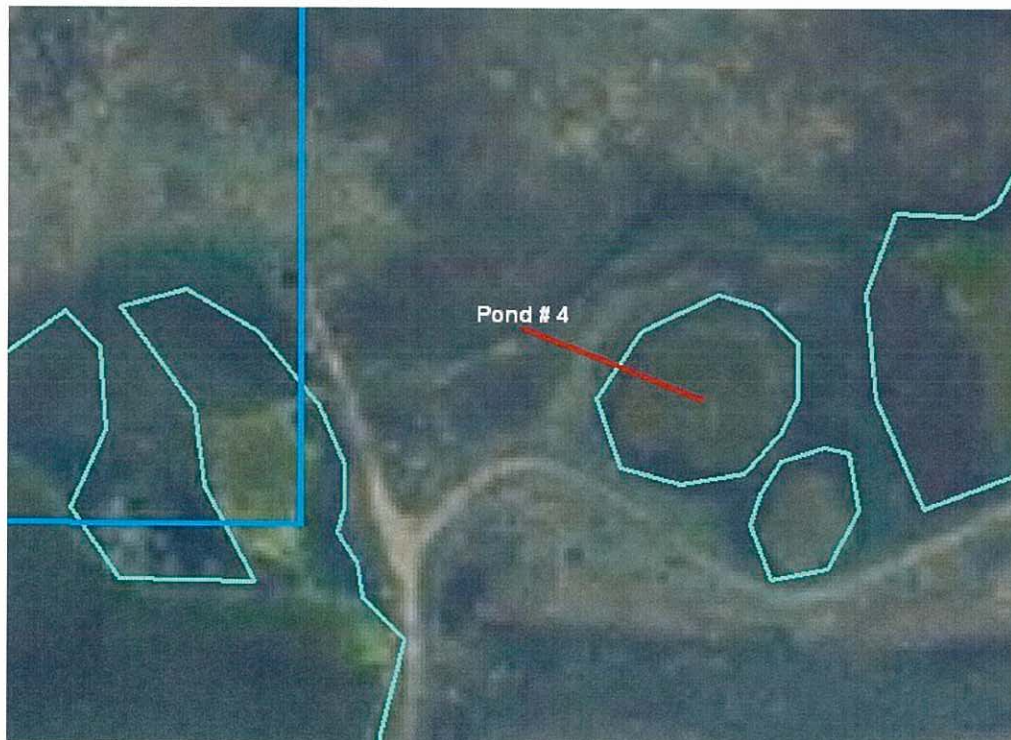
#### Pond #4

**Pond #4** has no manmade surface connection to Pond #3, but Ponds #3, #4 and #5 appear to be in equilibrium at typical pool levels. Both Ponds #4 and #5 are very similar in size and shape to aerial photo depictions from 1966, prior to the 1980s dike work. Pond #4 is likely affected by diverted flows and the continuation of the dike which forms Pond #3. On 17 May, 2010, thirty two depth measurements were made from a boat with a tape measure within the open water of the pond.

**Average depth was estimated to be 1.6 feet, N=32** (Depths taken from open water only-See Pond #2 above)

**Total Surface Area = .4 acres**

**Maximum Volume Estimate = .64 acre-feet**

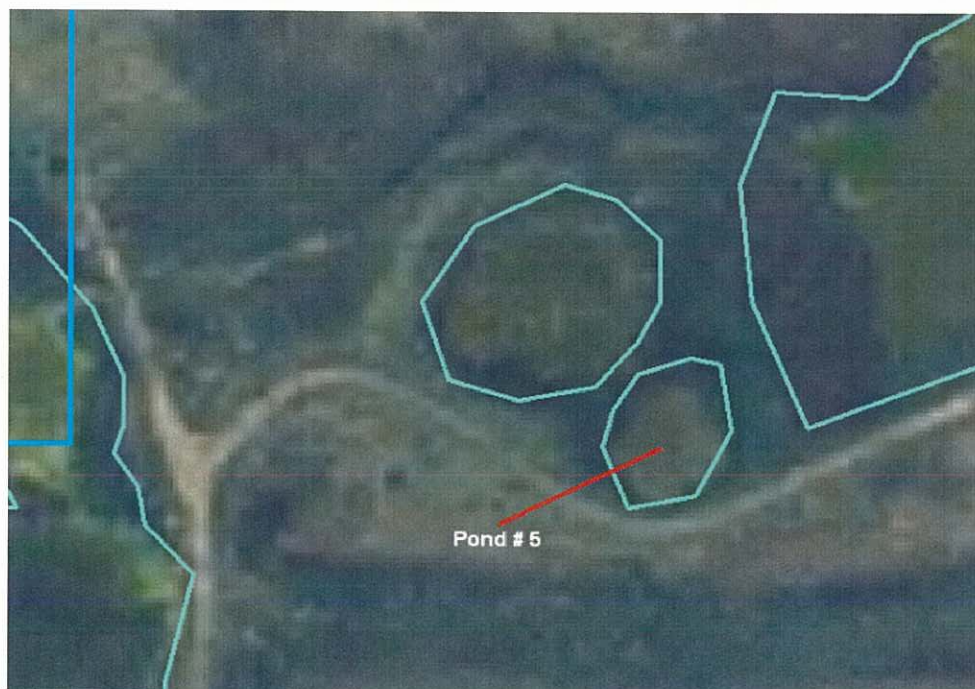
**Pond #5** has no manmade surface connection to Pond #3 or #4, but appears to be in equilibrium with those ponds. Both Ponds #5 and #4 are very similar in size and shape to aerial photo depictions from 1966, prior to the 1980s dike work. Pond #5 is likely affected by diverted flows and the continuation of the dike which forms Pond #3. There is a control structure on the outflow from Pond #5 emptying into the natural drainage. On 17 May, 2010, twenty eight depth measurements were made from a boat with a tape measure within the open water of the pond.

**Average depth was estimated to be 1.5 feet, N=28** (Depths taken from open water only-See Pond #2 above)

**Total Surface Area = .15 acres**

**Maximum Volume Estimate = .23 acre-feet**

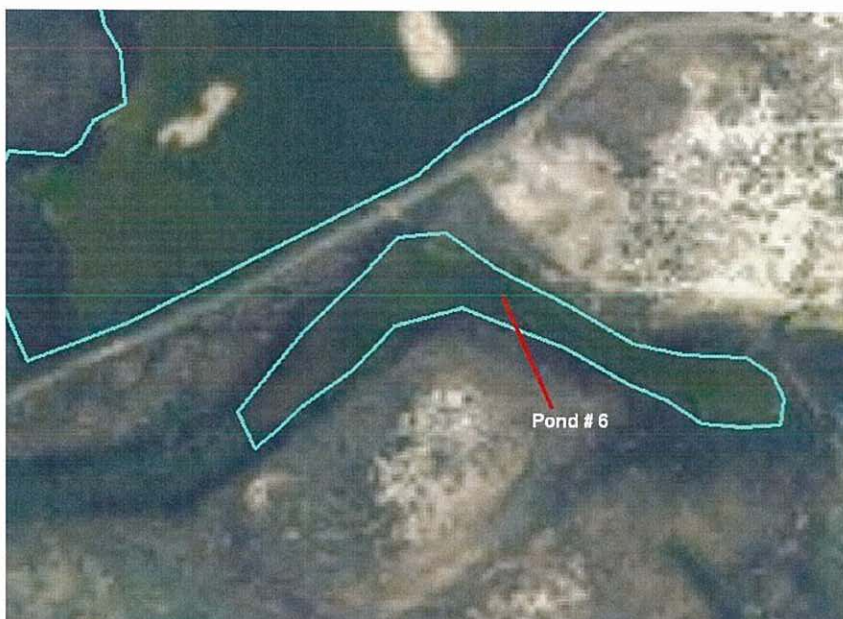
## Pond #6

**Pond #6** is formed by a dike within the natural drain. It receives any natural flows down the natural drain or through Ponds #3 and #5, as well as diverted flows from Ponds #3 and #5. There is a screw head gate on the dike but no functional water level control structure. The maximum water level is essentially set by the elevation of the permanent spillway (lowered in the early 1990s) on the southeast end of the dike. On 17 May, 2010, one hundred thirty five depth measurements were made from a boat with a tape measure within the open water of the pond.

**Average depth was estimated to be 1.4 feet, N=135** (Depths taken from open water only-See Pond #2 above)

**Total Surface Area = .97 acres**

**Maximum Volume Estimate = .41 acre-feet**
