Permit No. 79-7210

3. Source: Unnamed Stream and Tolo Lake tributary to Telcher Creek

**79-7219 Tolo Lake  
Field Exam Exhibit**

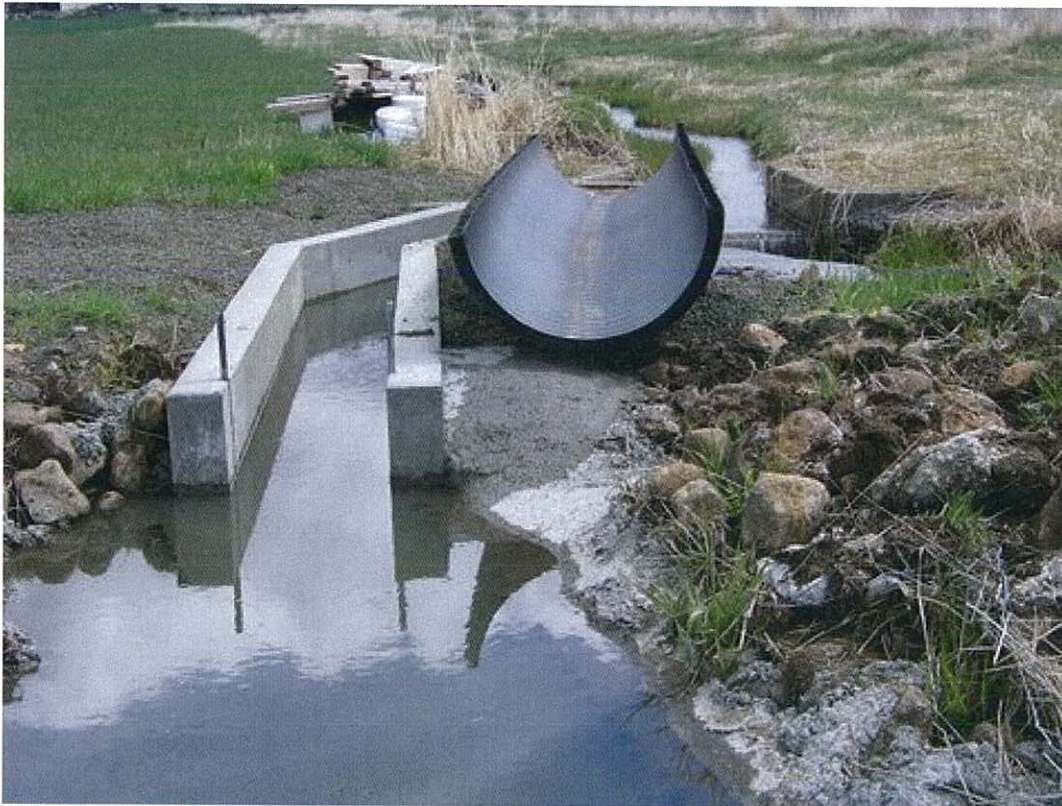
The site pictures also indicate that the diversion works were repaired/replaced at the point of leakage witnessed the year before with a concrete rectangular channel. Flow through the diversion is confirmed in the pictures.

Downstream of diversion in conveyance channel to Tolo Lake looking upstream at the point of diversion, Spring/Summer 2009. Leaky basalt caissons (previous picture) have been replaced with concrete walls. Conveyance channel has been lined with cement downstream of end of diversion.

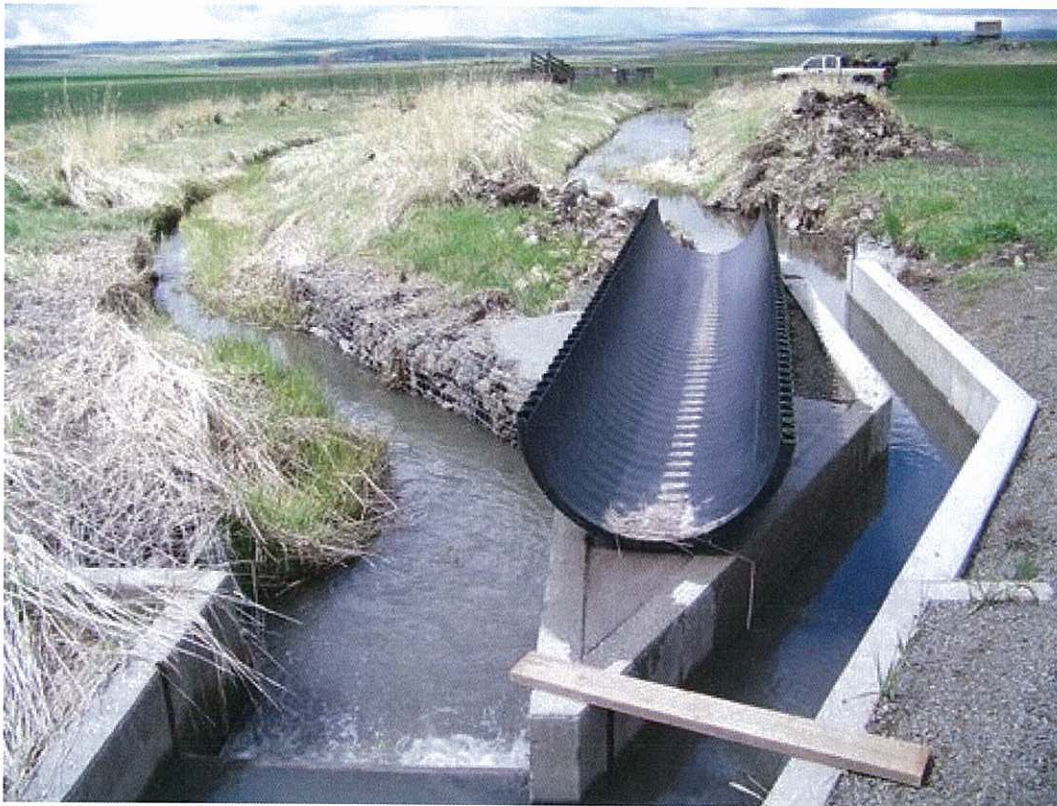
Upstream of diversion looking downstream Spring/Summer 2009. Tolo Lake is located near the tree that can be observed in the far background on the left side of the image.

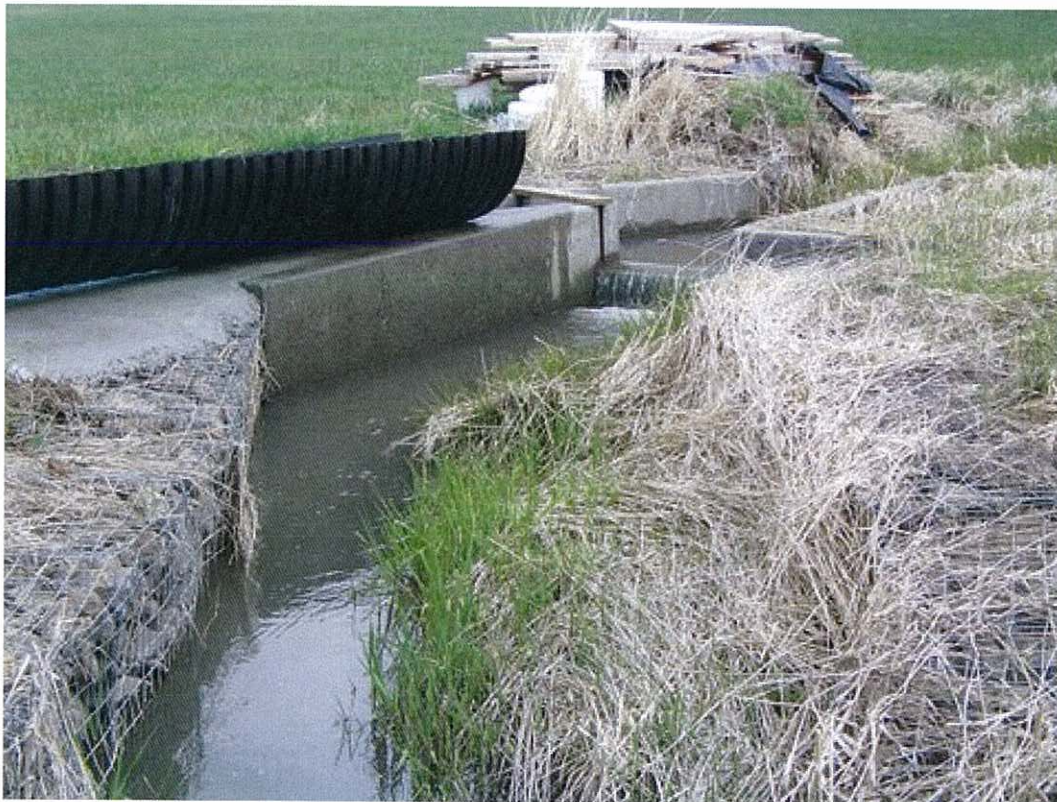
Downstream of diversion in Techler Creek channel looking upstream at the point of diversion, Spring/Summer 2009.

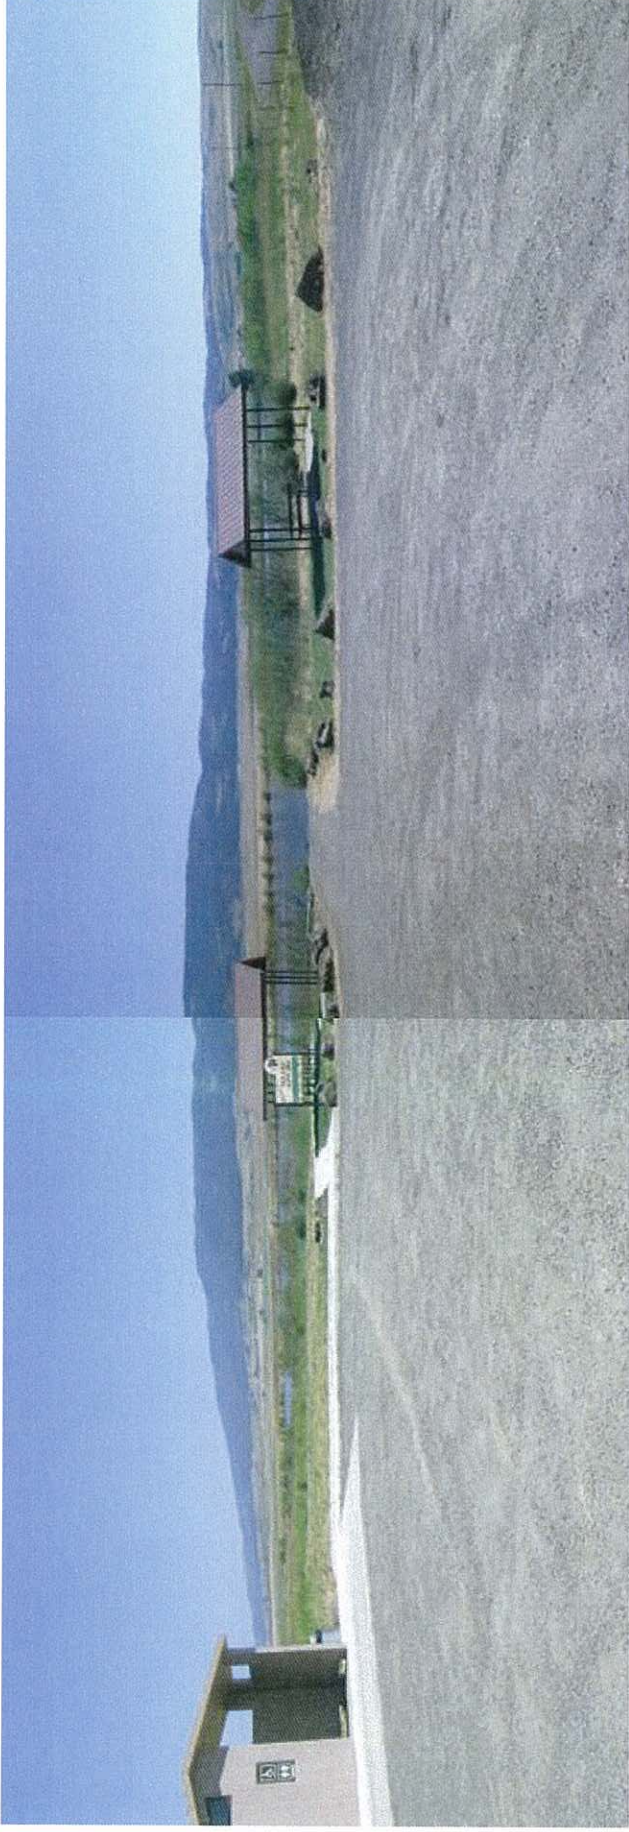
Tolo Lake Picnic Area and Boat Launch, recreational place of use.
