STATE OF IDAHO  
DEPARTMENT OF WATER RESOURCES  
**BENEFICIAL USE FIELD REPORT**

Permit No: 71-7169

Exam Date: 8/27/2008

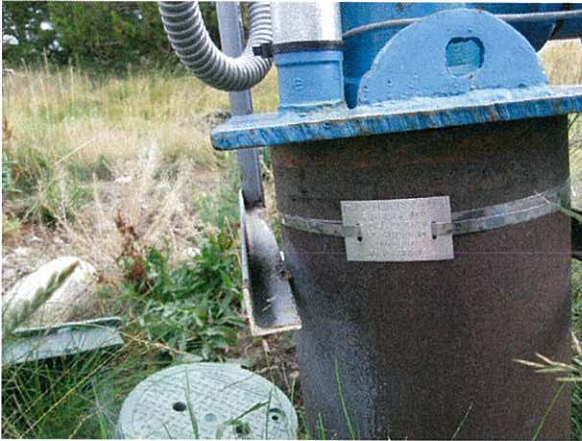
The top photo is a close-up of the well head and site tag. This is a 40 Hp motor. It is located in the southeast corner of the yard of the main house/lodge.

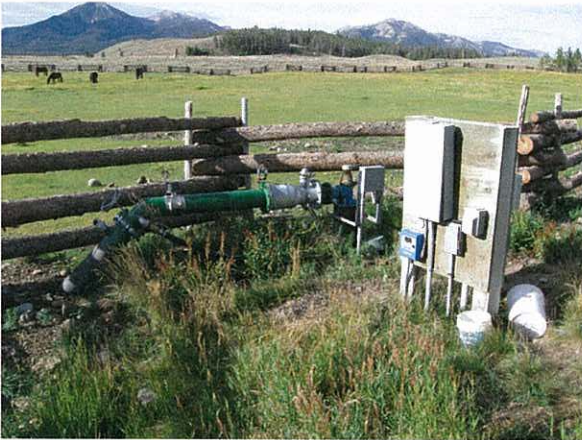
The second photo shows discharge system from the well.

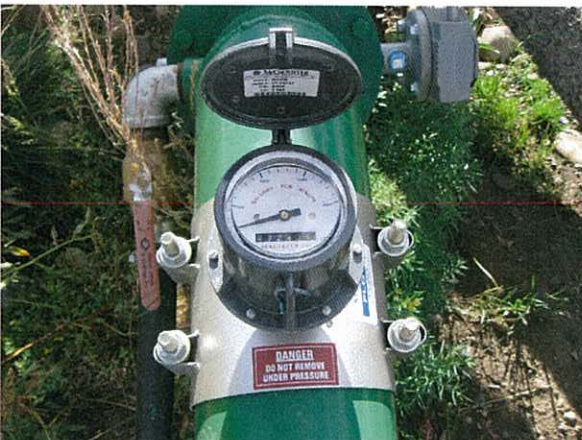
The third photo shows the flow meter on the well.

2. Measurements: At the same time that the measurement was done for this permit, I also calibrated the flowmeter for this system. The flow meter was reading 11% low compared to the flow meter being used. I feel the flow measurement we made was a fairly good measurement, and that the poor installation of the flow meter was the reason for the difference between the Department's meter and the meter installed on the pipeline.

The owner has installed a McCrometer flow meter on the pump, so it appears as though they have complied with all of the conditions of their water rights. I would add the condition that this water right is under the control of the watermaster for Water District 170. The watermaster accompanied me during the field exam and we also calibrated the flow meter for this system.

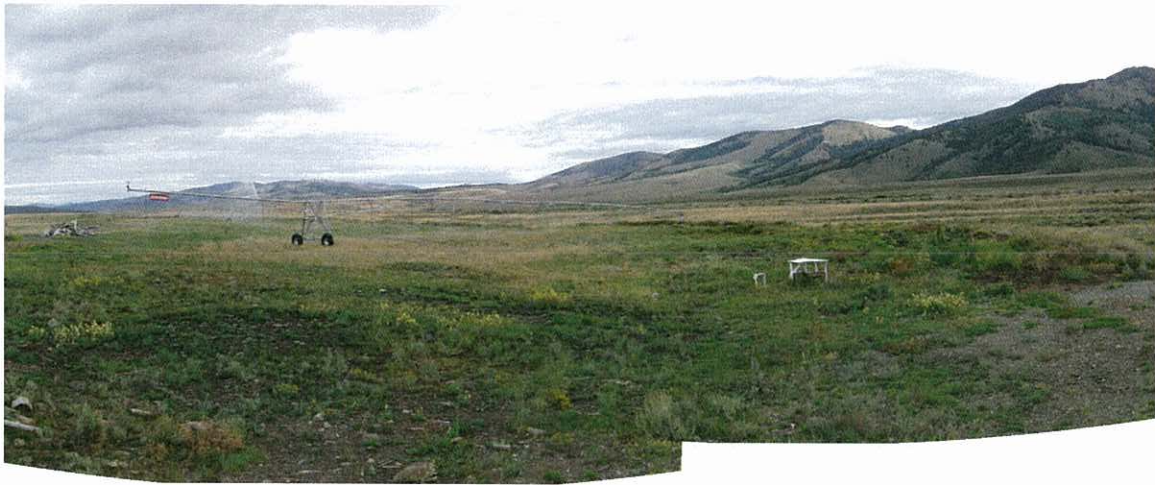
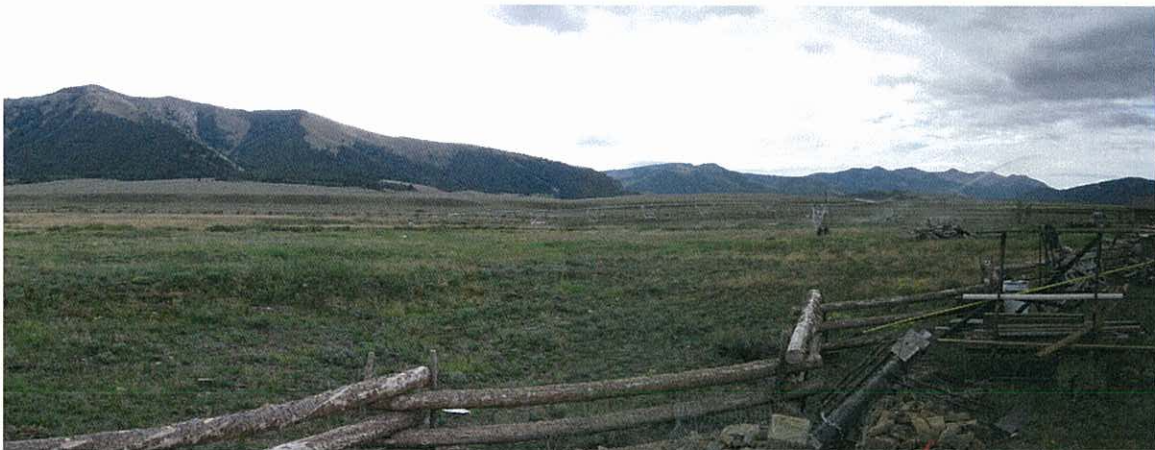
These are photos of the small pivot located northeast of the lodge.

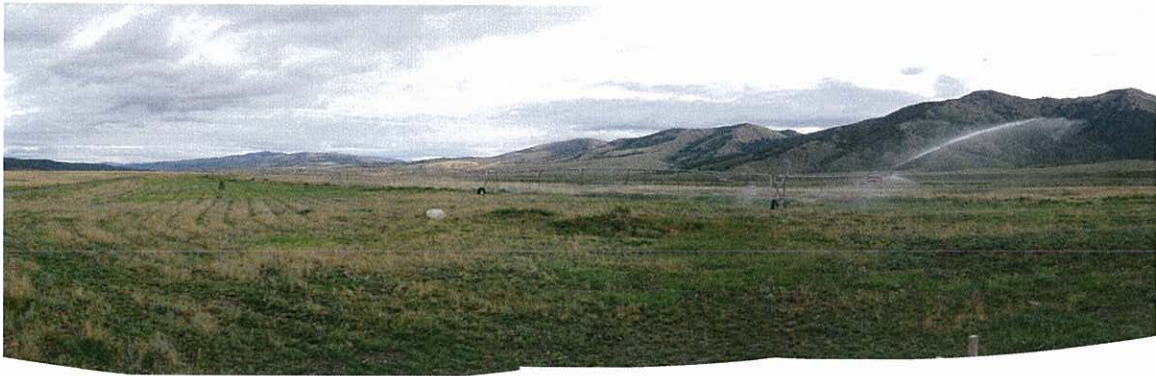
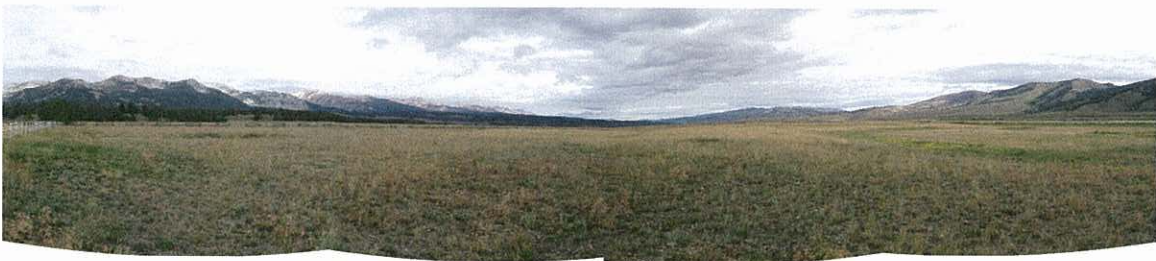
The top two photos are of the large pivot. The large pivot is located due north of the main ranch area.

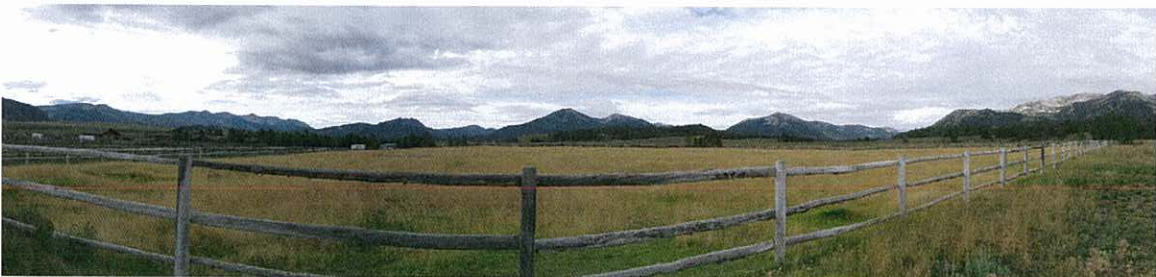
The bottom photo shows the north pasture that is northeast of the main ranch area.

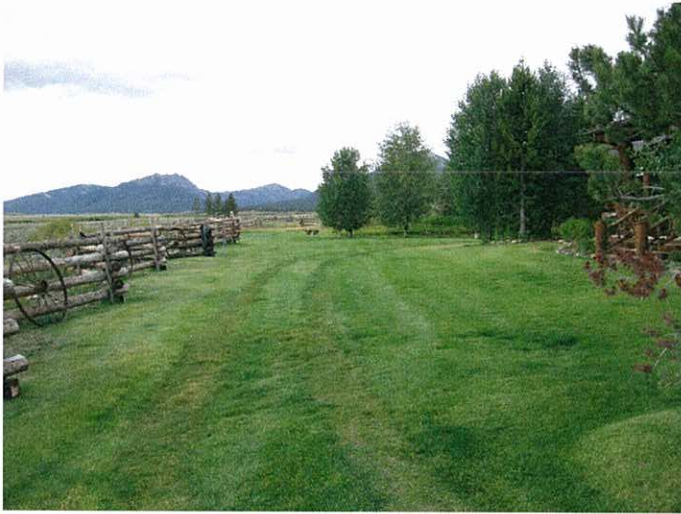
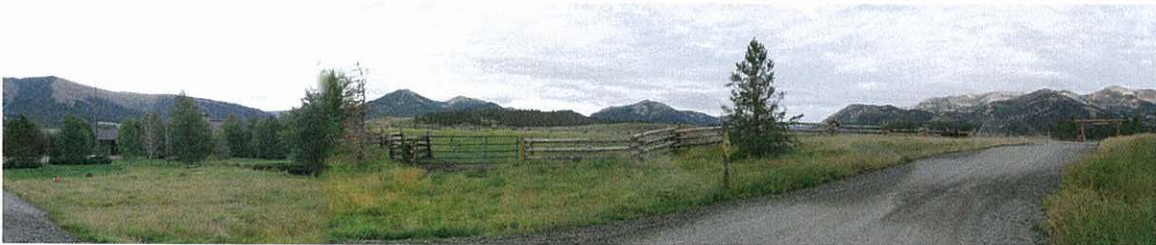
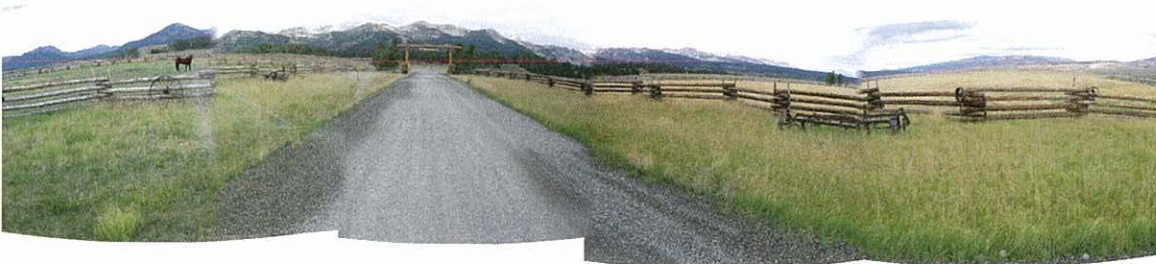
These photos show the front entry into the ranch that is irrigated and portions of the yard. All irrigation on this property comes out of this single well.

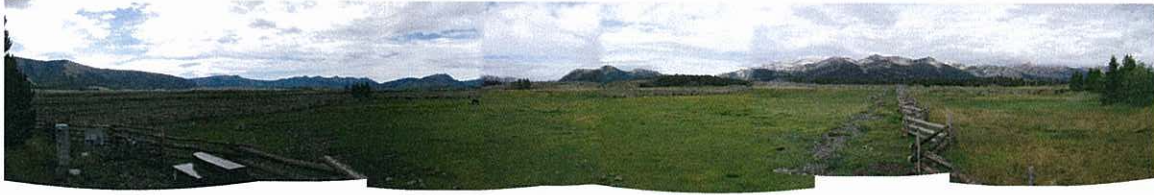
The photo shown above shows the southwest pasture that is south of the homestead and runs along the highway.

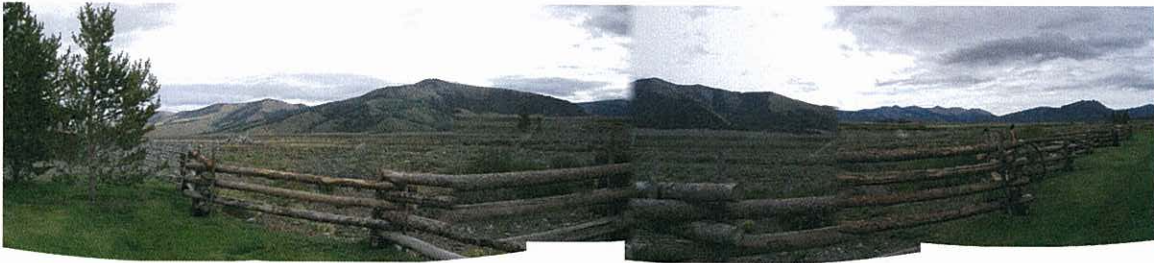
The bottom photo shows the southeast pasture. This pasture is clearly irrigated, but it they haven't pulled the sagebrush out of this pasture. It does appear to have crested wheat and other drought tolerant grasses in it. Due to the low diversion rate allowable, this pasture is the last one to be used.
