STATE OF IDAHO  
DEPARTMENT OF WATER RESOURCES  
**BENEFICIAL USE FIELD REPORT**

Permit No: 45-7342

Exam Date: 9/19/2007

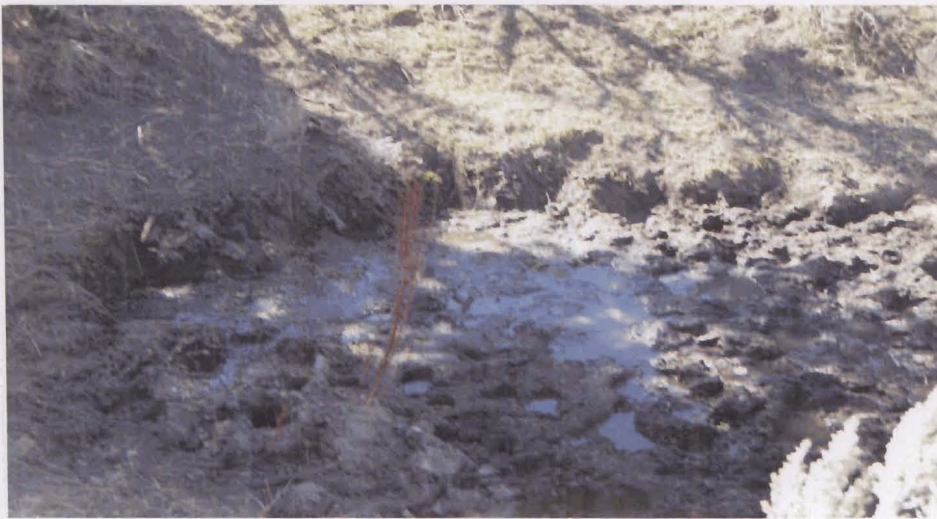
Benny Walker, Kelly Chirstensen, and Jeff Cooper performed the field examination on September 19, 2007. The apparent head of the Spring (POD) had been developed, though it was impossible to see in what manner. No information was available from Steve Davis (BLM-Burley) or the current range technician about the system development or construction materials. However, some information was derived from a Preliminary Order Before the State of Idaho, In the Matter of Application for Permit No. 45-07342 in the Name of the Bureau of Land Management, which indicated that ...the spring was developed using (10) feet of perforated pipe close to the surface of the ground.

From the field examination, it was assumed that a spring box had been placed at the POD and covered with soil. The POD was found to be in the same legal as described by the applicant (T15S R22E Sec 21 SWSW), apporixmately 500 ft east from the access road. The application gives the local name of Darens Spring as the source, tributary to Goose Creek. However, according to the USGS Blue Hill Quad Map, the source is actually an unnamed spring, which was inferred to be tributary to cold creek. At the time of the examination, the spring dissipated just below the developed system into its natural drainage.

Photo # 1 The head of the spring  
Looking SW in this photo

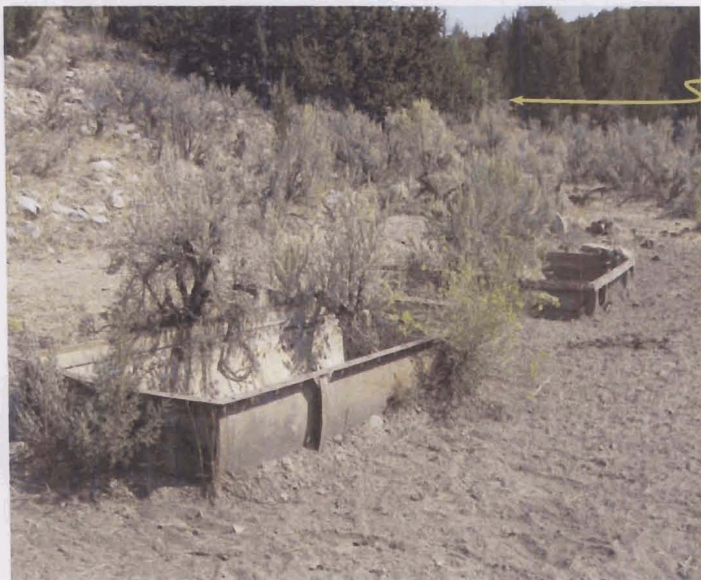
The POU was found to be in the location as described by the application (15S 22E Sec. 21 SWSW). Two stockwater tanks had been placed ~10ft north of the natural spring drainage, ~215 ft east of the access road, and ~285 ft west of the POD. There is approximately 40 ft of head over 288 ft for a gradient of 0.14 between the POD and POU. The two tanks that make up the POU were constructed from an aircraft engine shipping container that had the following dimensions (LxWxD): 8 ft x3 ft x 3 ft (West Tank) and 8 ft x 3 ft x 2 ft (East Tank) for a total volume of 150 cubic ft or 1122 gallons. Because a large portion of the system was buried, we were unable to locate the inlet to the tanks, though it appeared the two were tied together. A buried outlet was apparent ~15 ft west and downstream of the tanks.

Photo # 2 Two tanks looking East.

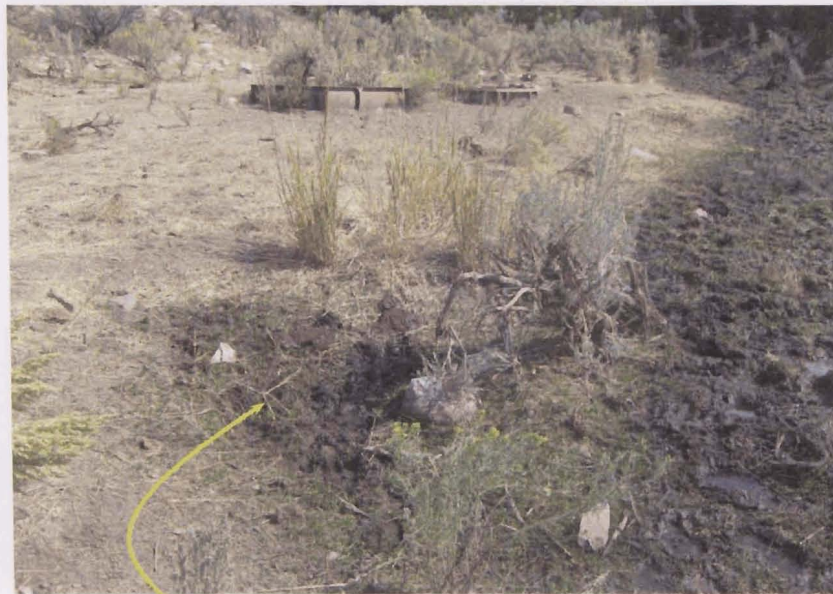
Spring head location East of tanks.

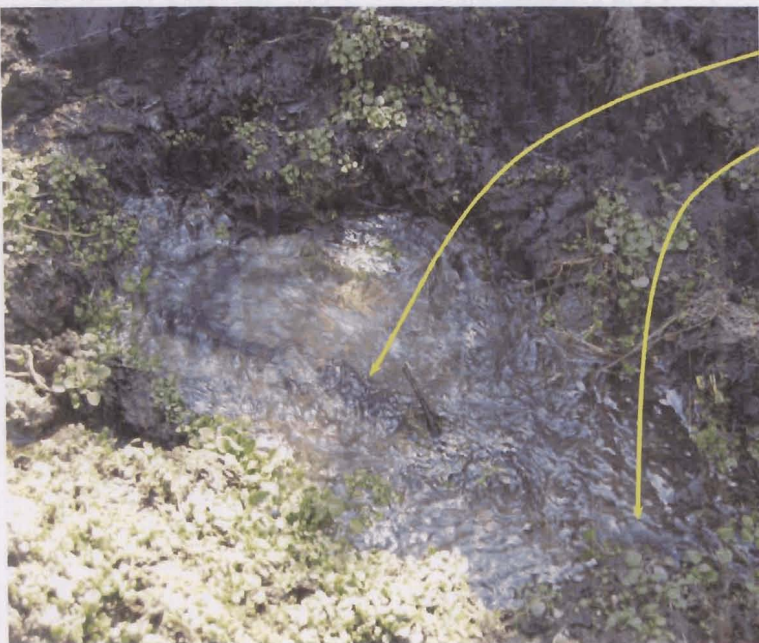
Photo # 3 Outlet approximately 15 ft west and downstream of the tanks
