FIELD EXAM FOR 37-08461 PHOTOS TAKEN 06/28/96 BY COREY SKINNER.

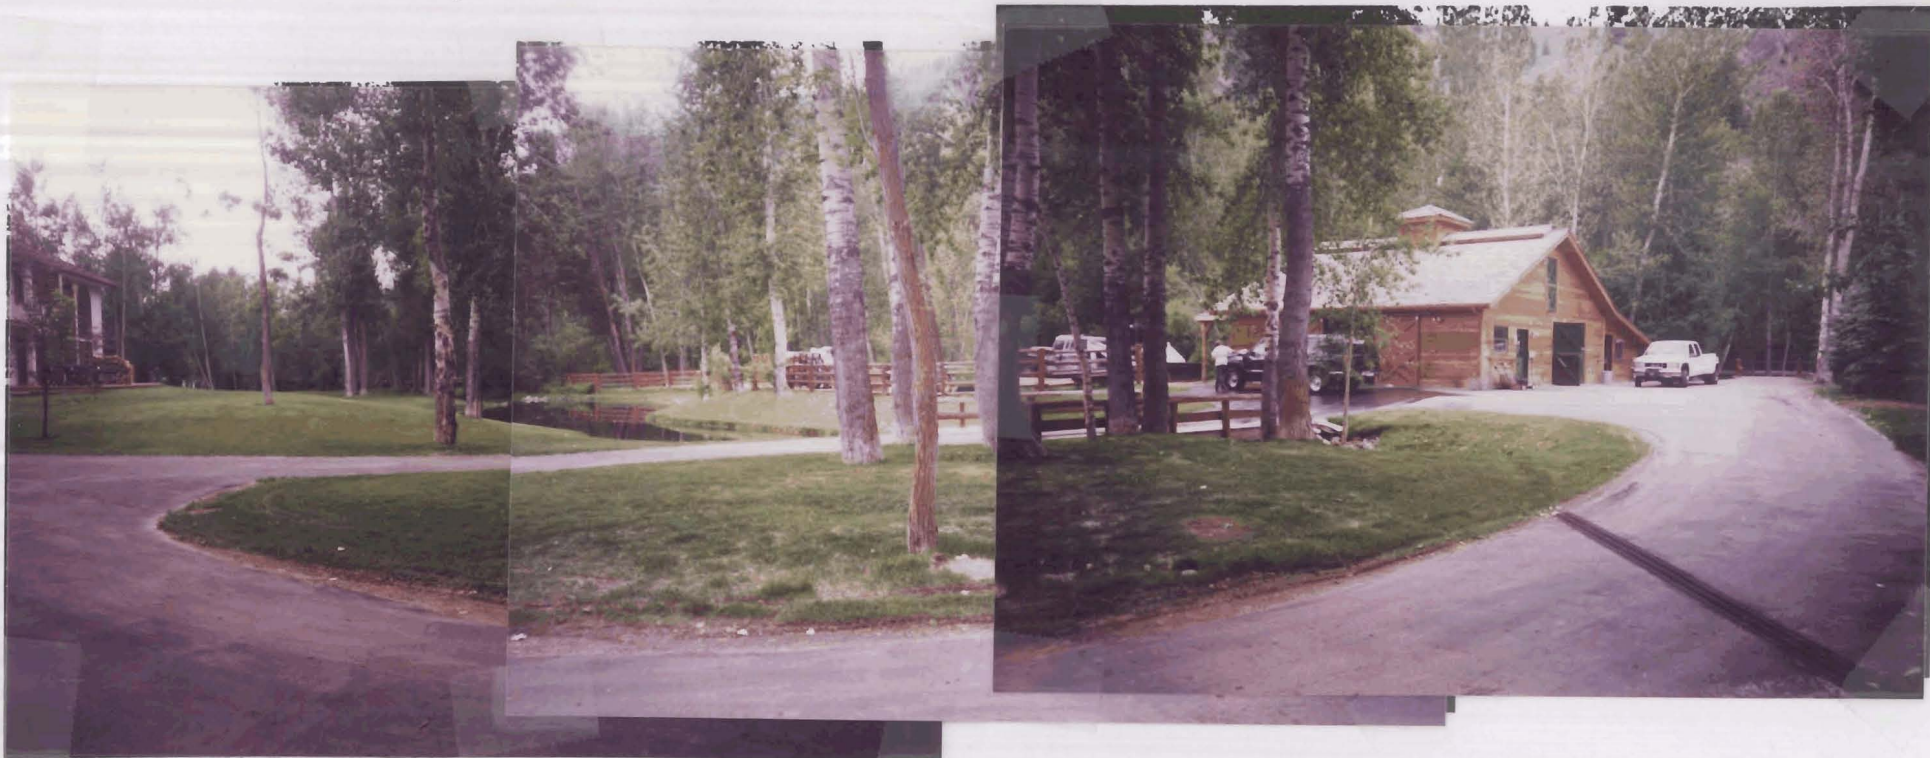
View showing irrigated area between residence (left edge of view) and horse barn. Domestic uses include residence and a sink in the barn. Horses were not present at time of exam. Mr. McAllister said they were grazing on some different property. Facilities are definitely intended for horses and horses have been present. Mr. McAllister said that five horses are the most that have ever been housed at the facility. Pond in center of view is fed by water from Big Wood River, apparantly rights 37-00557, 37-00558, and 37-00559. Transfer applications have been filed to show the pond use(s) and add supplemental (to groundwater) irrigation use.

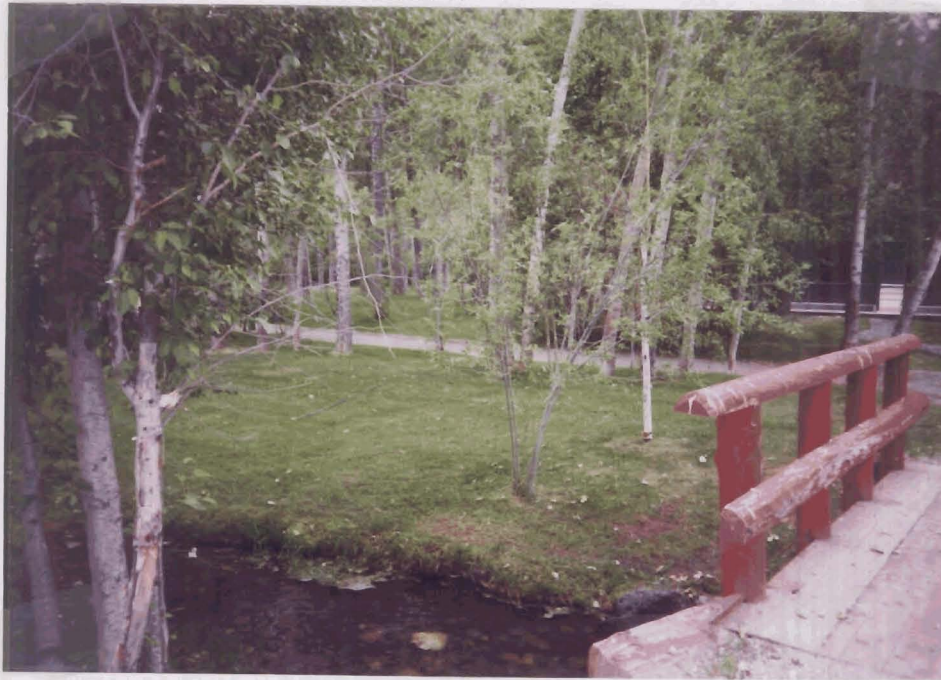
View showing irrigated area between horse barn and tennis courts. Bridge visible at right edge of photo is over waterway fed by Big Wood River.

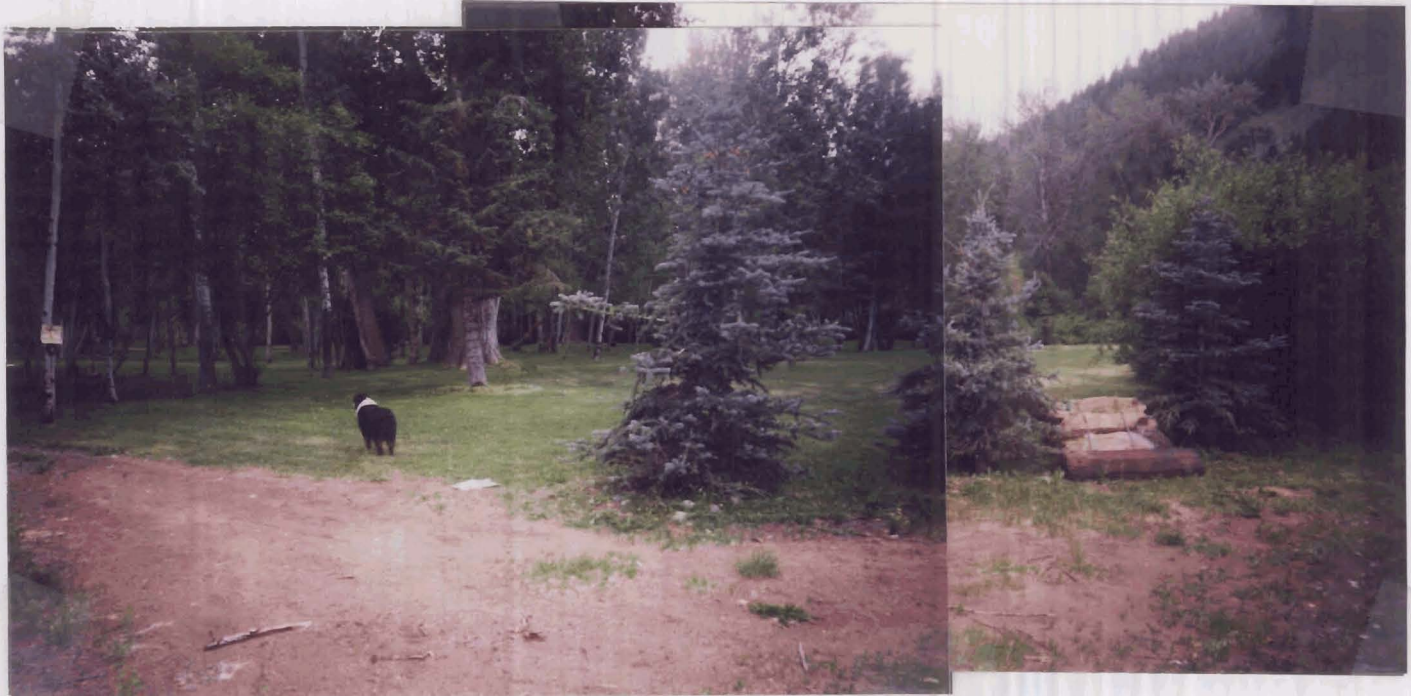
View showing irrigated ground at the back of Lot 34 of Flying Heart Ranch Number II Subdivision. Photo was taken from North Boundary of Lot 34 at Big Wood River's edge looking south to south easterly.

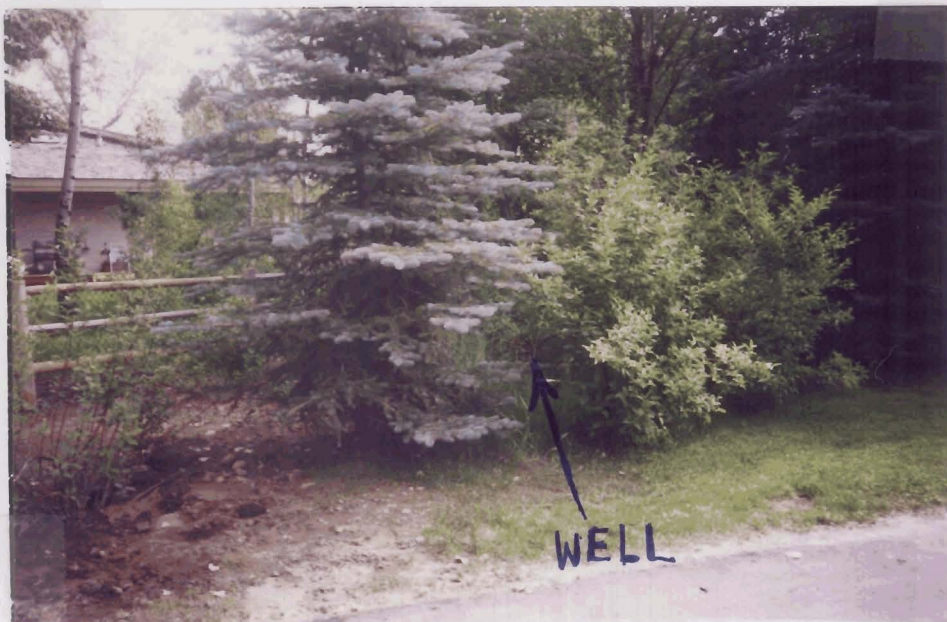
View showing point of diversion (well indicated by arrow). Fence in background is north boundary of Lot 34 Flying Heart Ranch Number II subdivision. Residence in background is on Lot 33 and owned by someone else.

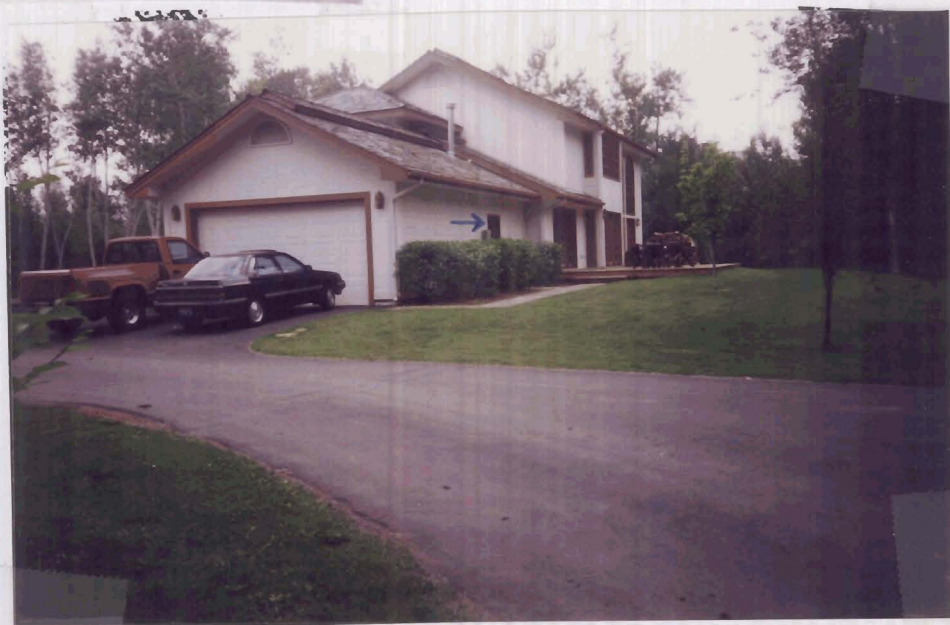
View showing residence (guest house) and irrigated ground around residence. Arrow indicates location of garage doorway shown on system diagram on page one of Field Report.

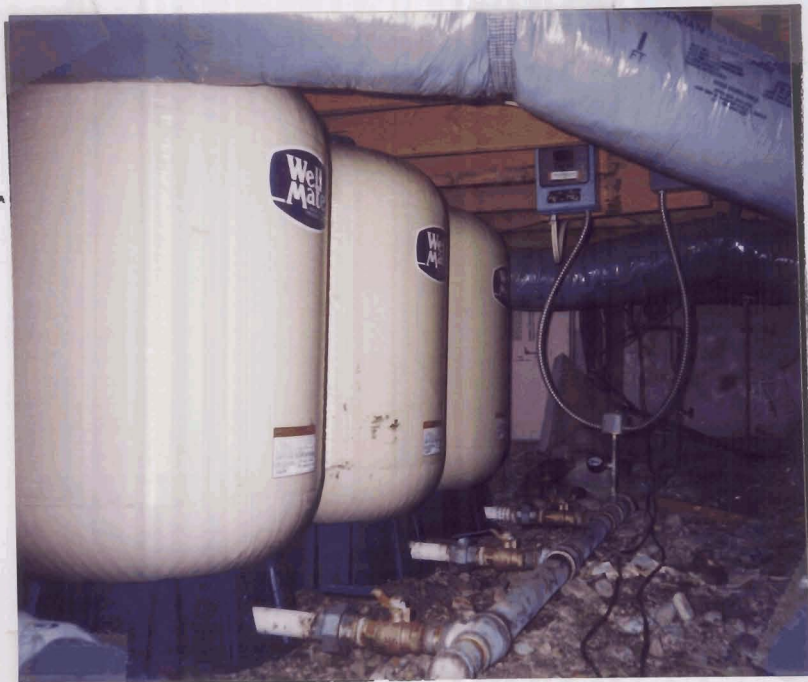
View from under residence, near garage, showing pump, motor & pressure tanks.

STA-RITE VIP III:  
2 horsepower  
pump model 40P4GO2S-34  
motor model M4GO2S-20  
3 Well Mate Pressure  
Tanks.
