Scott Carlisle  
(Star Valley Trout Farm)  
6/20/2006  
Prepared by: C. Bird  
Field exam done on 6/13/2006

Department of Water Resources  
Eastern Region

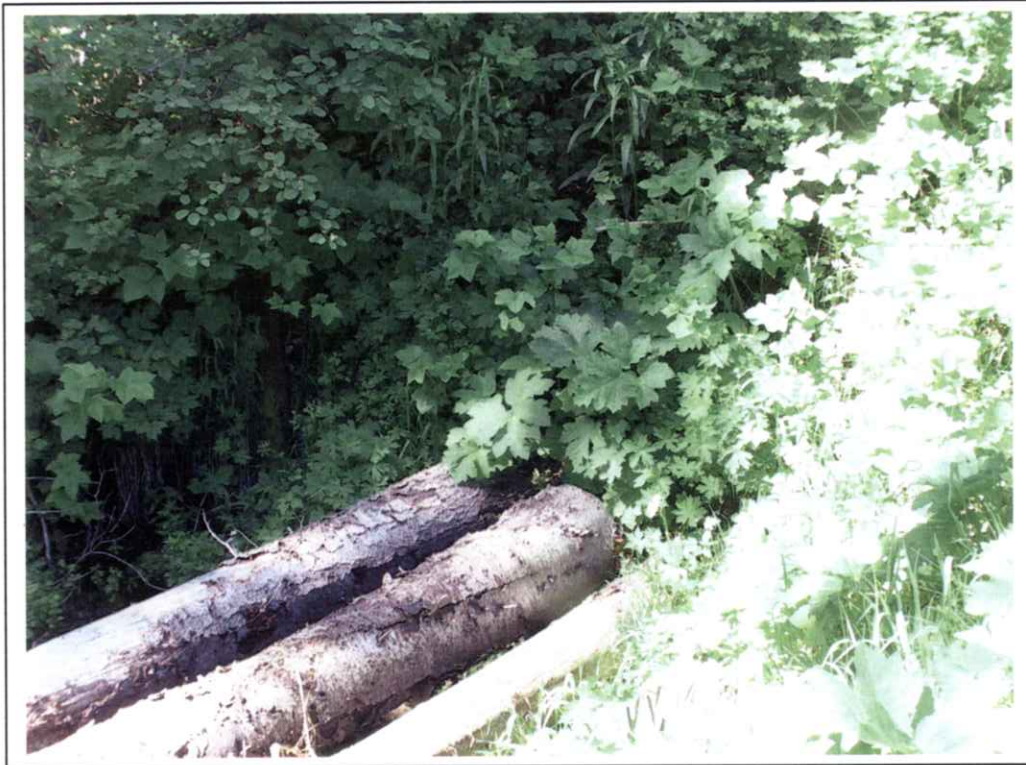
Photo 1376  
10:56 am

Photo 1. Looking in a southwesterly direction at the head of Spring Crk where the 4" and 1½" pipe is buried. 4" pipe goes to the hatchery and the 1½-inch pipe goes to the home and lodge. Pipes were installed in 1996. This is also the proposed site to install covered structure for permit 24-10673. GPS  
FILENAME: DOMHCH

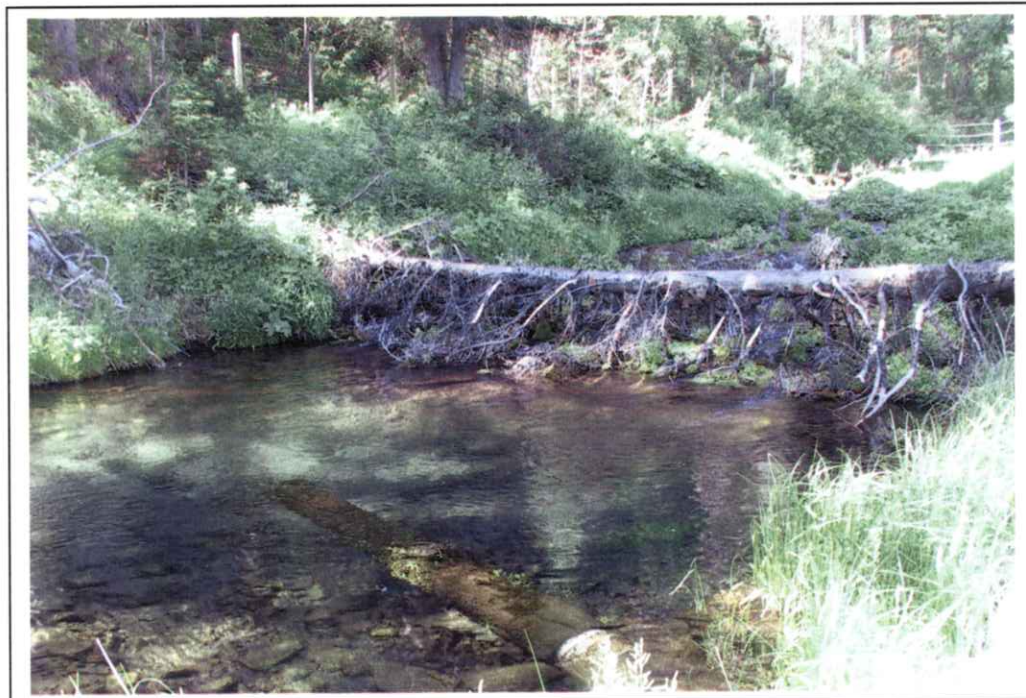
Photo 1377  
11:03 am

Photo 2. Looking south at 10-inch pipe in Spring Crk. This pipe supplies water to 6 concrete ponds. Pipe was installed in 1996 after getting approval from the Forest Service under Special Use Permit FS 2700-4 (7/93) GPS  
FILENAME: 10INPL

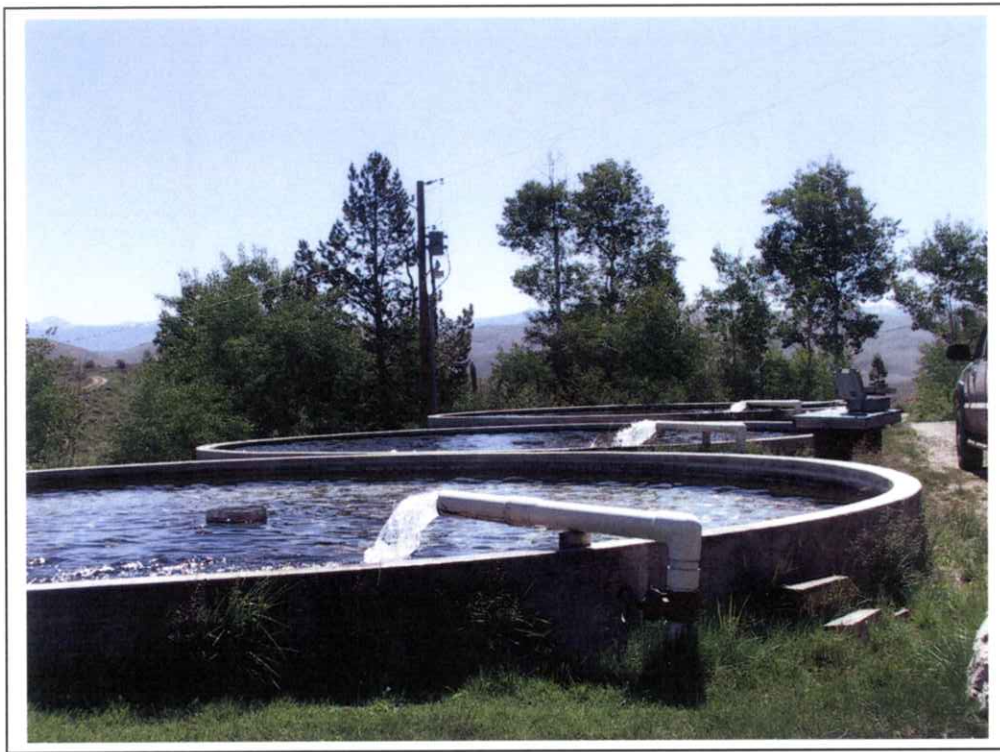
Photo 1378  
11:23 am

Photo 3. Looking east at 3 of the 6 concrete fishponds. Water supplied to the ponds by the 10-inch pipe in Spring Creek. These structures were built about 5 years ago according to Scott Carlisle. The diameter of each structure is about 30 ft X 30 inches deep and all 6 ponds were operating at the time of my visit. Inlet pipe is a 4-inch PVC pipe going into each pond. GPS FILENAME: POU4IN

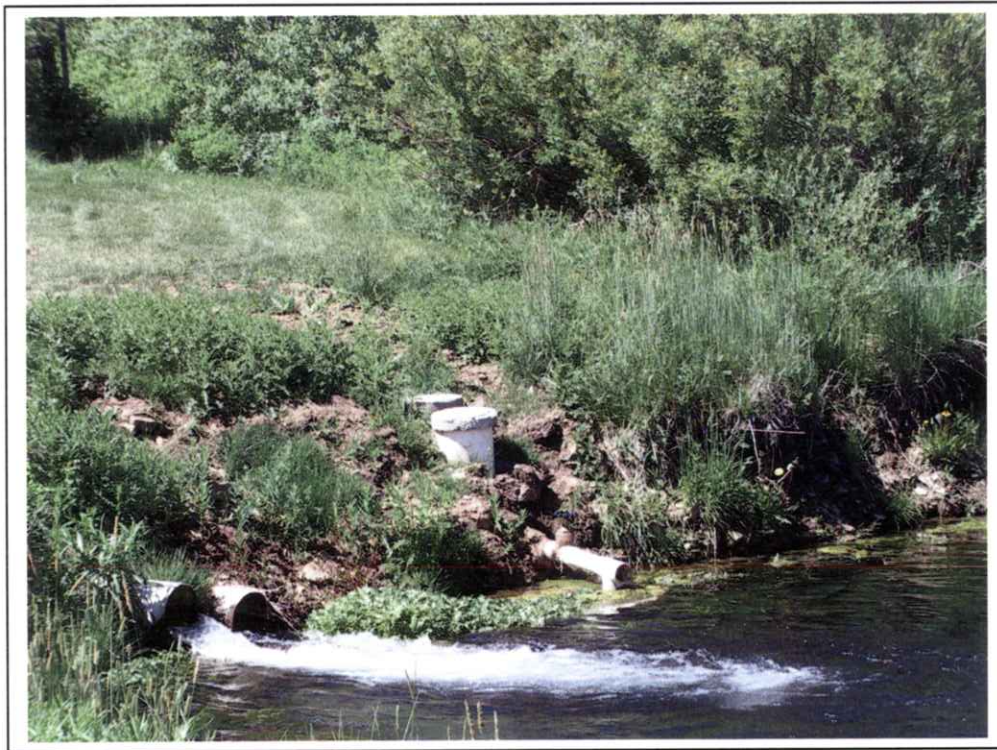
Photo 1379  
11:32 am

Photo 4. Looking in a southwesterly direction at 2-10" pipes that dumps water from the concrete ponds into a sediment pool before going back into Spring Creek. GPS FILENAME: PTOFIJ

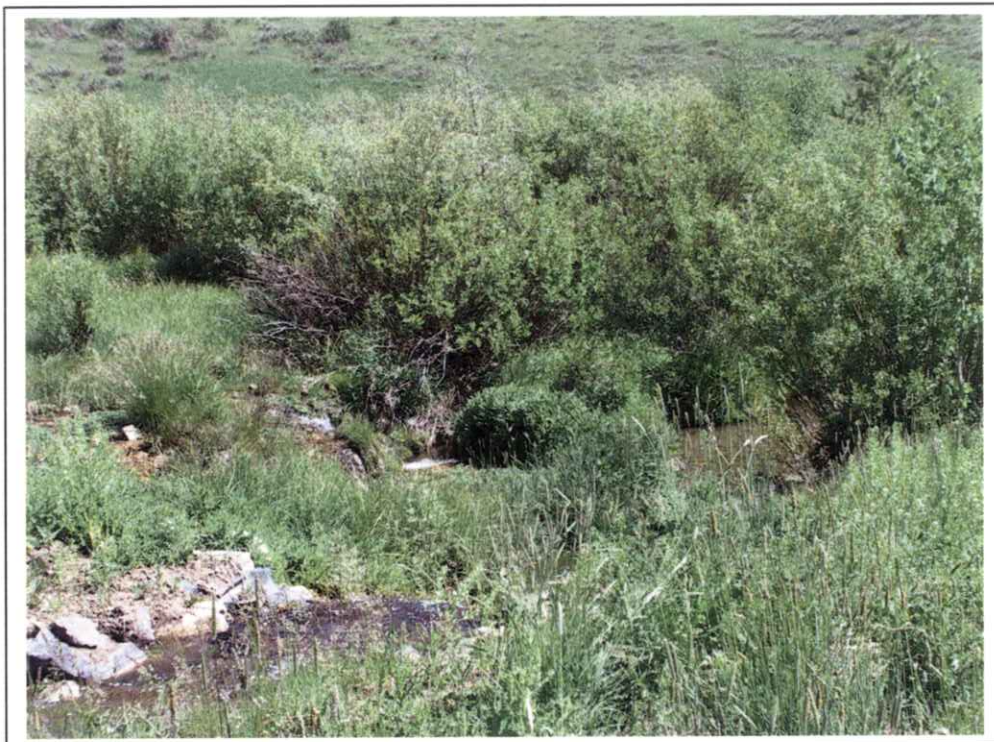
Photo 1380  
11:33 am

Photo 5. Looking in a northeasterly direction at Spring Creek and the water from the settling pond as it flows back into Spring Creek.

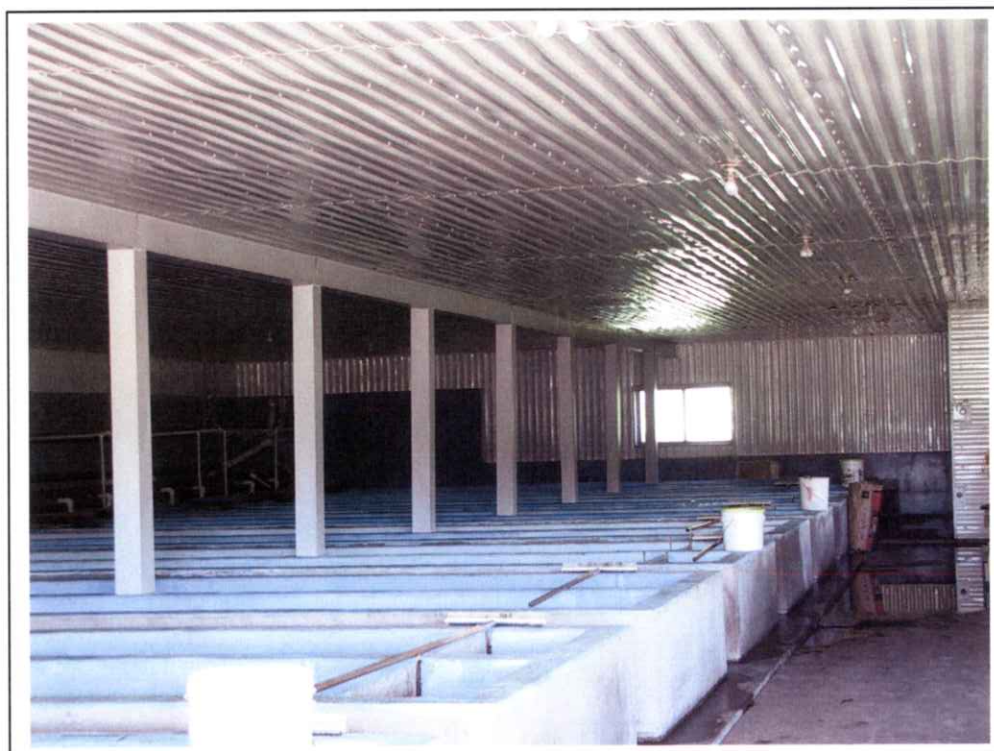
Photo 1381  
11:51 am

Photo 6. Looking in a westerly direction into the hatchery at the large raceways. GPS FILENAME: HATCHY

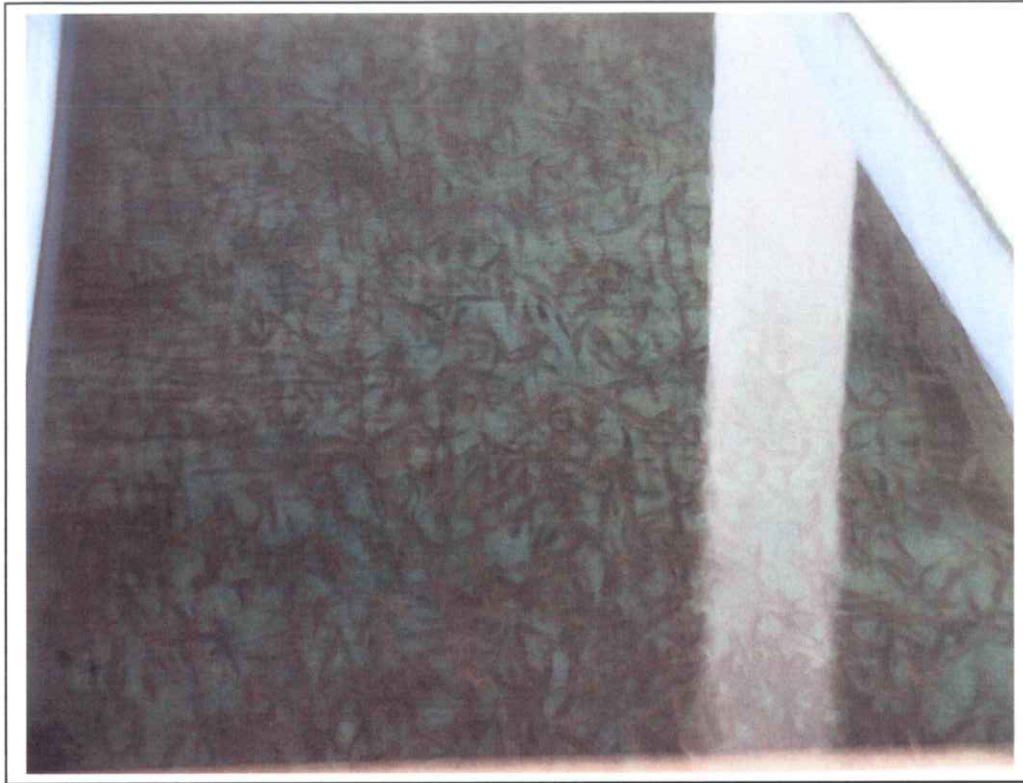
Photo 1382  
11:52 am

Photo 7. Looking into one of the large raceways at the hatchery.

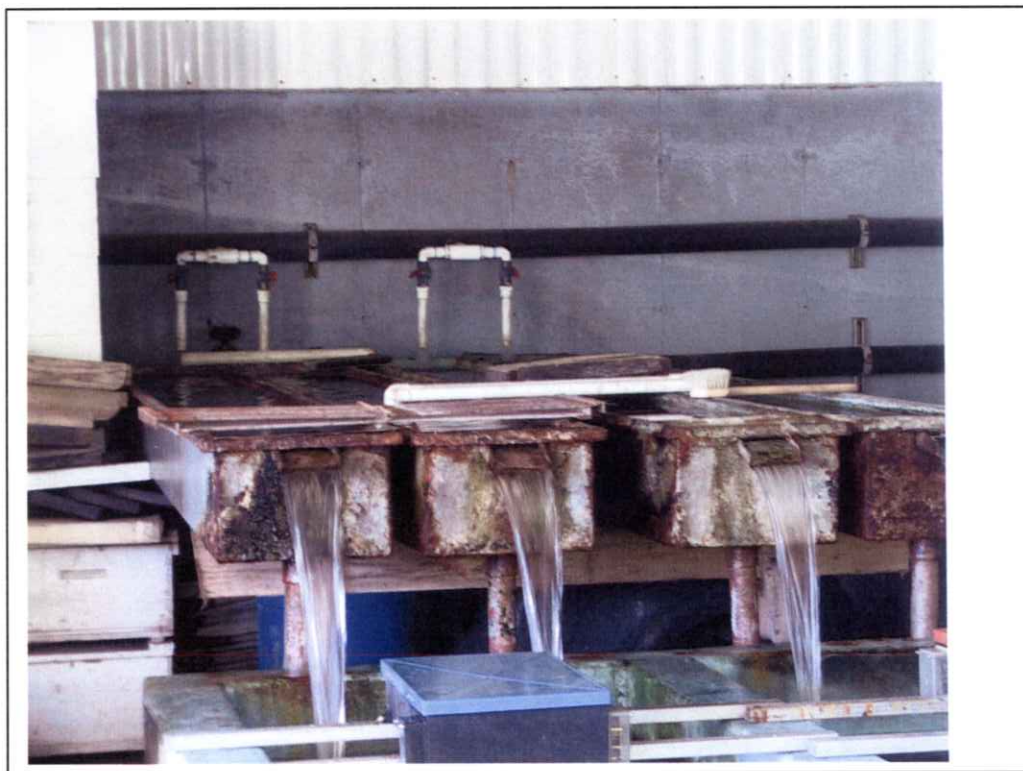
Photo 1383  
11:58 am

Photo 8. Looking in a southerly direction at the water coming into the small raceways. The supply line is 1-inch PVC pipe that dumps water into the trough then it flows into the small raceways. A 4-inch pipe from Spring Creek supplies the hatchery water.

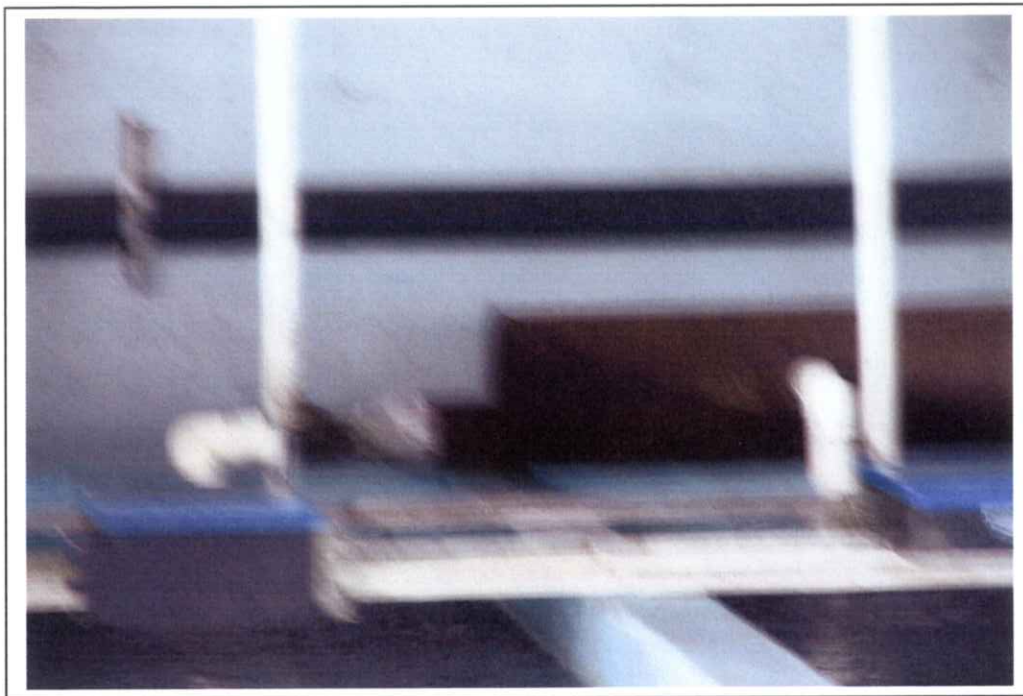
Photo 1384  
11:58 am

Photo 9. Looking at the 2-inch PVC pipe coming into the large raceways in the hatchery.

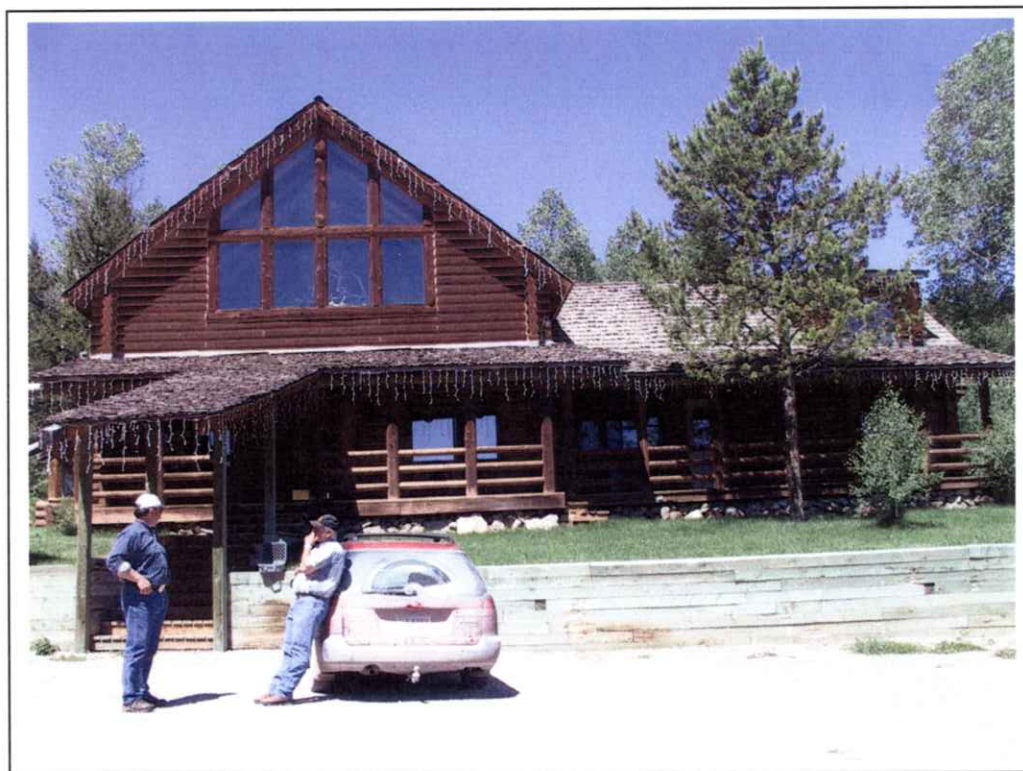
Photo 1385  
12:14 pm

Photo 10. Looking west at the lodge/restaurant. Scott Carlisle is talking with Steve Spencer from the Forest Service. GPS FILENAME: LODGE

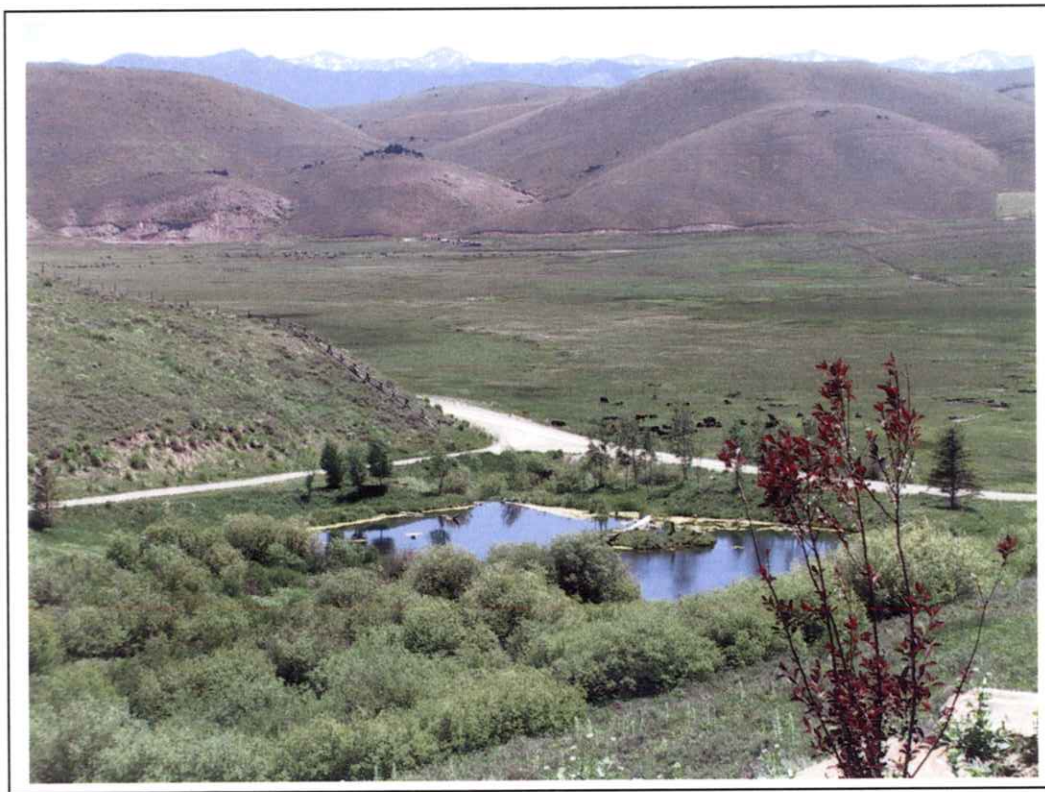
Photo 1387  
12:23 pm

Photo 12. Looking in a northeasterly direction from Scott's house at earth ponds described under 24-2038.

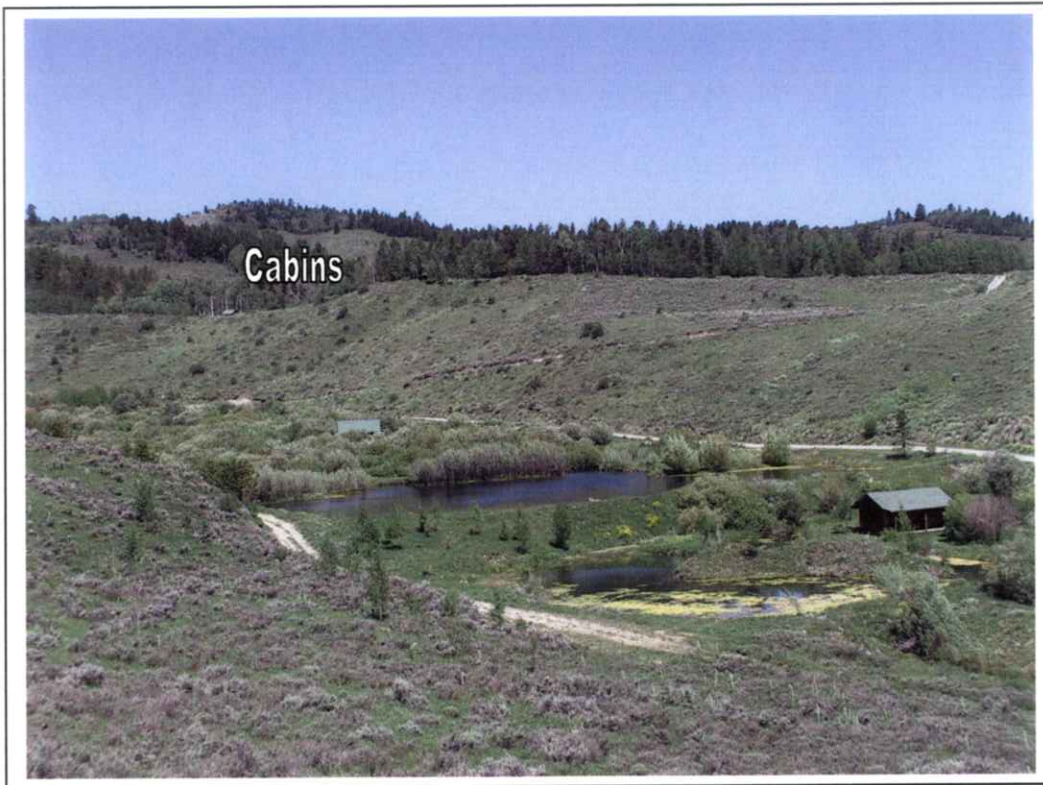
Photo 1388  
12:24 pm

Photo 13. Looking in a northwesterly direction from Scott's house at earth ponds under 24-2038.

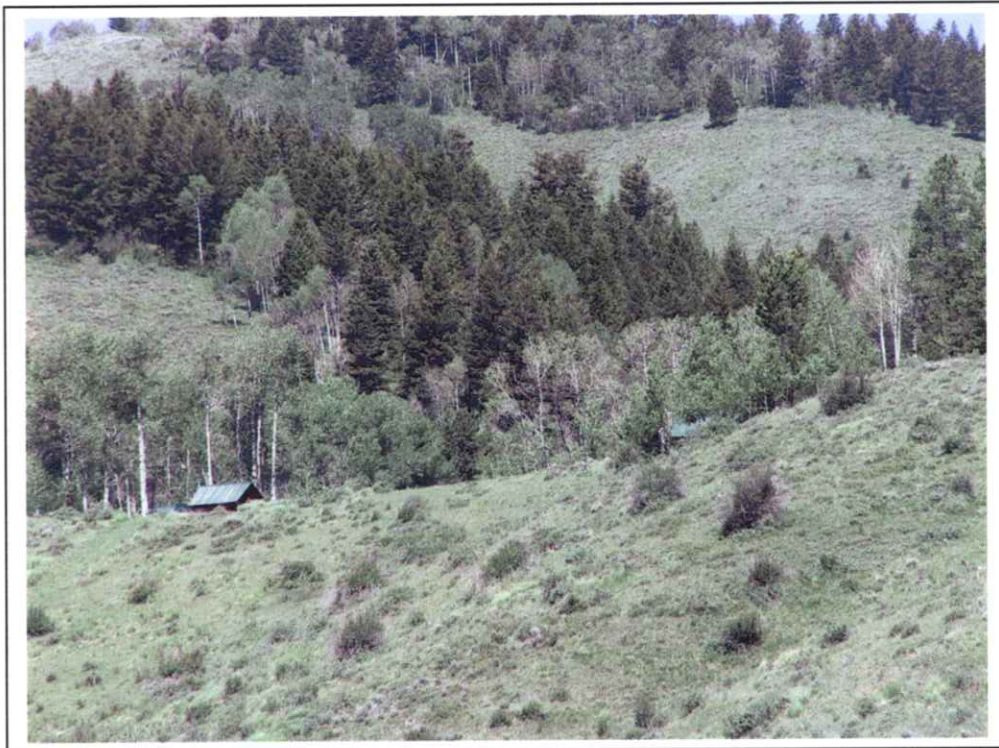
Photo 1389  
12:24 pm

Photo 14. Looking in a northwesterly direction from the house at the 4 cabins on the hill that overlooks the earth ponds. According to Scott Carlisle there is no water used in the cabins.
