# MEMORANDUM

**TO:** Application for Permit 37-21771 File

**SUBJECT:** Field Review

On March 14, 2006, Corbin Knowles and I visited the property involved with Application for Permit 37-21771. The following photos document our observations....

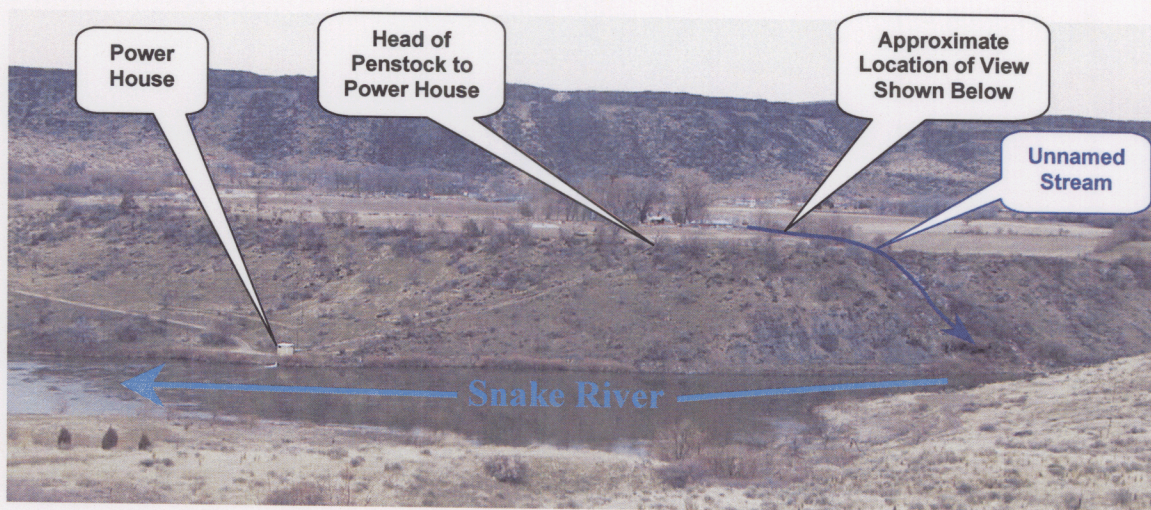
**ABOVE:** View looking northeast across the Snake River towards the property involved with Application for Permit 37-21711 showing the location of the unnamed stream (source) relative to the power house (place of use).

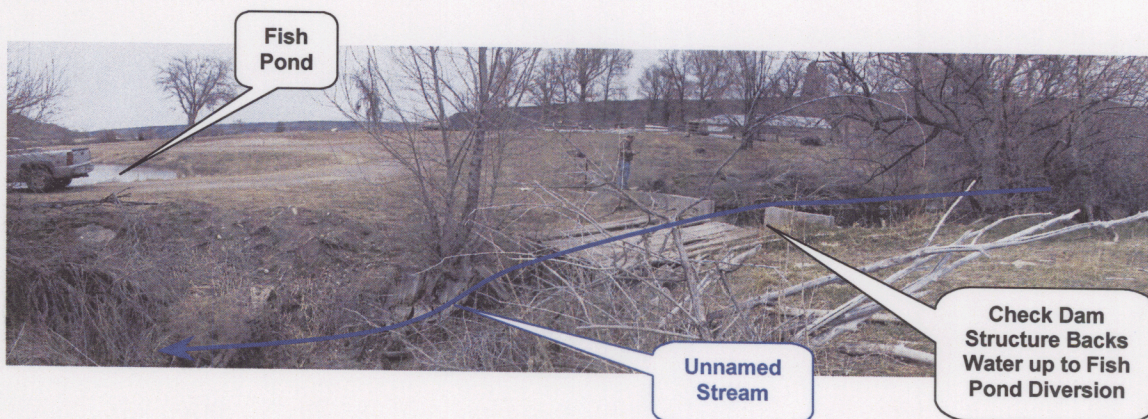
**BELOW:** View looking across the unnamed stream channel that serves as the source of water for Application for Permit 37-21711.

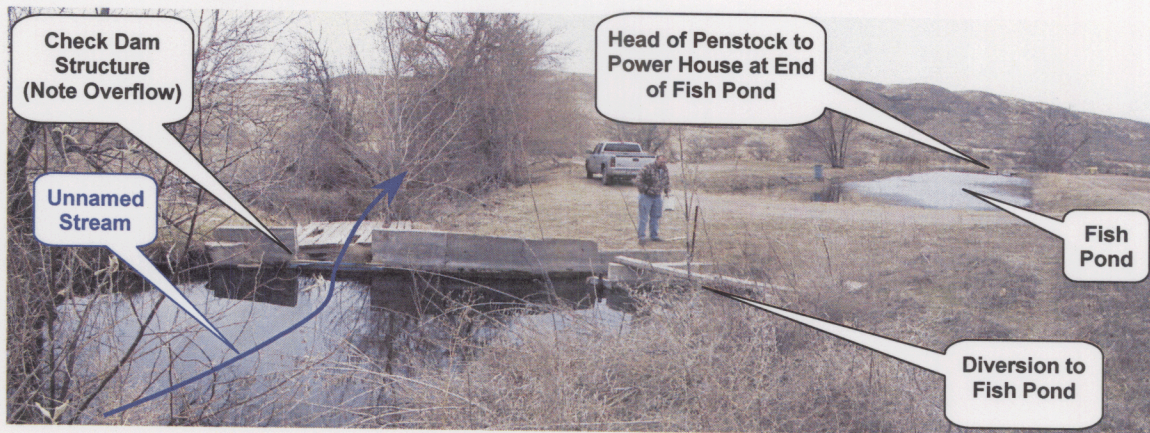
**ABOVE:** View looking down the unnamed stream channel that serves as the source of water for Application for Permit 37-21711.

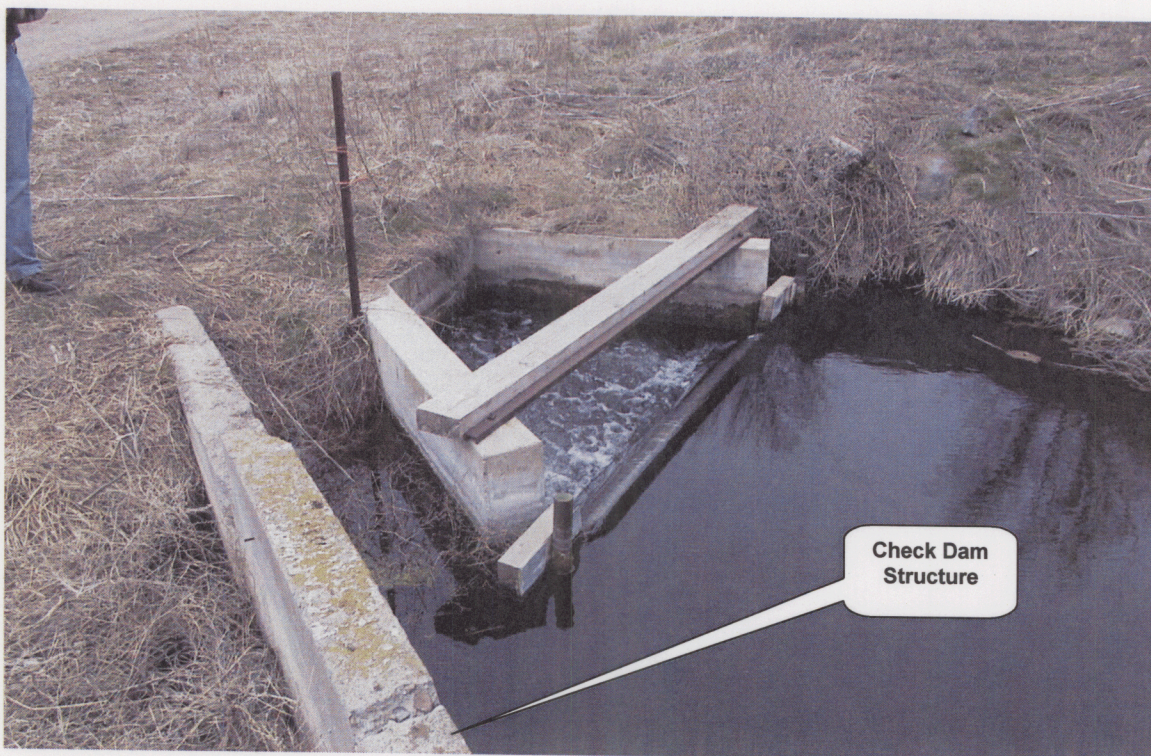
**BELOW:** View of diversion to fish pond (and power house penstock below fish pond) on right (north) side of the unnamed stream above the check dam structure. At the time of this photo, 6.88 cfs was flowing over the Cipolletti weir and through this diversion, but note higher water marks on structures.

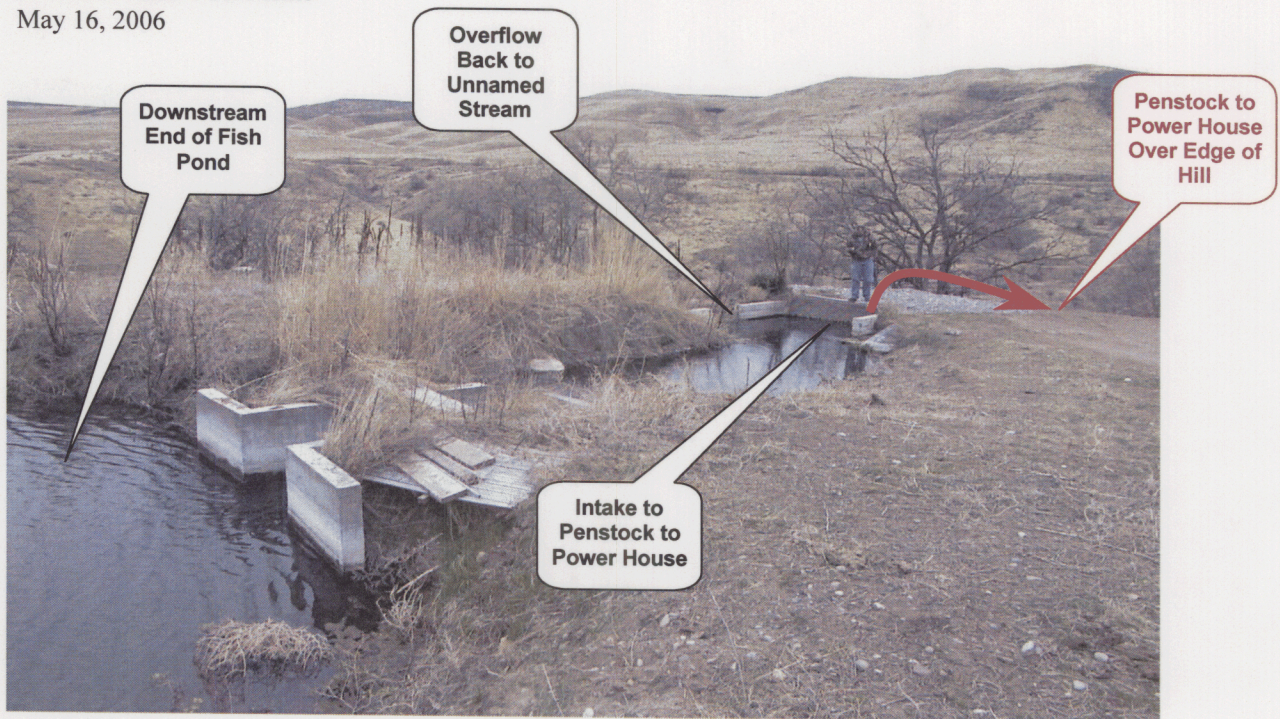
**ABOVE:** View at the downstream end of the fish pond shown in previous views with various points of interest indicated. There was a small amount of water ( $< 0.5$  cfs) flowing over the overflow back to the unnamed stream before spilling

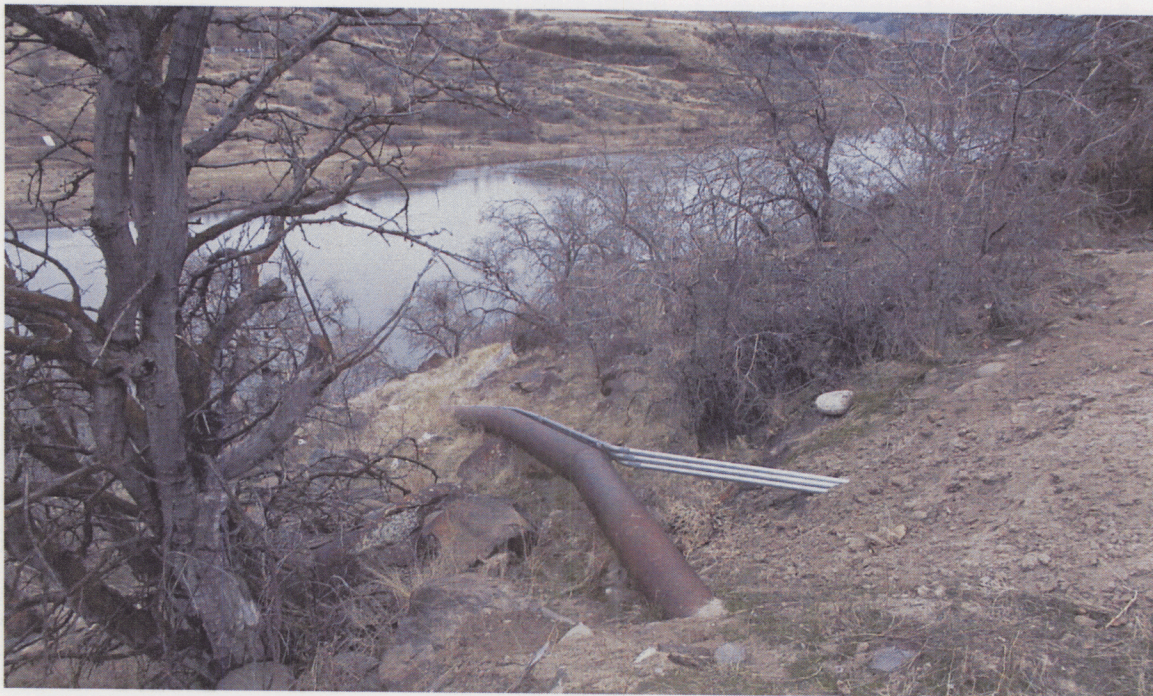
**BELOW:** View looking down penstock to power house below.
