STATE OF IDAHO  
DEPARTMENT OF WATER RESOURCES  
**BENEFICIAL USE FIELD REPORT**

Permit No: 51-12992

Exam Date: 11/30/2005

# FIELD EXAM 51-12992

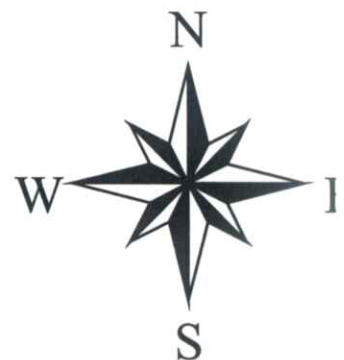
This is a 1974 Orthophoto Quadrangle map. There is no decernable feedlot shown on this map, which suggests that it was not in place at this time. The 1987 aerial photo does show the feedlot, so it is assumed it was built between 1974 and 1987.

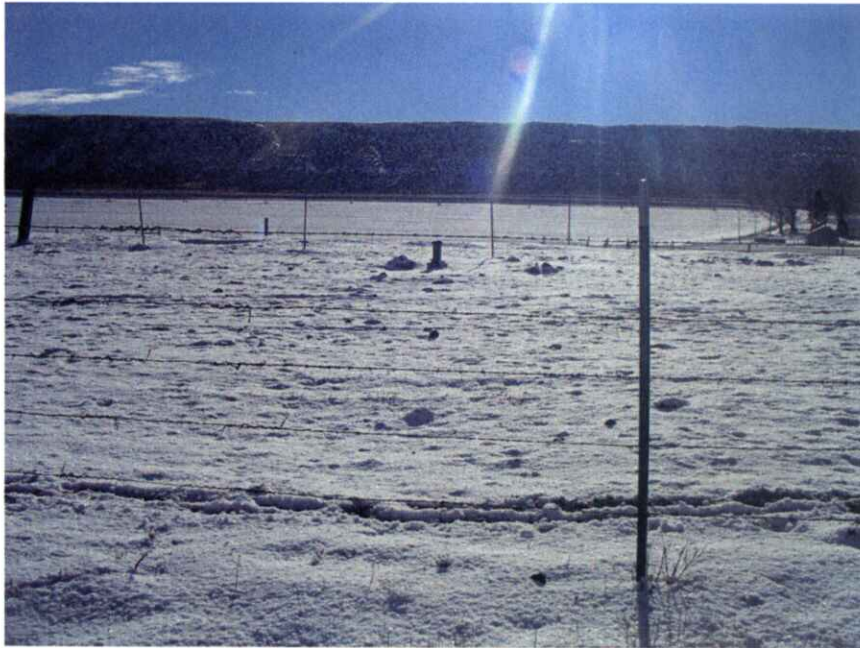
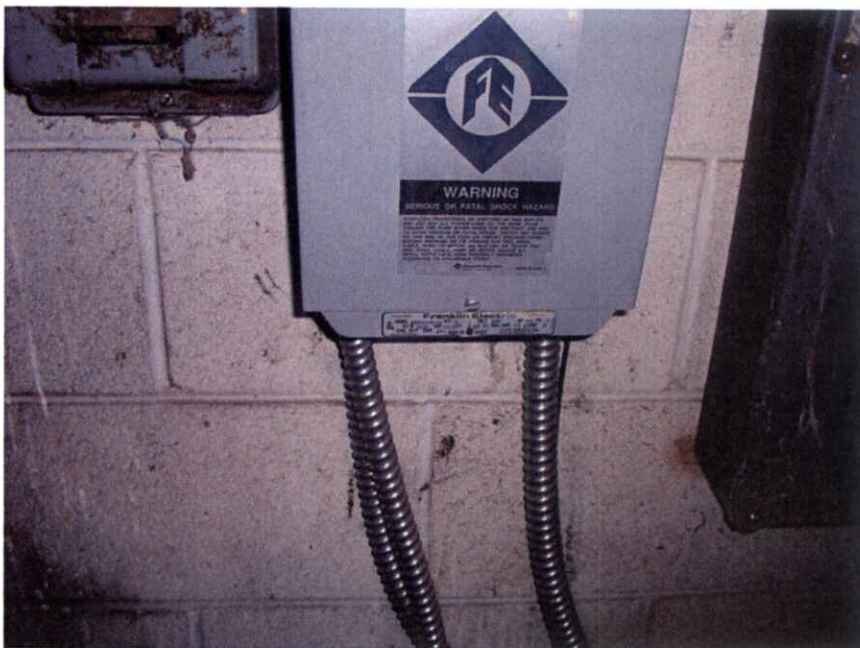
These are photos of the well and the power box for the well. The well is located in the middle of the pasture in front or south of the feedlot.

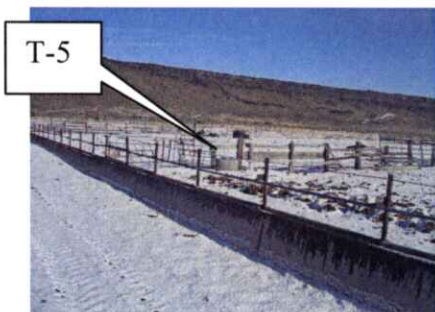
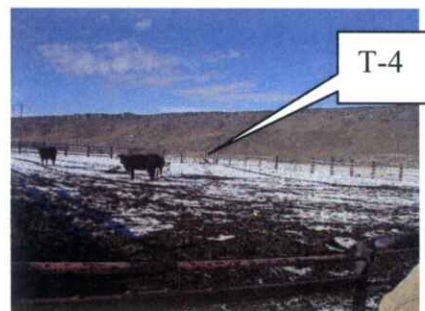
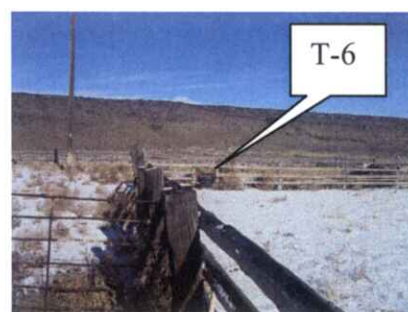
These are photos of the 7 water troughs. I have numbered each one of them to match the Feedlot Map.

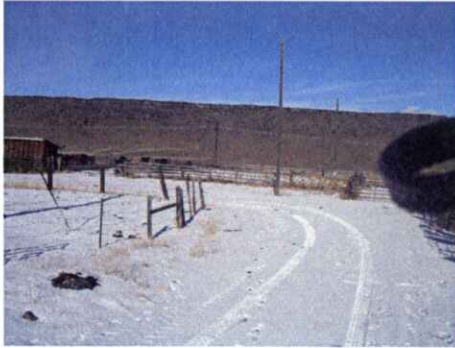
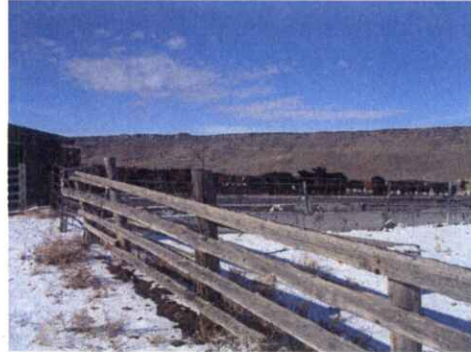
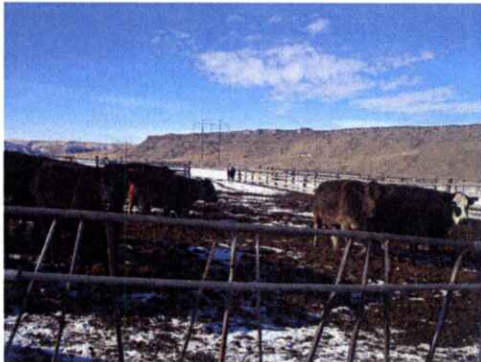
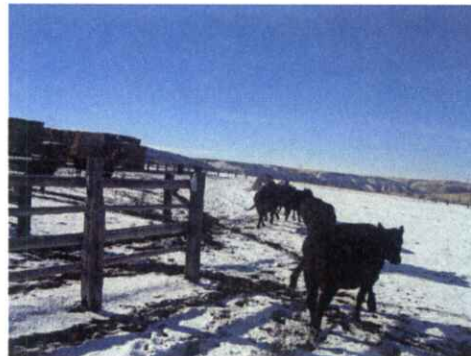
These are random photos of the feedlot. The bottom two photos show the open gate to the various pastures, and the cattle going out to the pasture. The only available stockwater from the wells is from the water troughs in the feedlot.

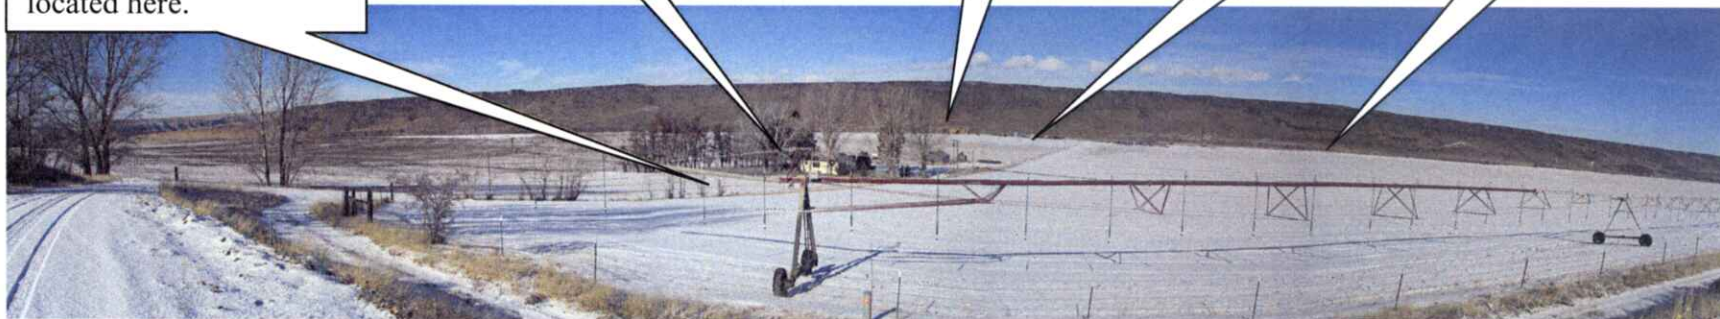
Well of 51-10321 is located here.

51-12992 well is located here.

This is a panoramic view of the farm. You can see the feedlot behind the home on top of the hill. The pasture runs along the back of the fields shown in the foreground.

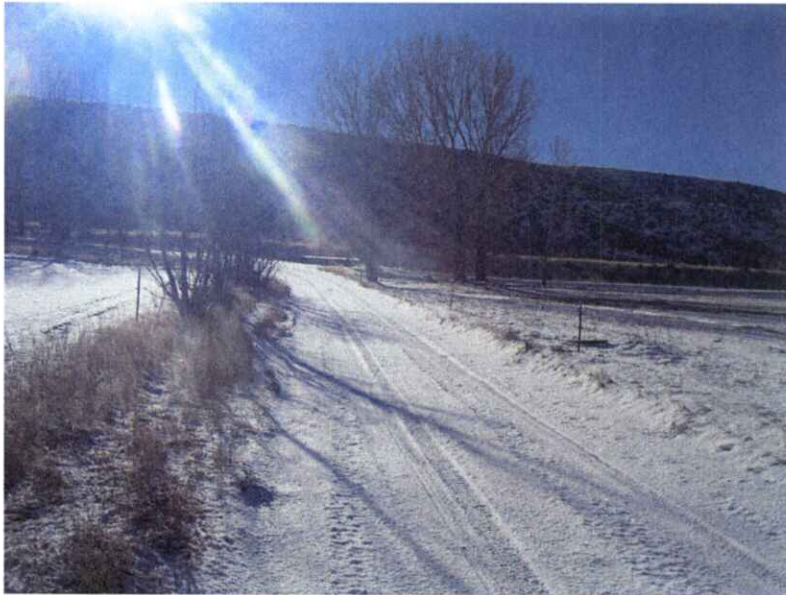
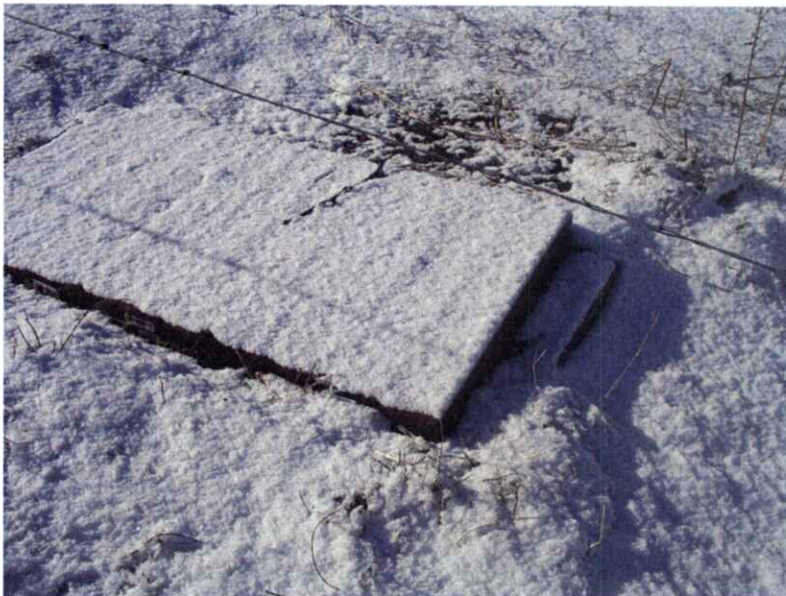
These are photos of the well pit for the well associated with water right 51-10321. The well is connected to the same system, but is described by another water right.
