1. This permit is for irrigation water for the Mountain View Subdivision. All lots have been developed in the subdivision. Surface water rights for the agriculture land where the subdivision was developed are being retained, but no surface water is now used for irrigation.

## IDAHO DEPARTMENT OF WATER RESOURCES

### WELL INSPECTION FORM

1. DRILLING PERMIT NO: 63-96-W-0075-0000 OTHER APPLICABLE NO: 63-12275

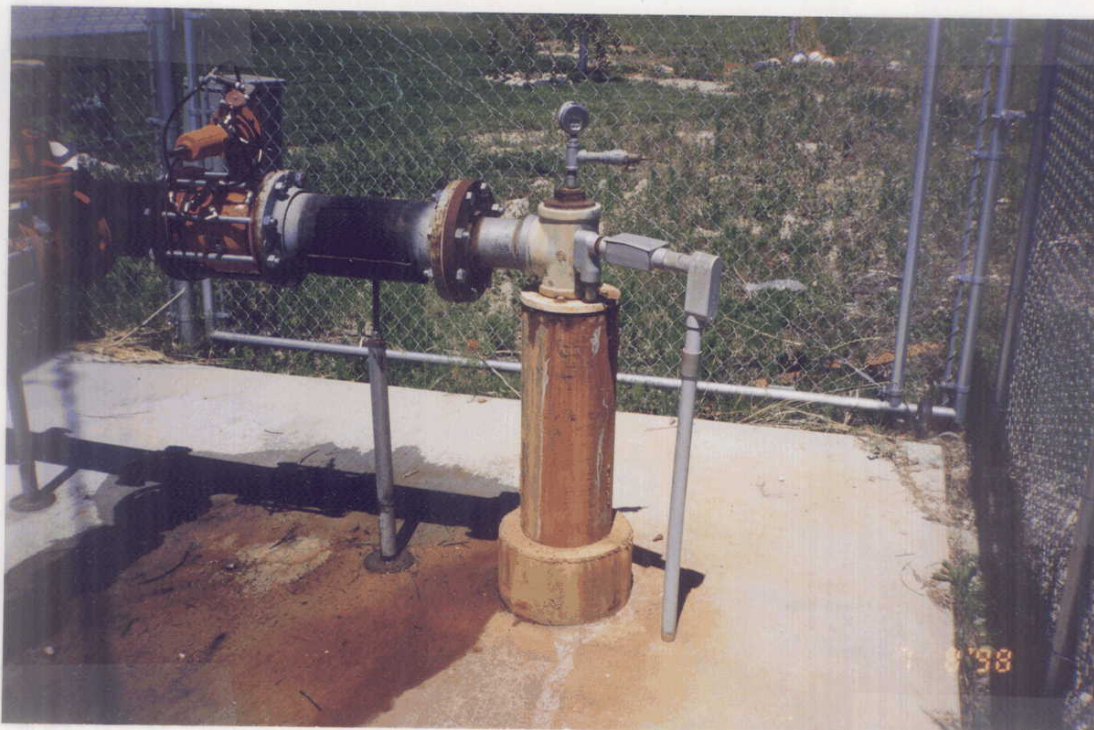
1 of 2

P/D

Well  
Site.

Flow  
Meter  
(Blue) in  
6" Service  
Line.

4" Waste  
Line is  
at left.

2. The well pump operates at a high rate of flow, and pressure, to meet peak irrigation demand in the subdivision. Control valves, and an automatic control system, dumps excess water above the demand at any given time into Mill Slough through a 4" waste line. At the time of the exam, the line pressure was 66 psi, and excess water was being dumped into Mill Slough. Teresa Cole said that this is a normal operation for the way the system was designed. It appears that a lot of groundwater is wasted along with high pumping costs to the homeowners.

This well is used for irrigation of the Mountain View Subdivision. The well pump operates at a high rate of flow and excess water above the water demand at any given time is discharged through a waste pipe into the nearby Mill Slough. The controls for the waste pipe operate automatically to dump excess water into the Slough.

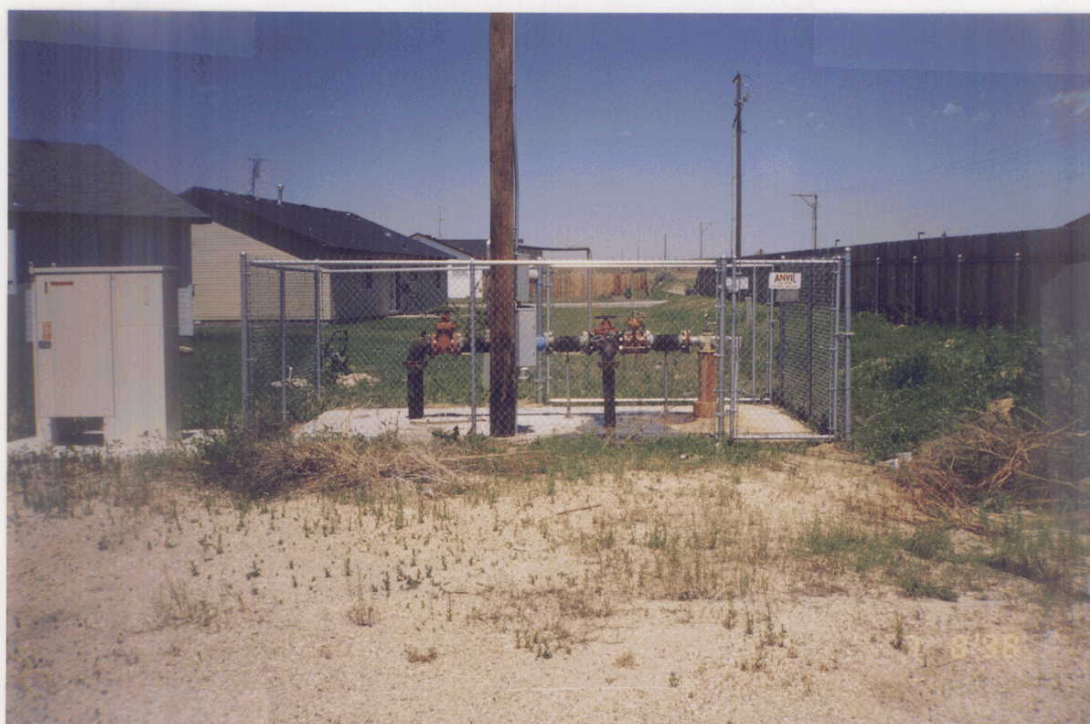
2 of 2

P/D, P/u

Waste Water  
flow from  
Cmp on  
left is  
from 4"   
Waste Line  
at well  
site.

Mill Slough  
in  
fore ground.
