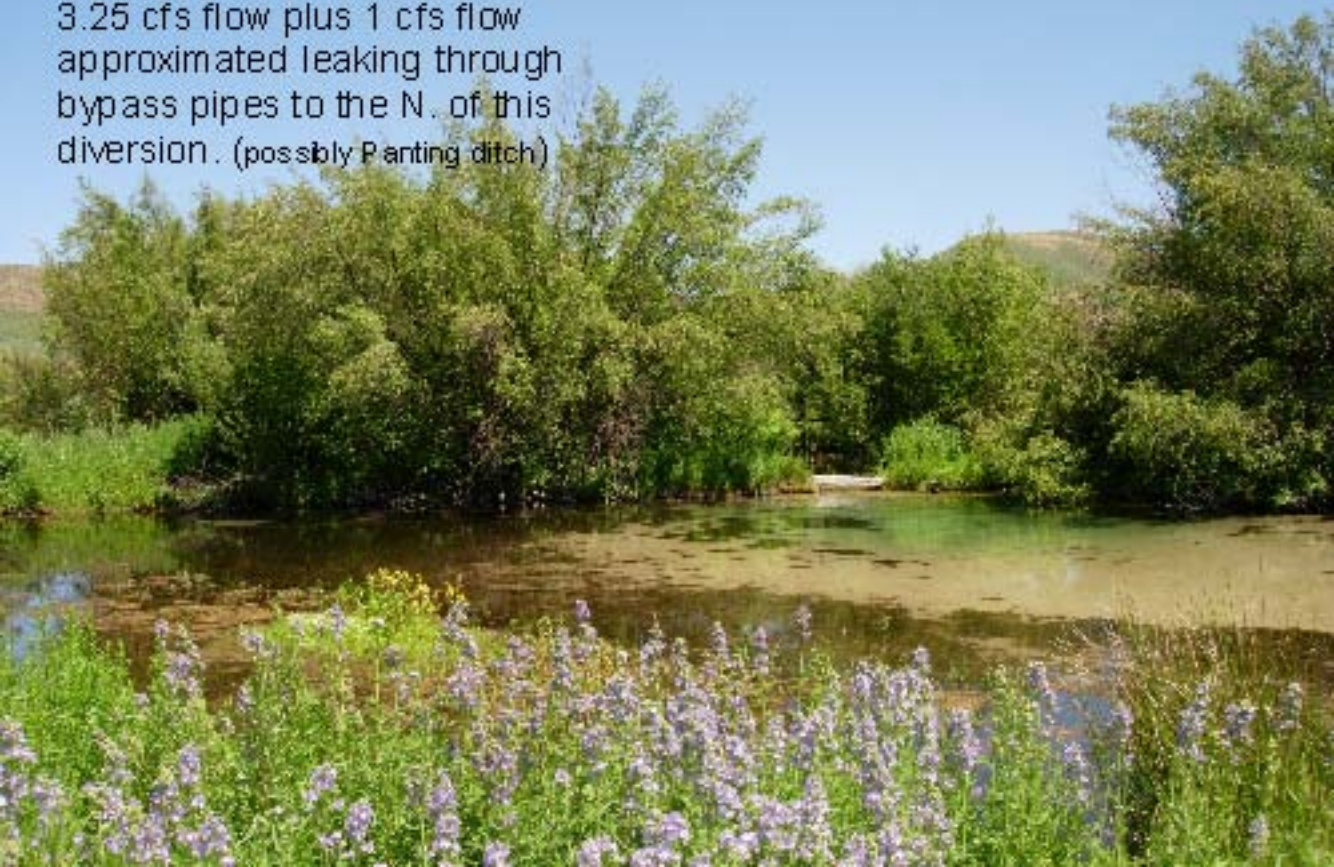
Formation Spring Labeled "two"  
current metered on 7/20/2011 at  
3.25 cfs flow plus 1 cfs flow  
approximated leaking through  
bypass pipes to the N. of this  
diversion. (possibly Panting ditch)

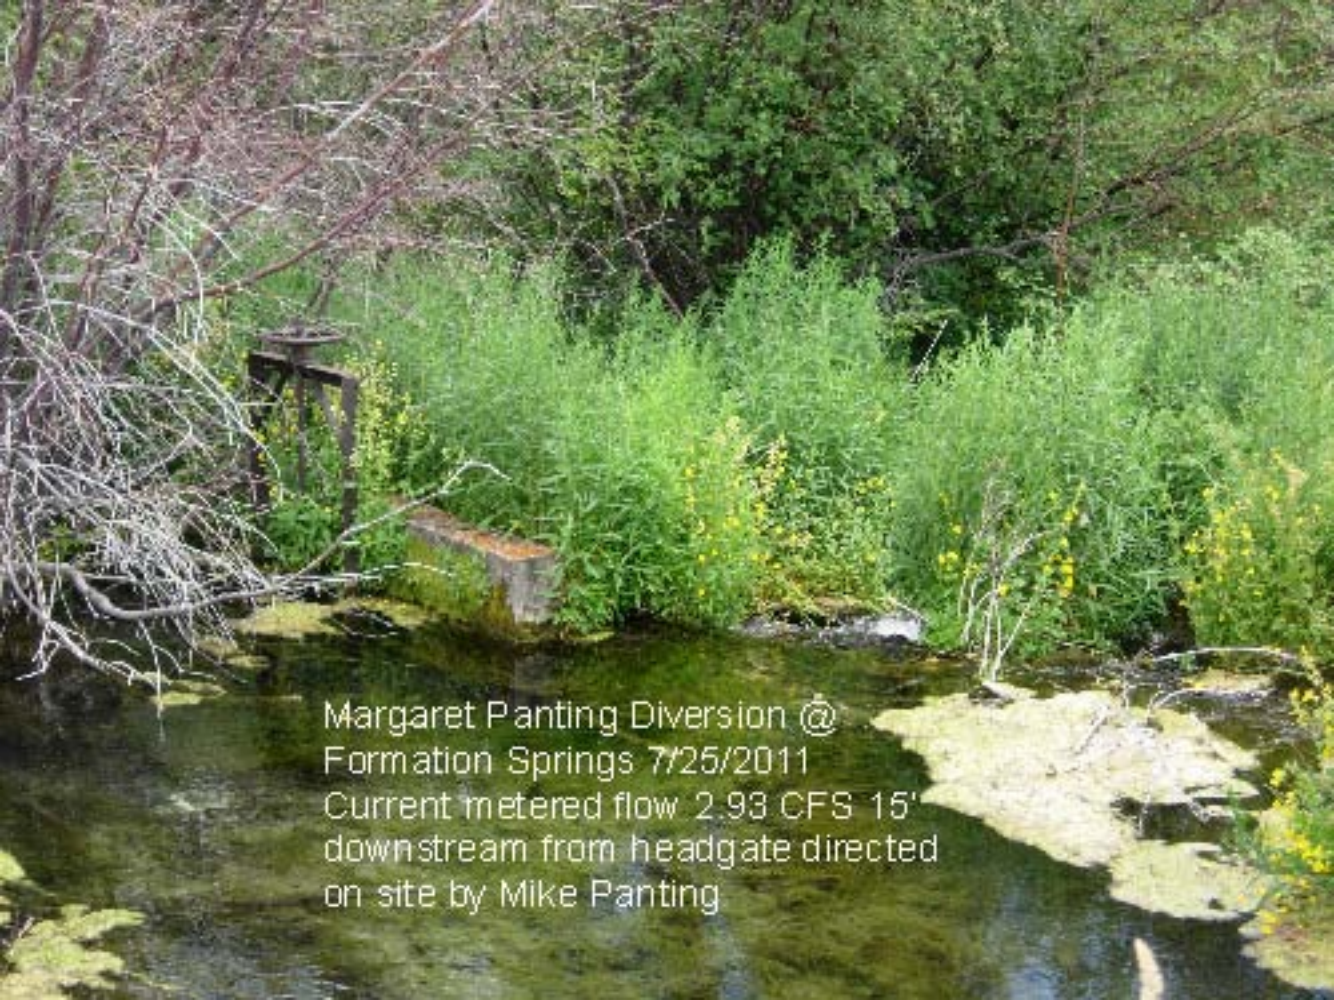
Margaret Panting Diversion @  
Formation Springs 7/25/2011  
Current metered flow 2.93 CFS 15'  
downstream from headgate directed  
on site by Mike Panting

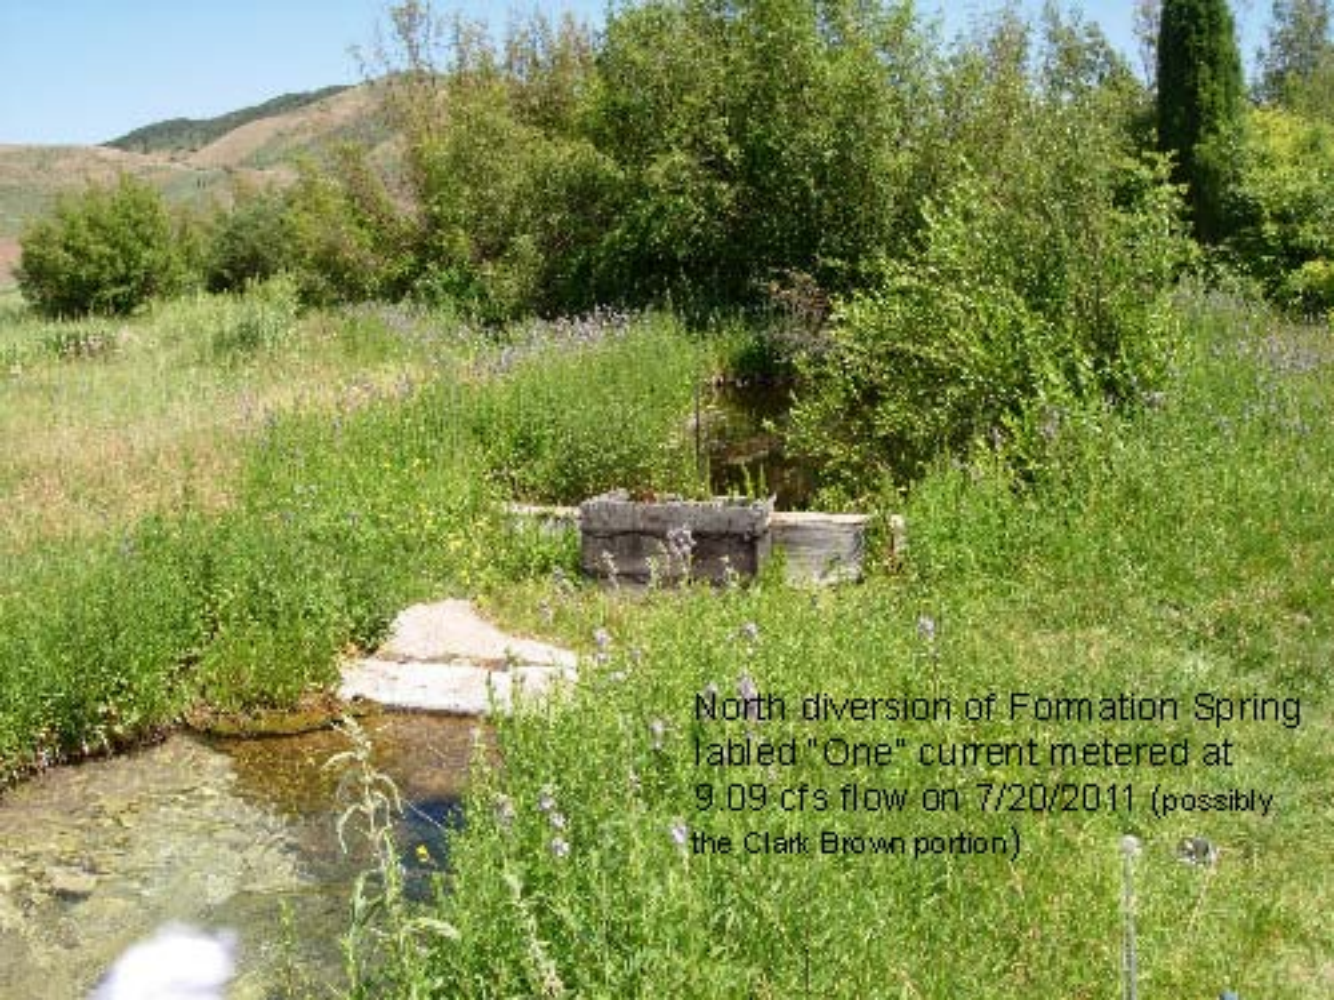
North diversion of Formation Spring  
labeled "One" current metered at  
9.09 cfs flow on 7/20/2011 (possibly  
the Clark Brown portion)

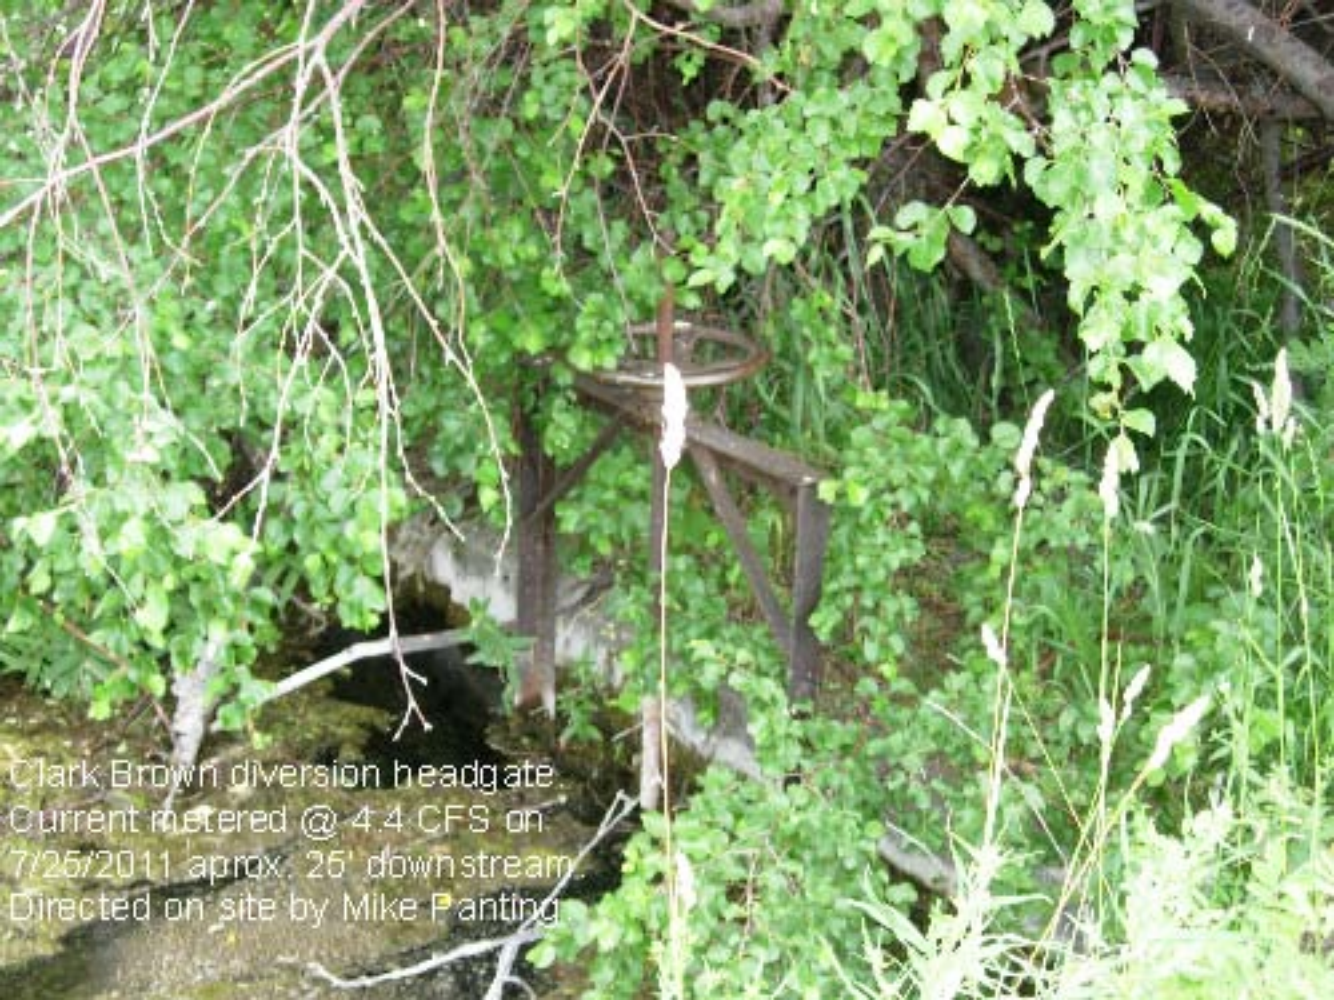
Clark Brown diversion headgate  
Current metered @ 4.4 CFS on  
7/25/2011 aprox. 25' downstream  
Directed on site by Mike Panting
