STATE OF IDAHO  
DEPARTMENT OF WATER RESOURCES  
**BENEFICIAL USE FIELD REPORT**

**Permit No:** 21-13204

2. **SOURCE:** Unnamed Stream- Fall River

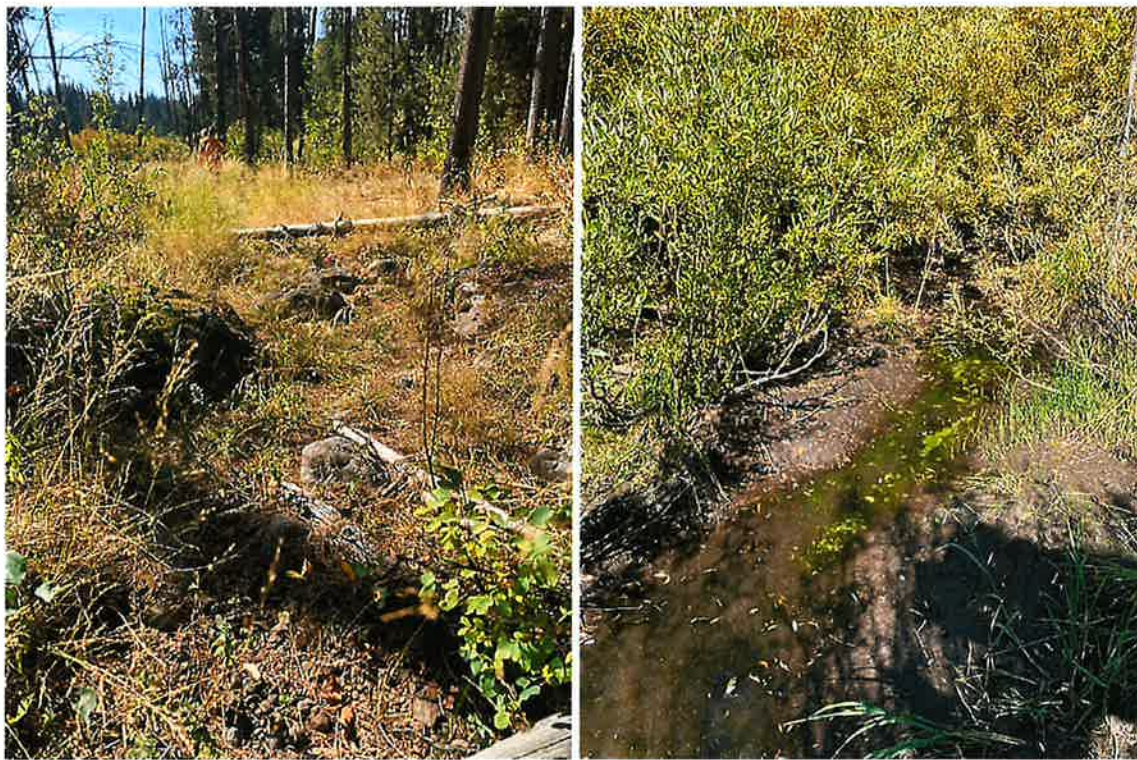
1. Small gravel sediment characteristic to small streams can be seen on the streambed, as well an elevated and defined bank profile highlighted in white.
2. Unnamed stream tributary to Fall River inflows into Thompson Hole Lake. GPS location 44.0937, -111.0632

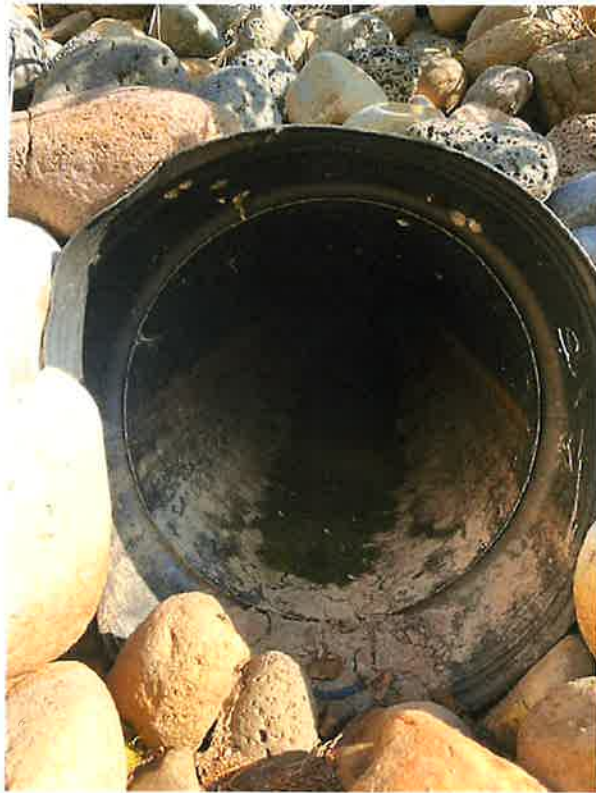
5. 1.5ft-2ft diameter culvert outflow to the lake from the dam side. The culvert is submerged on the lake facing side, but there is no outflow. The controlling box is regulating the lake level.

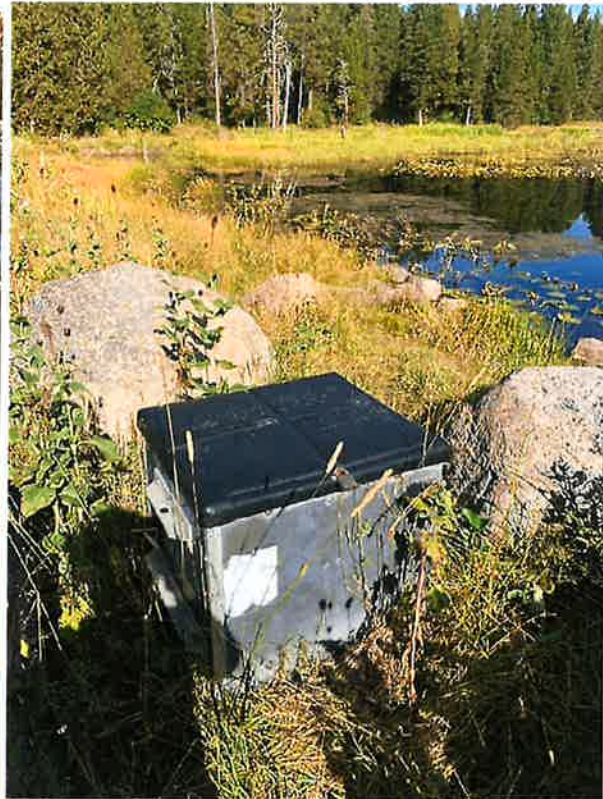
6. Outlet Control Box, located at the dam and just above the outflow culvert to the lake
