**STATE OF IDAHO  
DEPARTMENT OF WATER RESOURCES  
BENEFICIAL USE FIELD REPORT**

Permit No: 63-34957

Exam Date: 09/20/2023

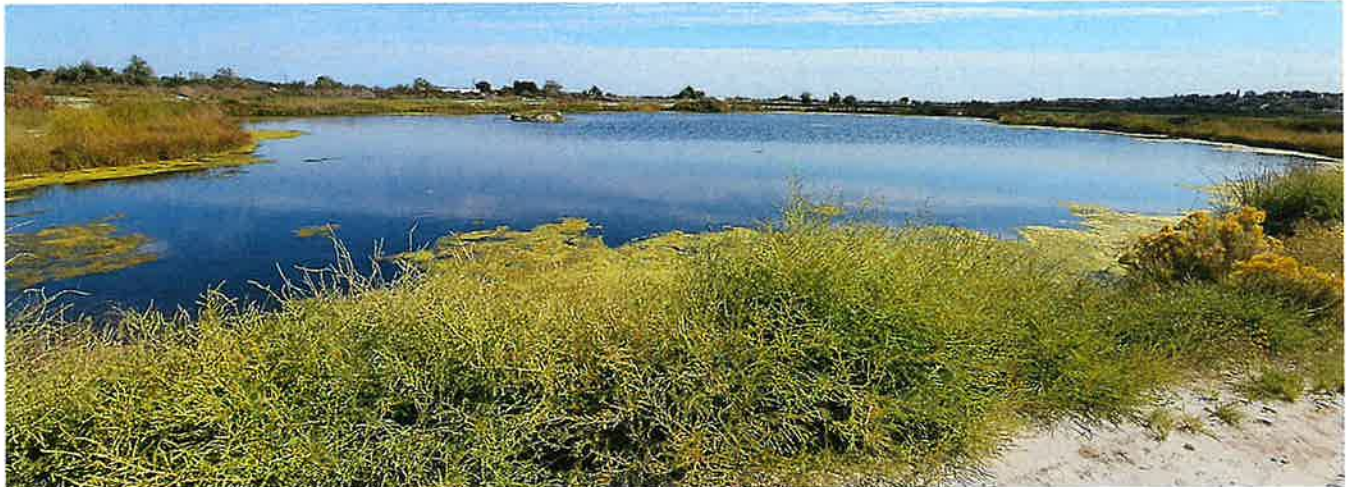
**Photo 1.** Image of the east pond looking in a southeasterly direction.

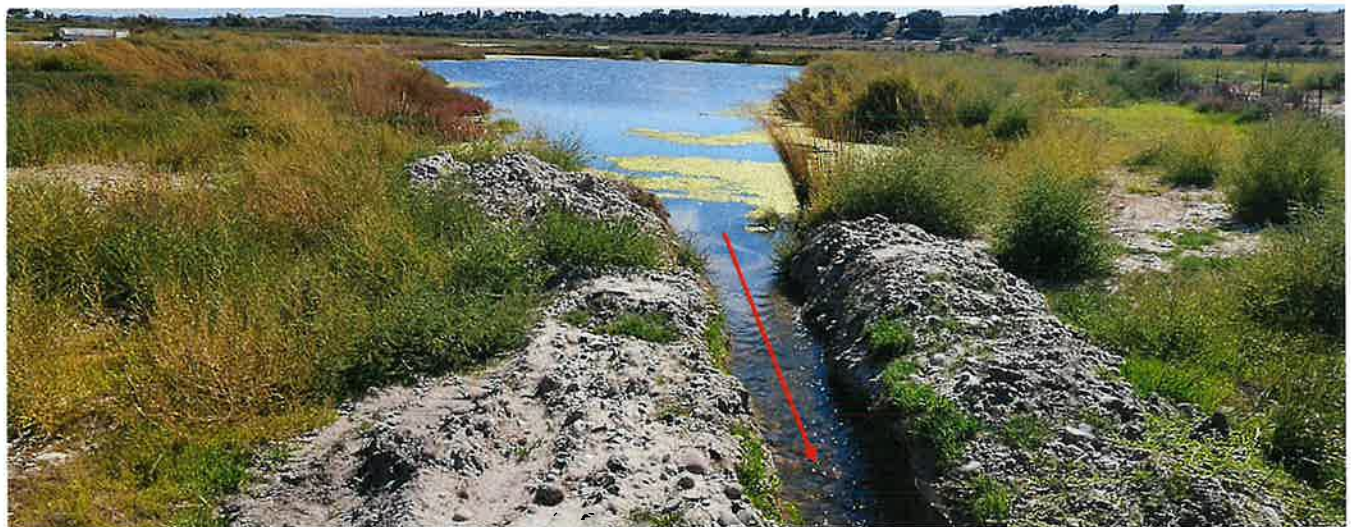
**Photo 2.** Image of the west pond looking south. Note the water flowing out of the pond in a northward direction.

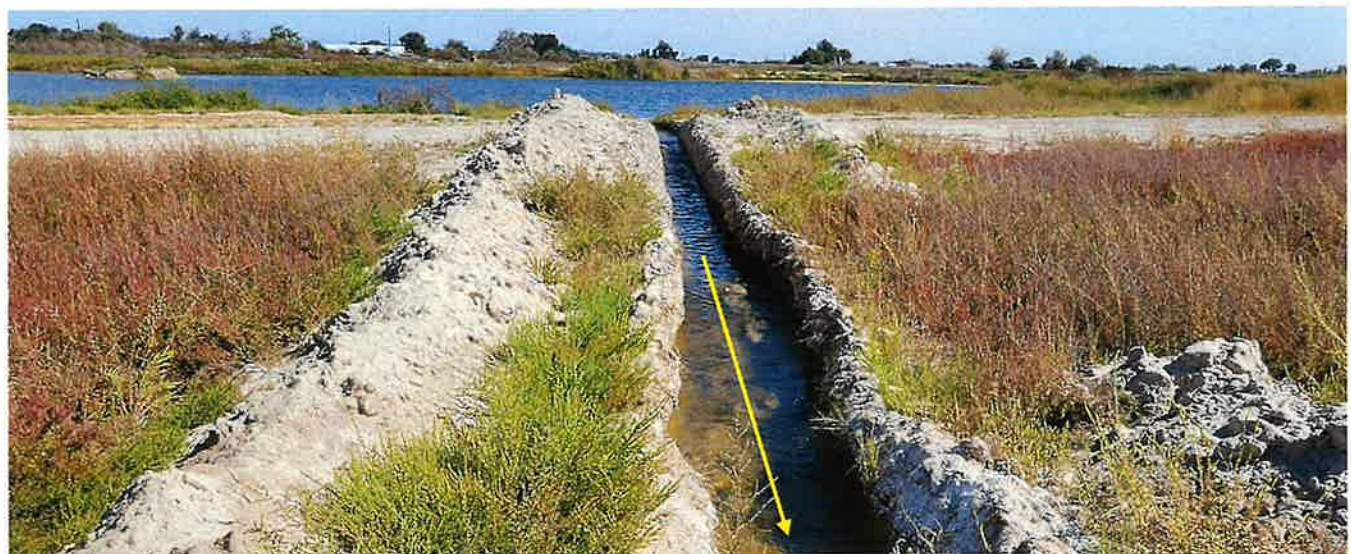
**Photo 3.** Image of the channel between the two ponds. Water is flowing from the east pond towards the west pond. The owner indicated that a buried pipe would connect the two ponds in the future.
