STATE OF IDAHO  
DEPARTMENT OF WATER RESOURCES  
BENEFICIAL USE FIELD REPORT

Permit No: 65-13686

Exam Date: 05/12/2023

CROSSTIMBER RANCH PROPERTY OWNERS ASSOC. 30 Meadowview Dr., Garden Valley, ID

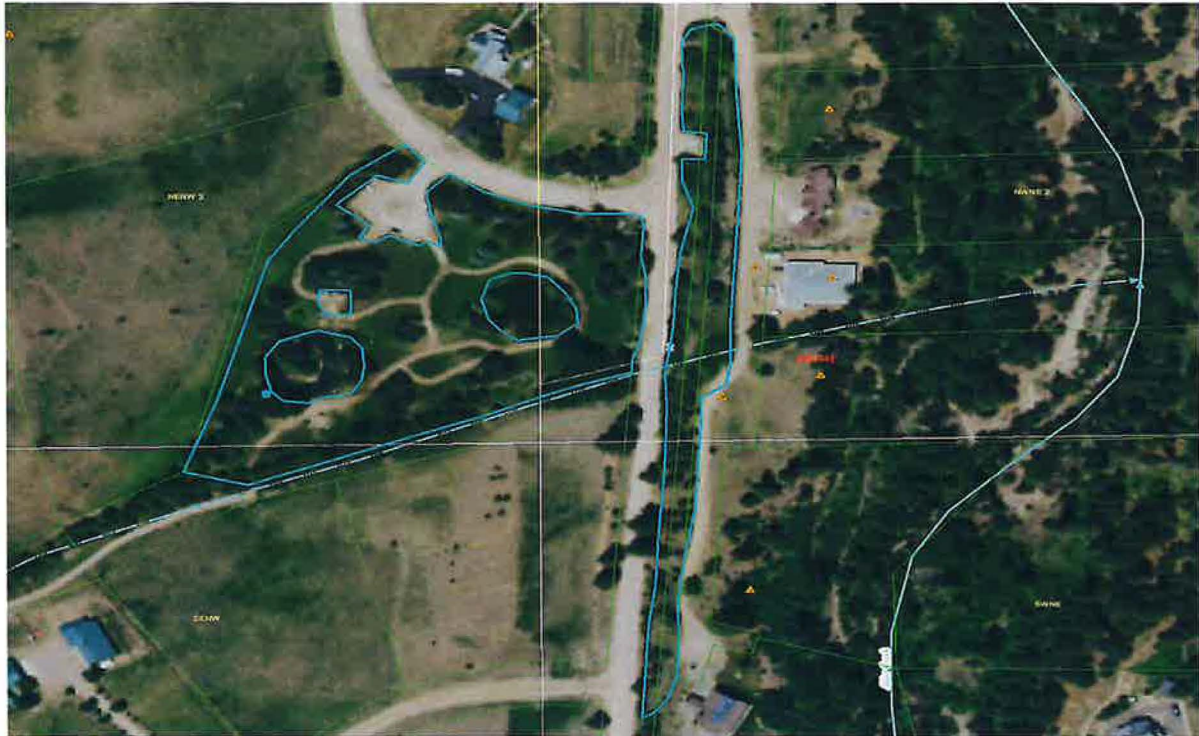
**Figure 1- GIS 2021-aerial image of POU (outlined in blue) and POD (blue point). Image includes the intermittent streambed that the ditch water is diverted along from west to east (dashed line) and Alder Creek, running to the north (blue line with arrow for direction).**

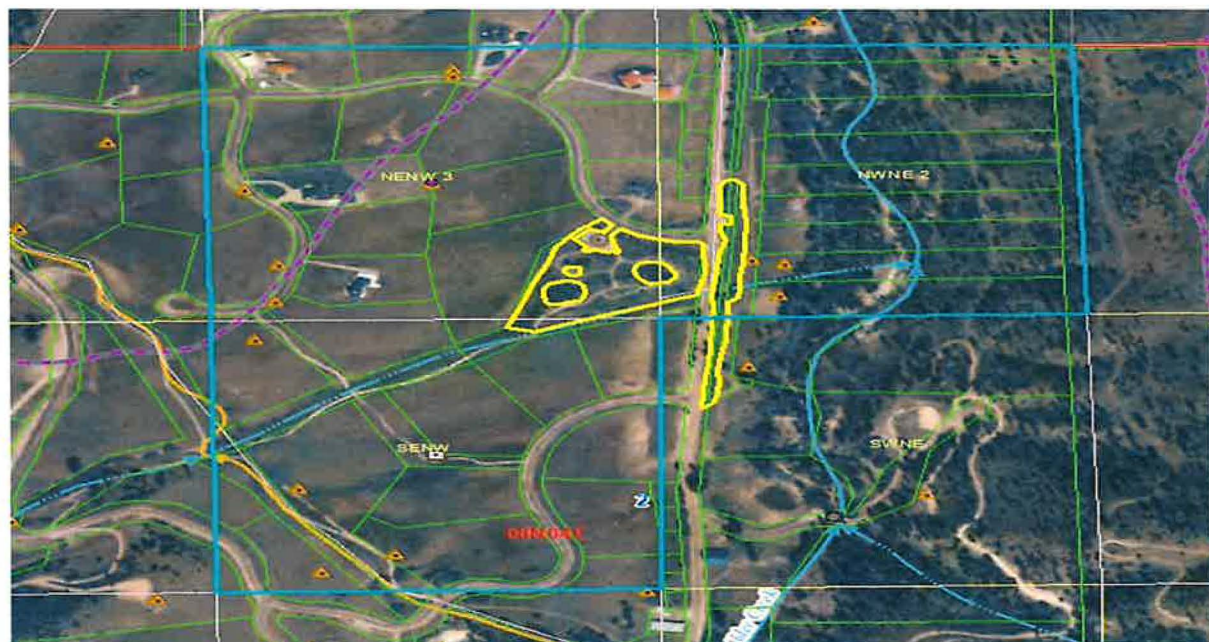
**Figure 2- GIS 2021-aerial image of Permit POU (outlined in blue) and POU confirmed in field exam (outlined in yellow). The area in the southeast is in a quarter/quarter not within the permit POU.**

During the field examination, it was determined that the place of use area included irrigation in the SWNE of section 2, Township 09N, Range 04E, which was not included in the place of use permitted for development (figure 2). Our escort for the field exam was notified that we would need to process and mail an amendment to the permit for signing before licensing, to ensure the entire place of use is included in licensing.

☒ Change P.U. as reflected above    ☐ Add P.U. as reflected above    ☐ None

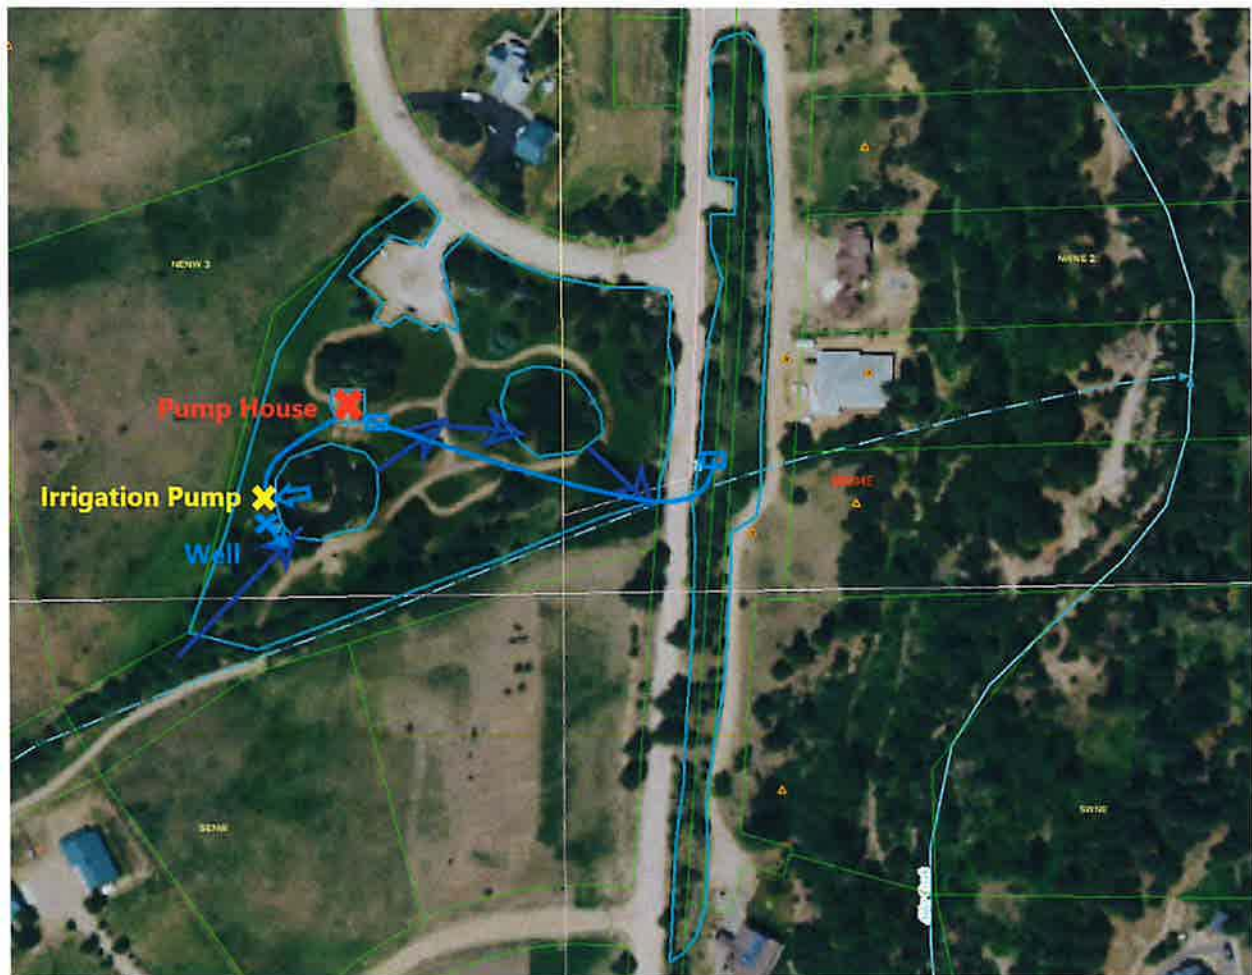
Figure 3- System diagram- Dark blue line (flow of water through ponds and ditches), Medium blue line (water lines from well and irrigation pump to control valves, Light blue outline (POU area).

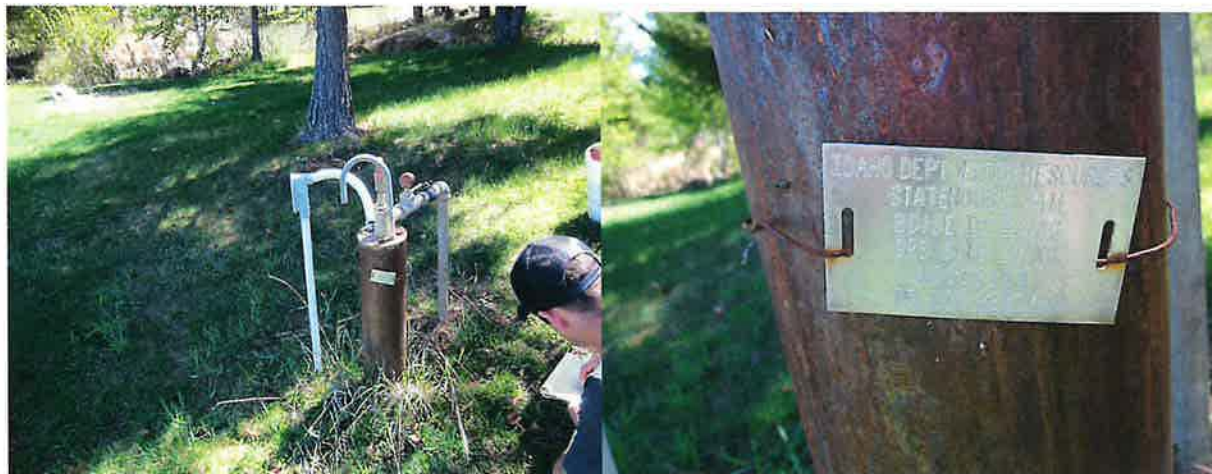
Photos 1 & 2- Wellhead located on the west side of the western pond. Tag visible in closeup photo on the right.

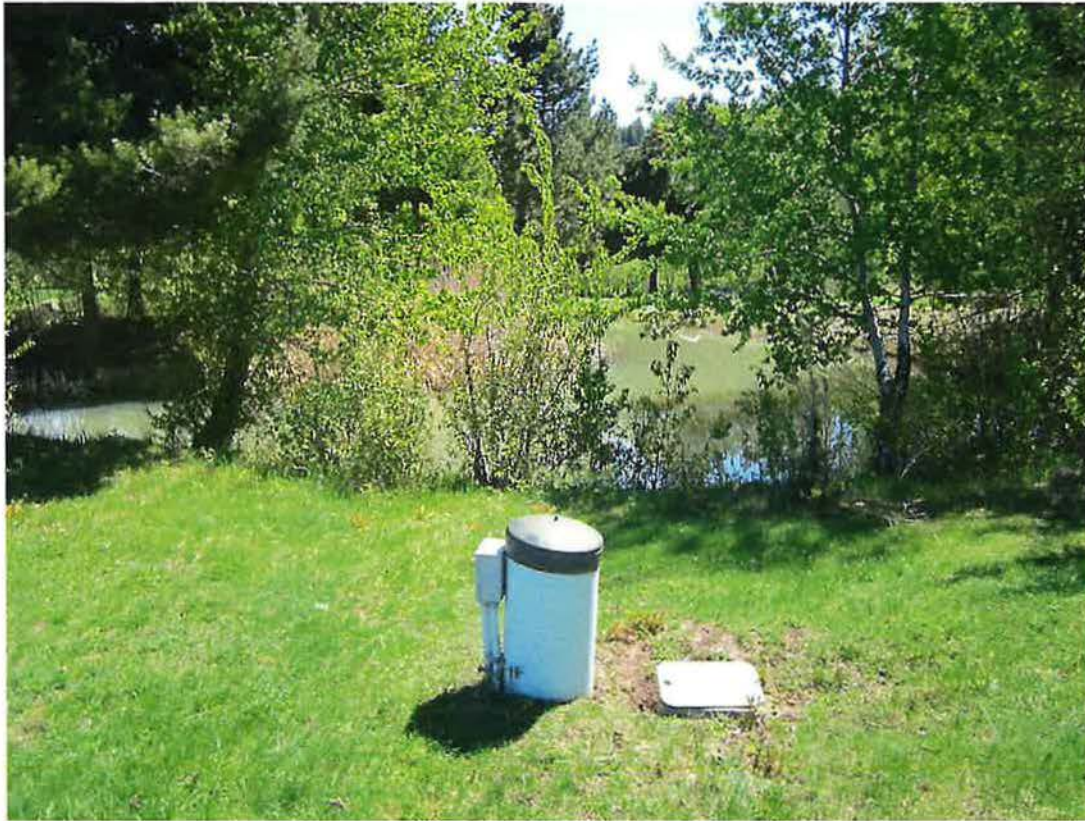
Photo 3- 3Hp irrigation pump, located west of the western pond.

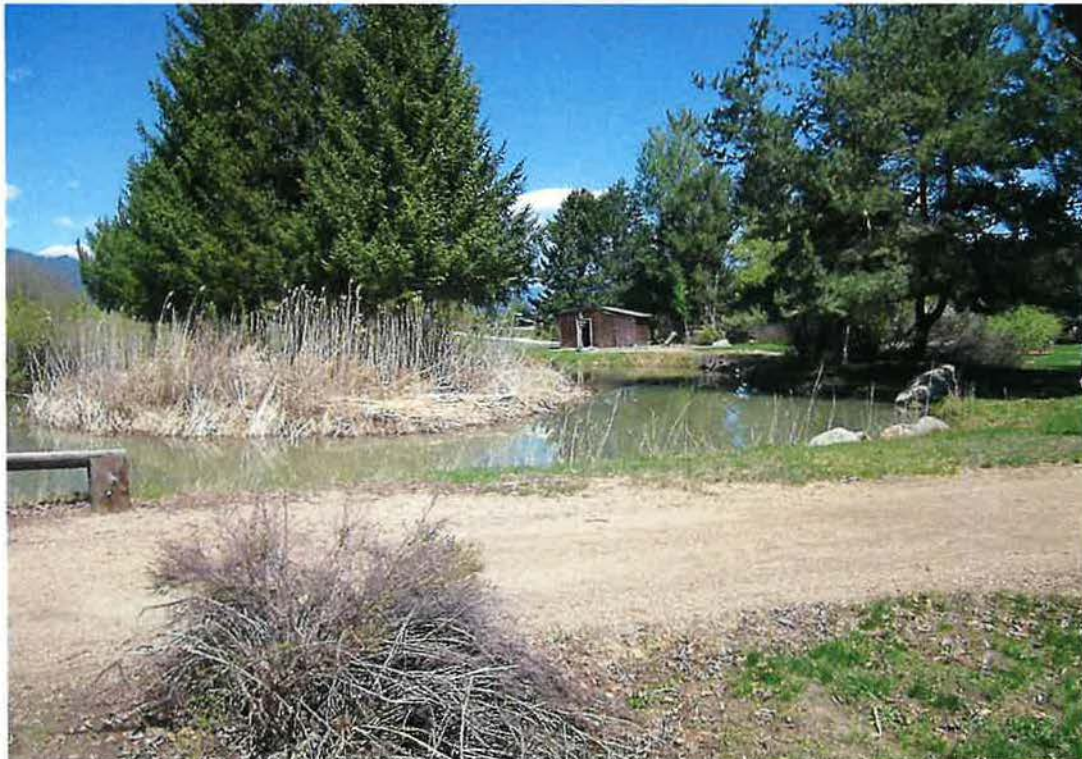
Photo 4- The brown structure with the green roof is the pumphouse, located between the ponds on the north side of the POU. Photo taken from the southwest side of the western pond.

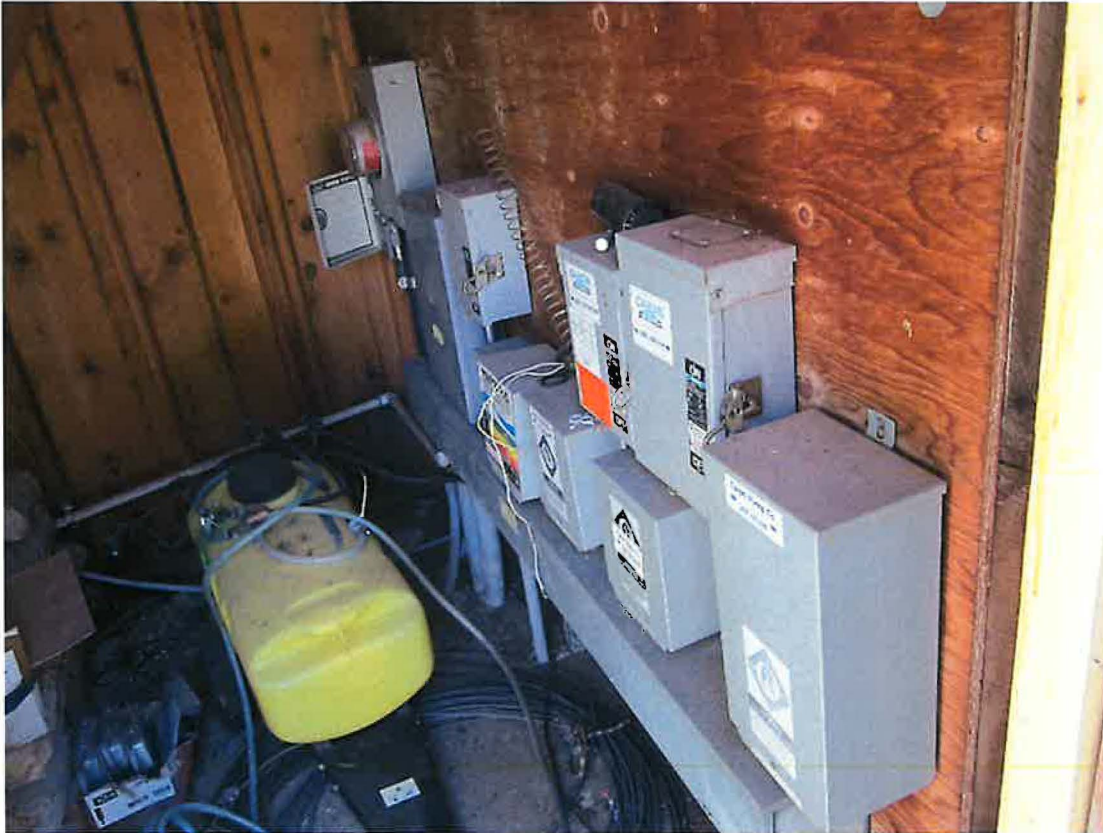
Photo 5- Power bank and pressure controls located inside of the pump house.

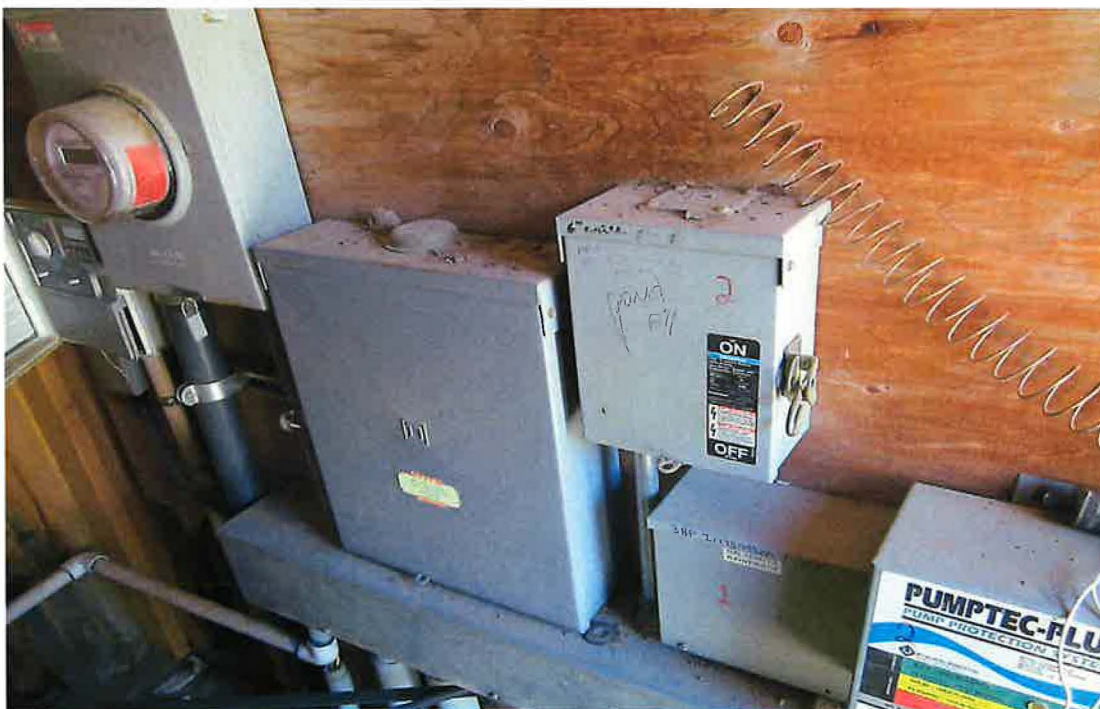
Photo 6- Junction boxes controlling the well pump (labeled #2 "Pond Fill") and the 3 Hp irrigation pump (labeled #1 Irrigation Pump). Pressure control can be seen in the lower right of the image.

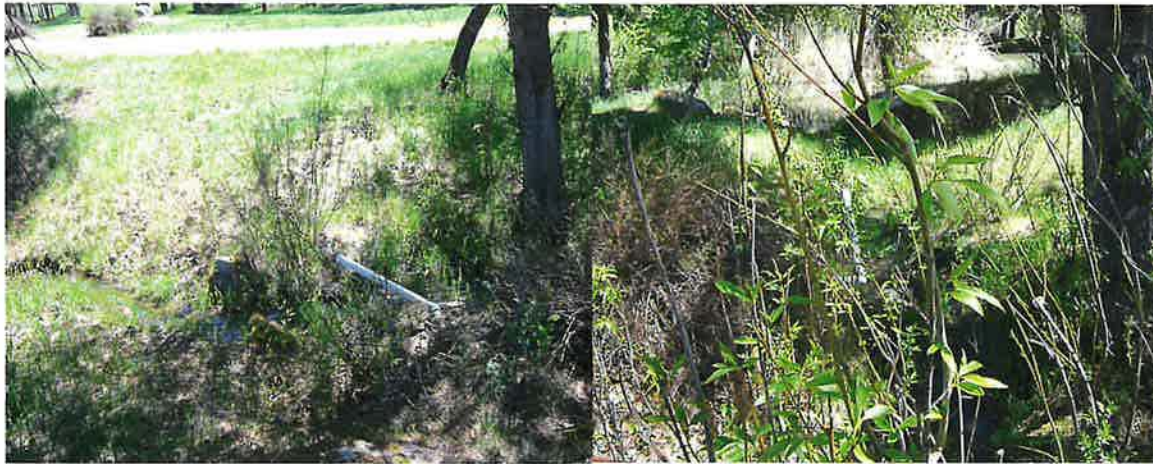
2. Measurements: A 2" PVC pipe discharges into the ditch draining into the storage pond. A cell phone timer was used to measure the time elapsed to fill the bucket (3 times), and an average of those times was used to determine the rate of flow.

Photos 7 & 8- Left photo of the outlet from the well pump delivering water into the ditch flowing east into the western pond. Right photo of the outlet taken facing to the east along the ditch towards the western pond.

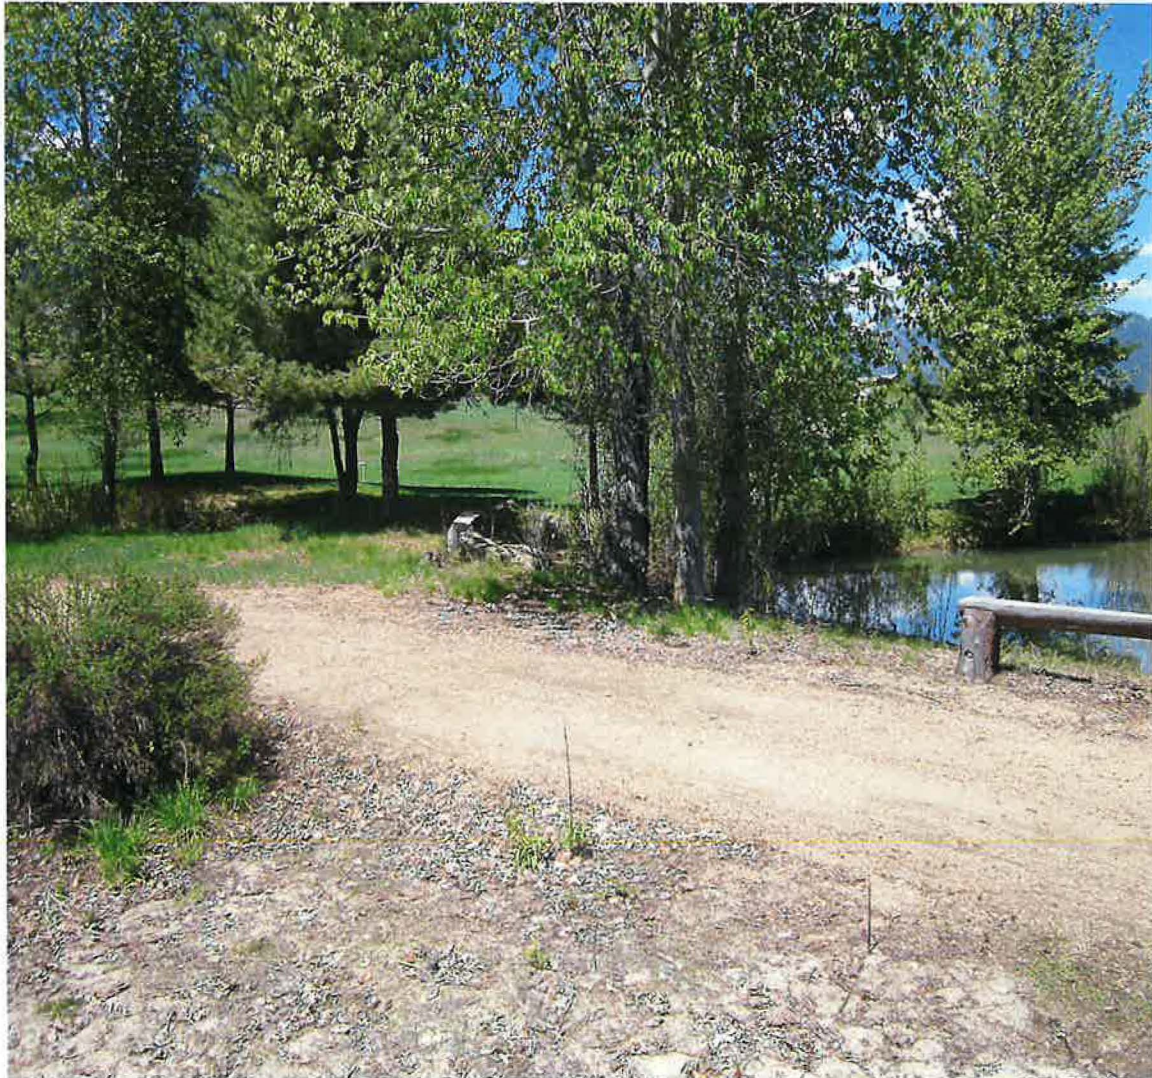
Photo 9- Ditch between the western and eastern ponds. Photo taken facing north.

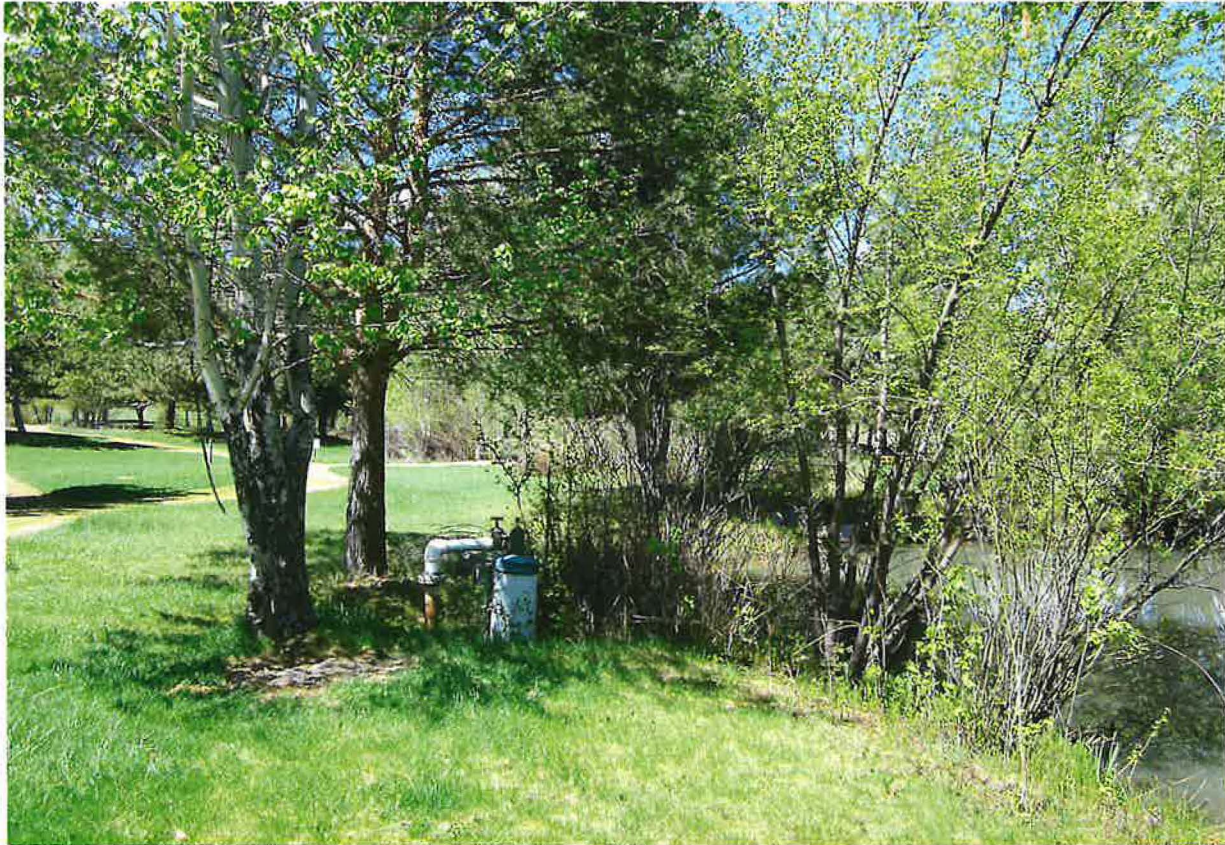
Photo 10- 5 Hp Recirculation pump (no longer functional) located on the south side of the eastern pond. Pump was used to recirculate water from the eastern pond to the western pond to be gravity fed back through the ditch running between the ponds.

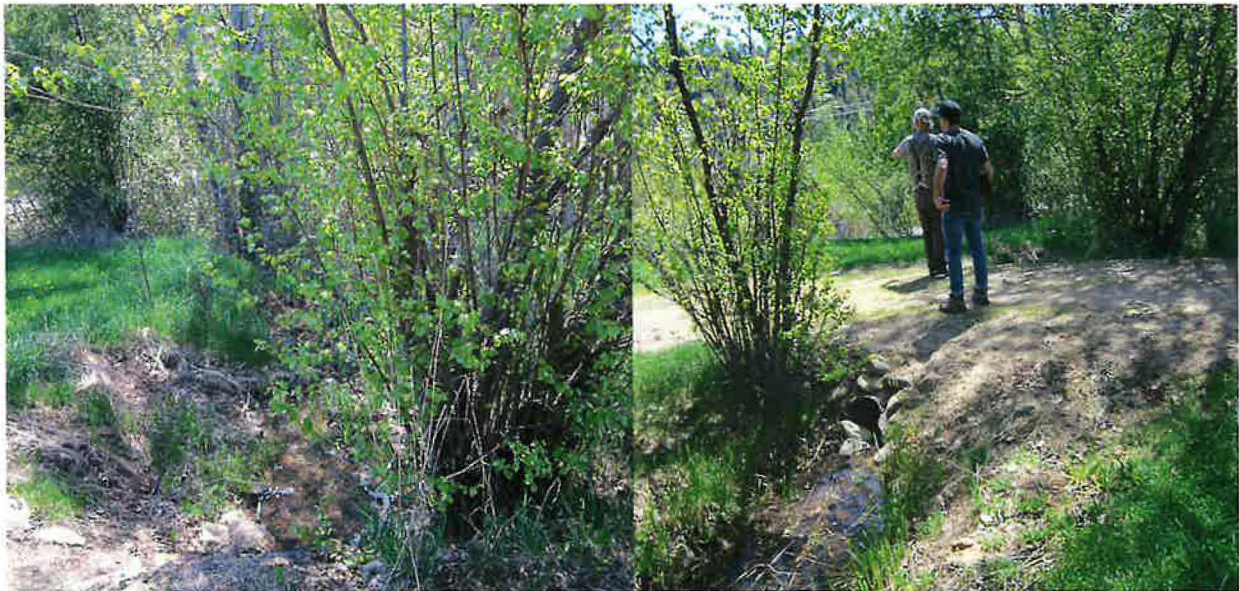
Photo 11 & 12- Left photo at the eastern side of the culvert standing on Alder Creek Rd facing east. The right photo is taken from the east side of the eastern pond facing east towards Alder Creek.

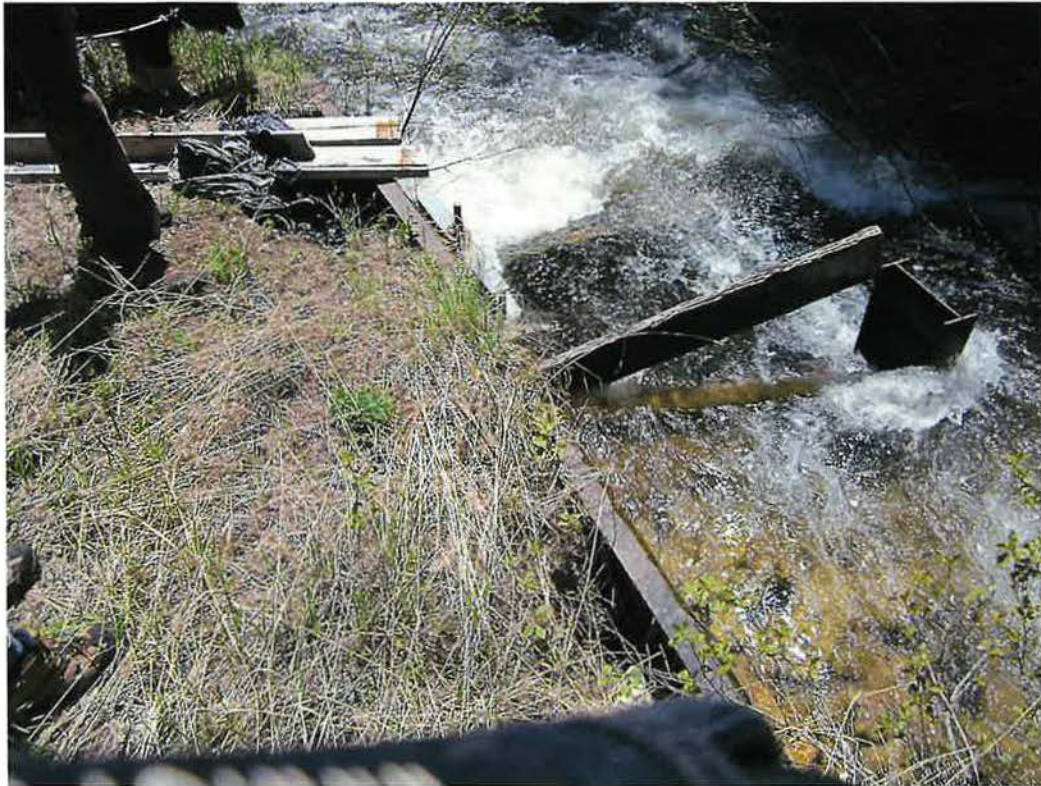
Photo 13- Head gate at Alder Creek, diverting water North into the irrigation ditch.

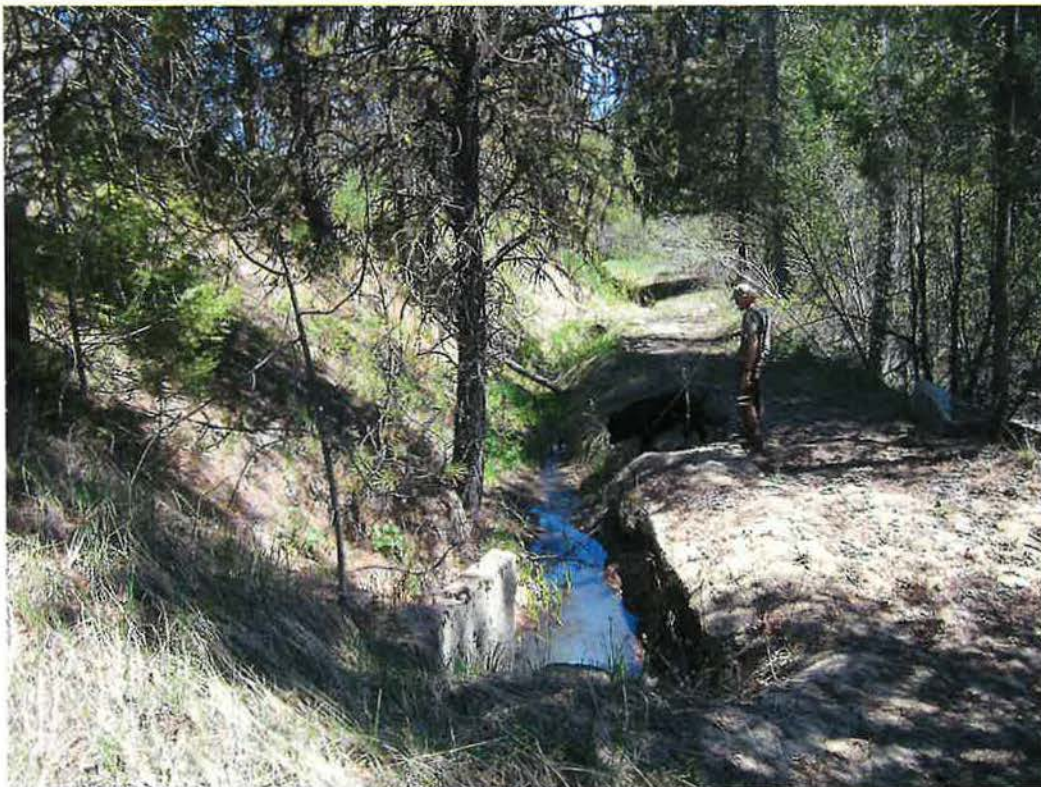
Photo 14- Irrigation ditch from headgate at Alder creek to the west side of the western pond.
