STATE OF IDAHO  
DEPARTMENT OF WATER RESOURCES  
BENEFICIAL USE FIELD REPORT

**Permit No:** 63-34677  
**Exam Date:** 08/30/2024

1. Current Owner:  
MORES CREEK RIM RANCHES WATER DISTRICT 1 PALOMA DR BOISE ID 83716-3295
2. Accompanied by: Kenny Everhart  
Phone No: (208) 509-0458  
Address: 134 Mores Creek Rim Rd (MCRR in Lot shared with Robie Creek Volunteer Fire Department)  
Relationship to permit Holder: MCRR Watermaster

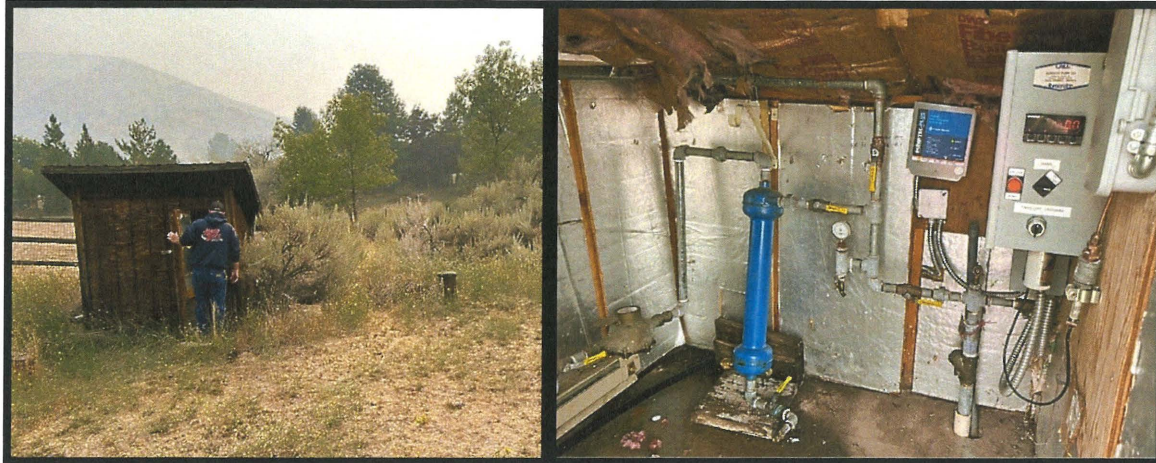
**Photo 3 (Left)-** Well #2 well head in the right of the image. **Photo 4 (Right)-** Inside of the pump house. The flowmeter in the left of the image is reduced from the 1 ¼" galvanized pipe to the 1" connections on the meter.

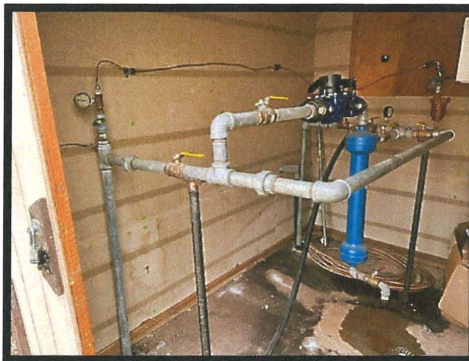
Photo 9 (above)- 1 1/4" Galvanized risers with flowmeter and pressure sensors.

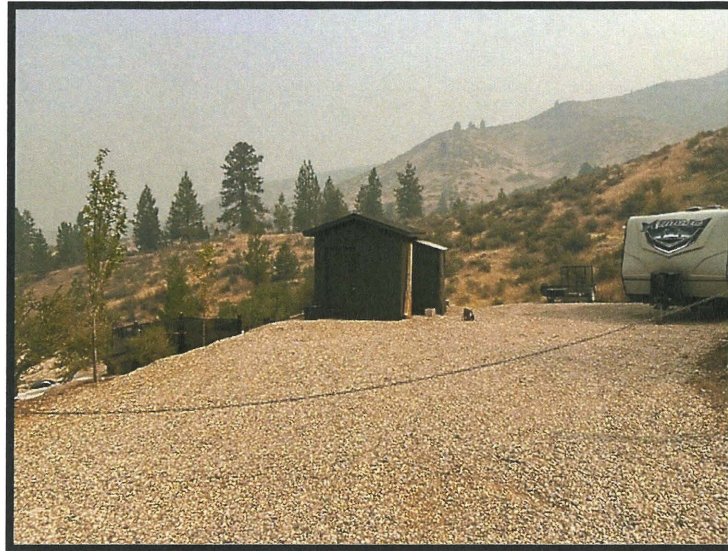
**Photo 12(above)-** Well #4 in the SWNW of section 27. The well has been abandoned due to contaminant levels. The well head has been crushed.

Comments: All wells for the system were drilled by Hiddleston from 1992 to 1997. In 2020, when pumps were replaced in wells #2 and #3 both pumps removed were 5Hp. The Watermaster believes that all the wells originally used similar pumps. Well #4 (297154) was abandoned upon the request of the DEQ after they deemed the water was unfit for consumption. However, all three wells were used during the development period.

**Well #4 (Abandoned):** Pumps removed from both other wells had 15 GPM pumps installed. It seems reasonable to infer that when all wells were active during the development period all had similar pumps installed. As no other documentation is available the past discharge is inferred as **15 GPM**.

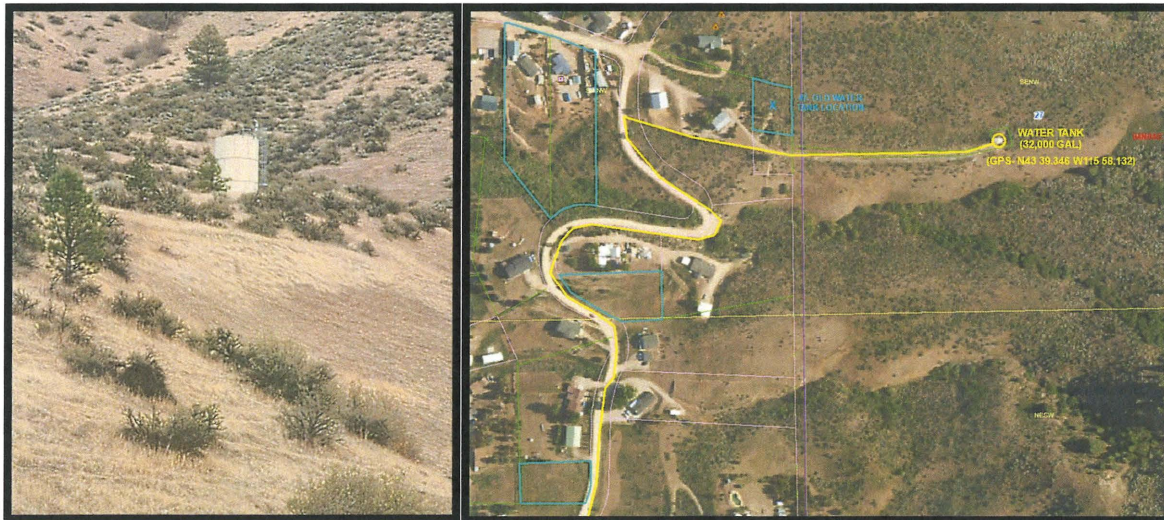
**Photo 13 (Left)-** The 32,000-gallon water tank northeast of the permitted place of use. **Figure 2 (Right)-** The parcel in the northeast of the POU is the original location of the water storage tank which was later moved to its current location uphill to the east of the POU.

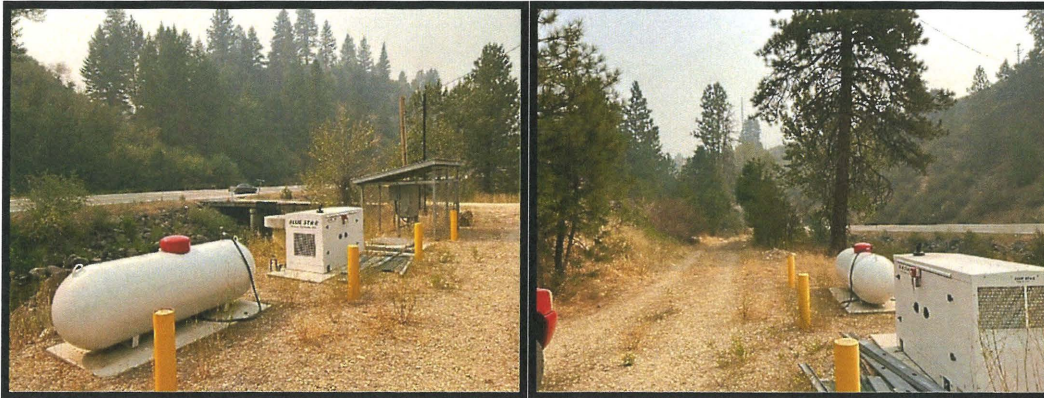
**Photo 23 (Left)-** Mores Creek surface water diversion from wet well (GPS Coords: N43°39.102' W115°58.839'. **Photo 24 (Right)-** The water main was bored in from the round vault to the water treatment plant just to the right of the cell tower visible on the ridgeline in the background.

The original groundwater system has been revamped to incorporate a surface water diversion system at Mores Creek (Photos 23-25) and treatment plant (Photos 26-31), which provide the primary water for domestic use within MCRR, with the groundwater to now only used as an emergency backup system. To address any enlargement concerns the Municipal use permit for the surface water system (63-34745) should be conditioned with a combined limit at licensing. Due to the development's location within the Basin 63 Ground Water Restricted Area the water bearing zone of 194 to 600 feet was reported on the permit and should be carried to the license.
