**From:** Dylan R. Hedden-Nicely <dylan@hedden-nicely.com>  
**Sent:** Tuesday, October 28, 2025 6:03 PM  
**To:** Roda, Evan  
**Subject:** RE: Preliminary Recommendations for CFPRBA Claim Nos. 97-7541 & 97-7544  
**Attachments:** PreliminaryDirectorReport\_97-7541.docx; Goose Creek Final Design.pdf; Final Goose Creek Conceptual Design Report.pdf; 97-7541 - Natural Conditions.png; 97-7541 - With Dam.png

# Restoration of Goose Creek Big Meadows Phase 1

# **Restoration of Goose Creek and Big Meadows**

## **Conceptual Design Plan**

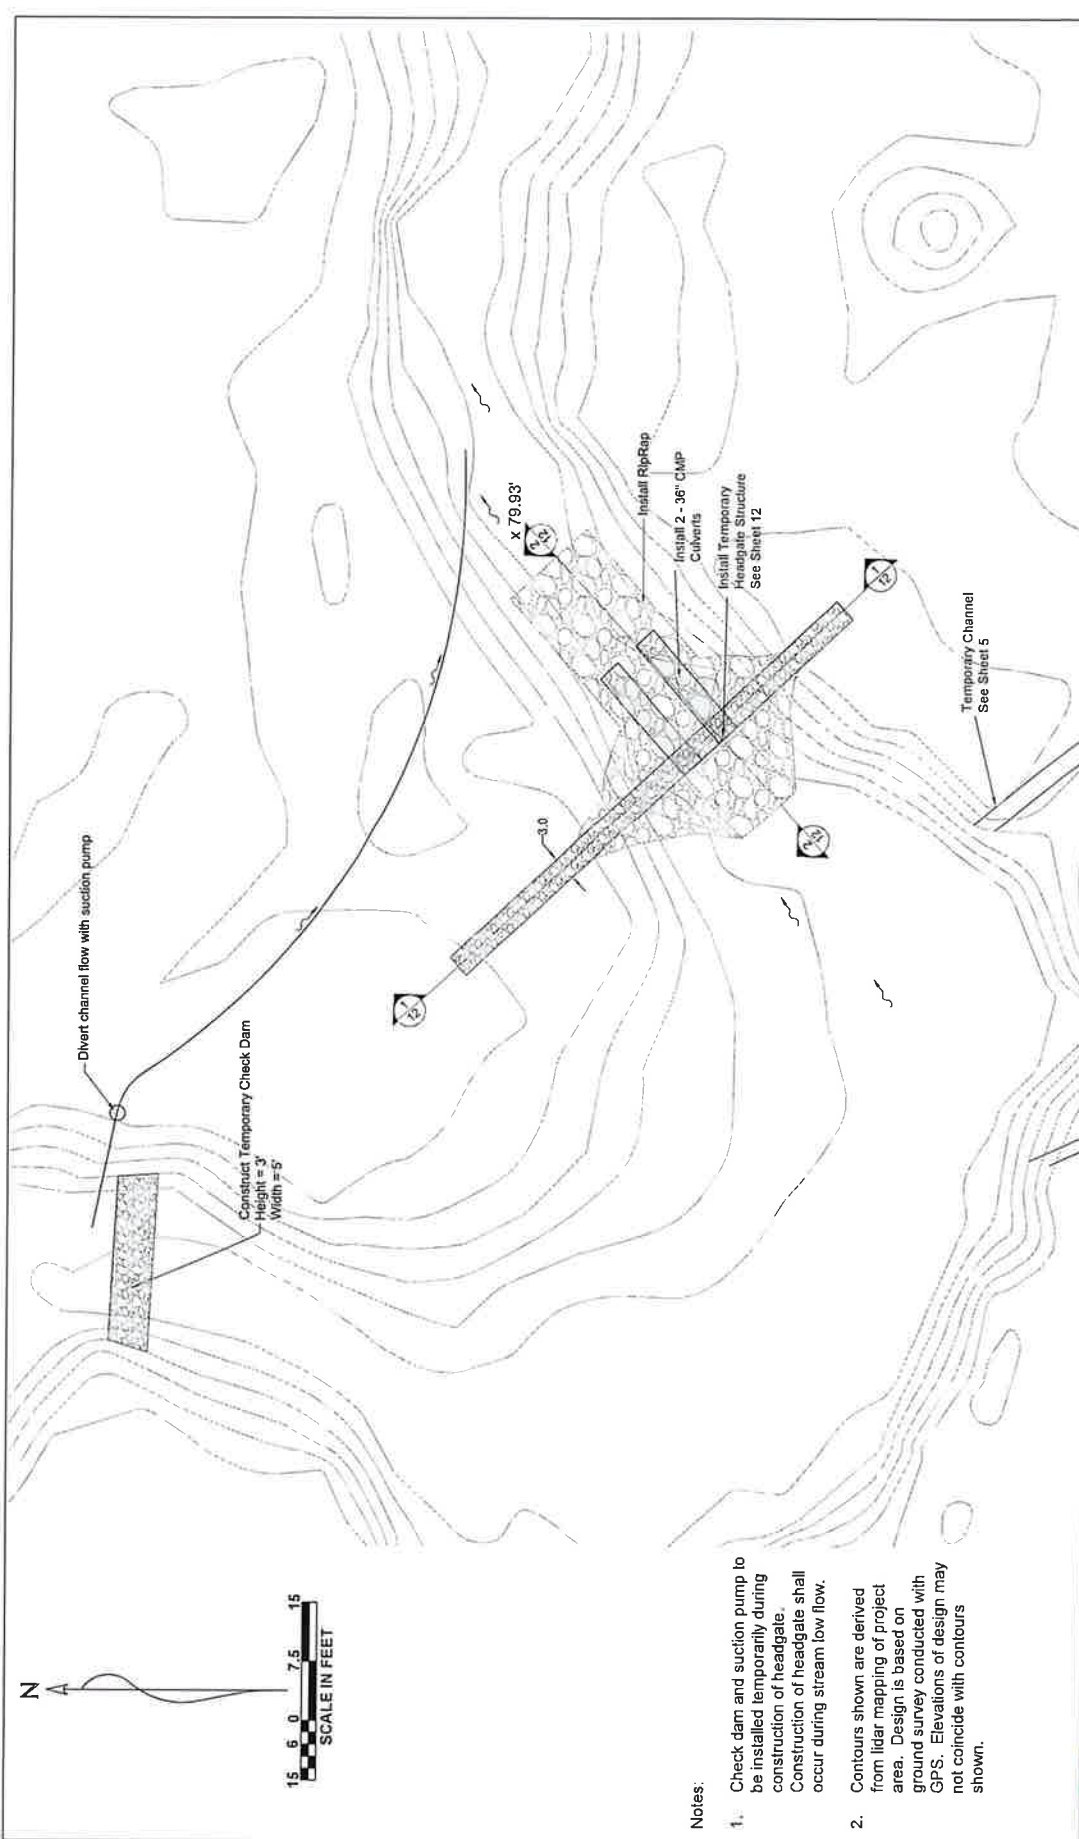
- Notes:
1. Check dam and suction pump to be installed temporarily during construction of headgate. Construction of headgate shall occur during stream low flow.
  2. Contours shown are derived from lidar mapping of project area. Design is based on ground survey conducted with GPS. Elevations of design may not coincide with contours shown.

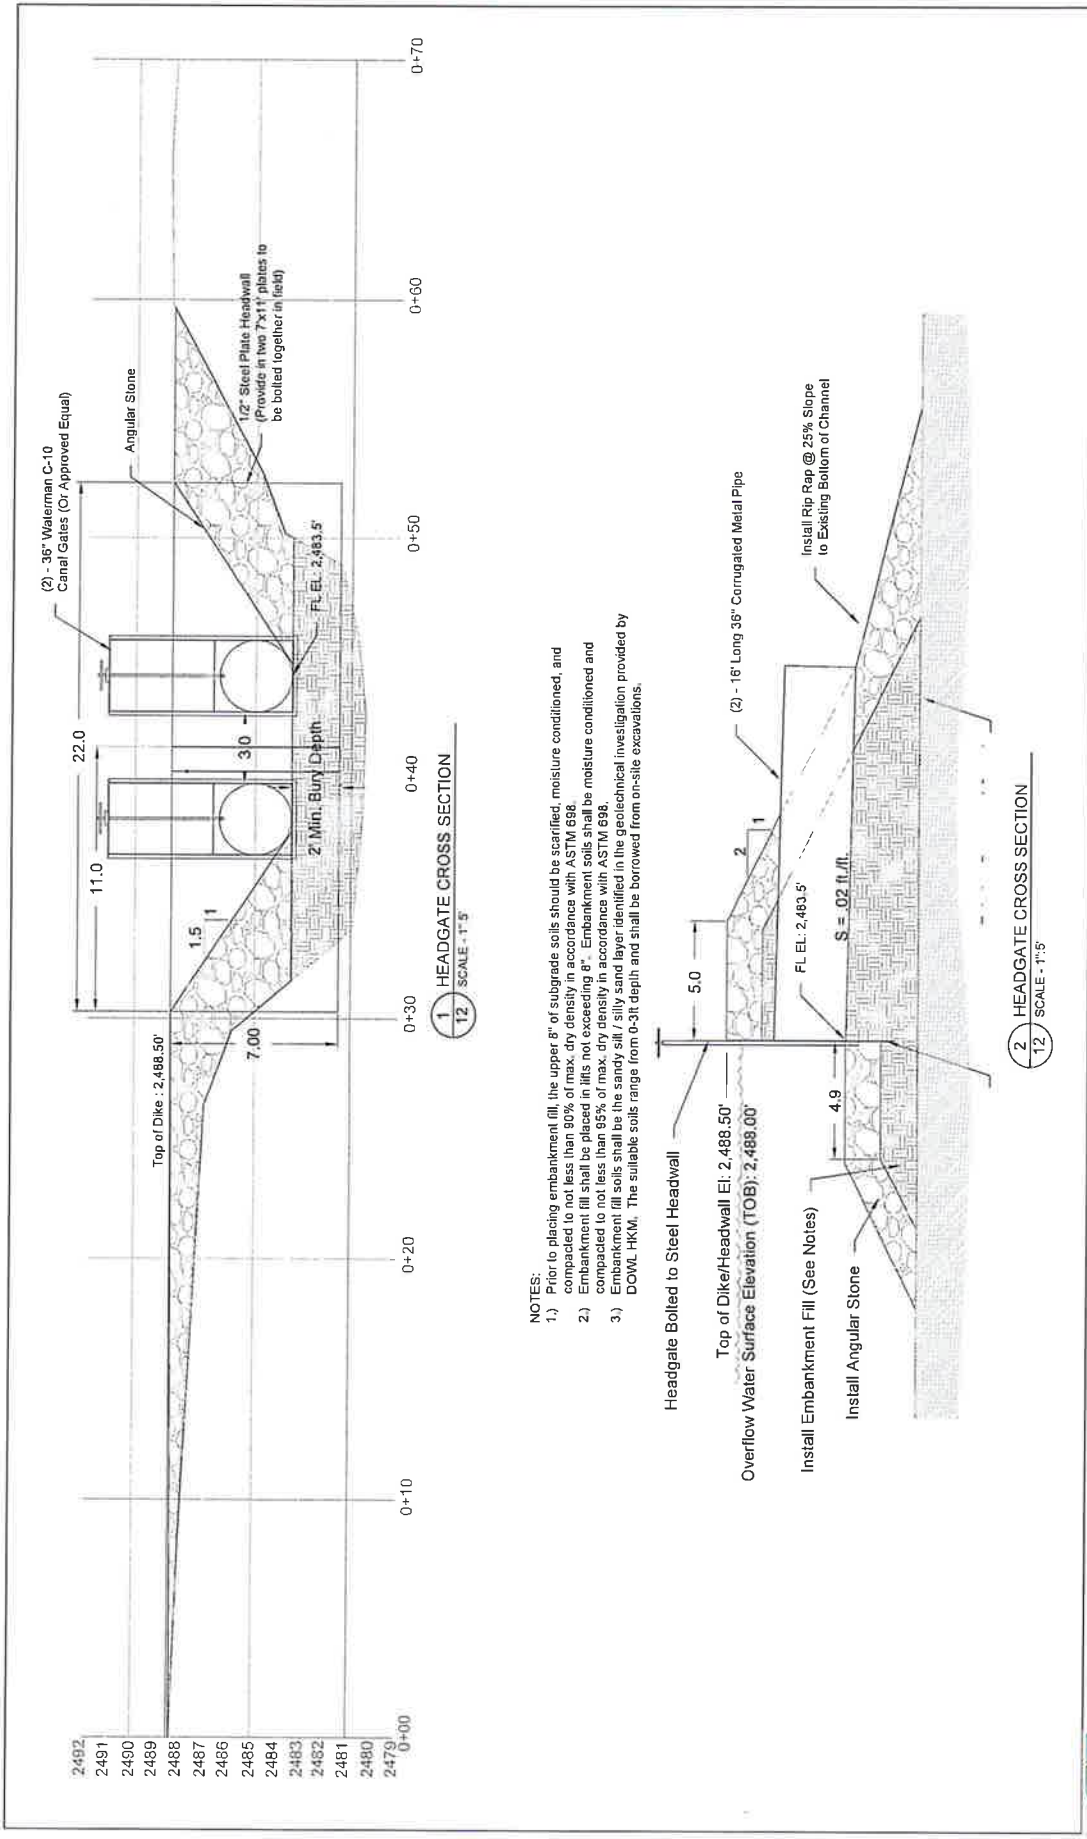
# **HEADGATE STRUCTURE DETAILS** **GOOSE CREEK STREAM RESTORATION - PHASE 1**

- 1) Prior to placing embankment fill, the upper 3% of subgrade soils should be scarified, moisture conditioned, and compacted to not less than 90% of max. dry density in accordance with ASTM 698.
- 2) Embankment fill shall be placed in lifts not exceeding 8". Embankment soils shall be moisture conditioned and compacted to not less than 90% of max. dry density in accordance with ASTM 698.
- 3) Embankment fill soils shall be the sandy silty / silty sand layer identified in the geotechnical investigation provided by DOW, HCM. The suitable soils range from 0.3ft depth and shall be borrowed from on-site excavations.

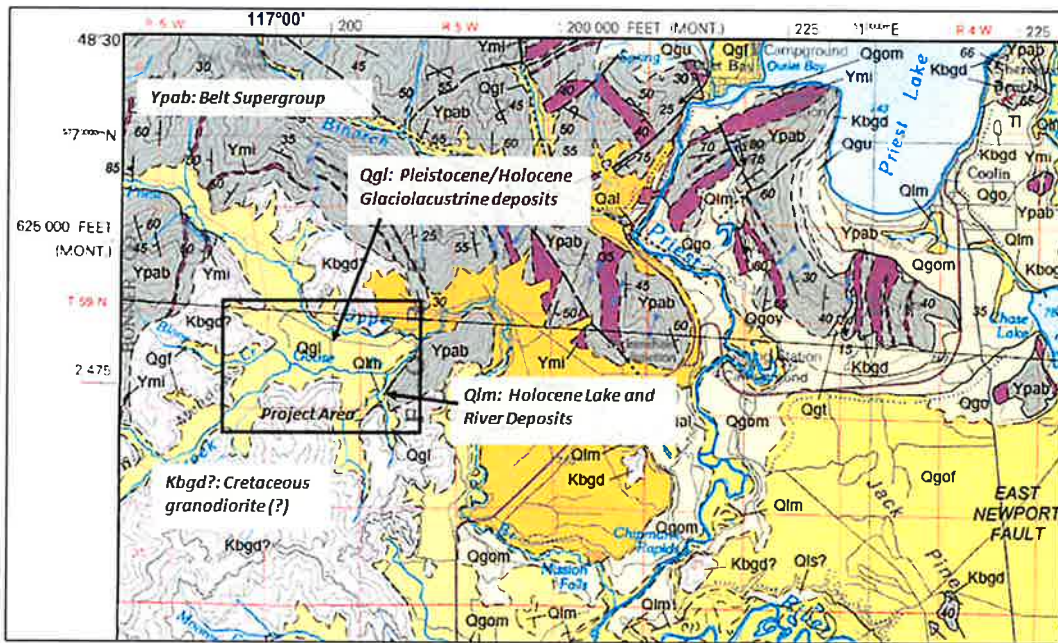
Figure 2. Geologic map of project area (Lewis and others, 2008).

The geologic mapping in the project reach (Figure 2) coupled with pit stratigraphy collected in support of channel design indicate that glacio-lacustrine conditions did exist in the project area resulting in the deposition of fine grained glacial lake deposits, and overlying peats are associated with subsequent deglaciation.

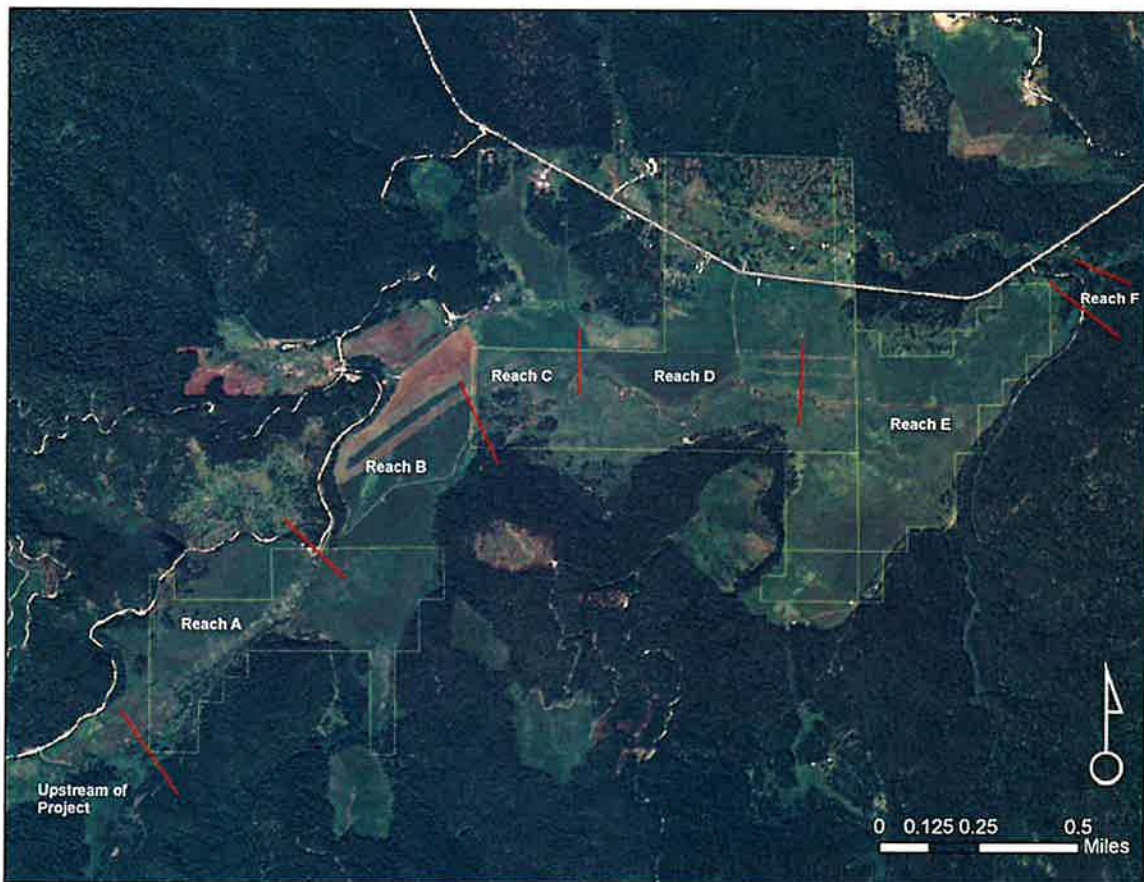
Figure 5. Reach breaks for Goose Creek in Big Meadows.

Due to the considerable length of channel through Big Meadows, aquatic and riparian habitats of Goose Creek vary in quality depending on the location within the valley. In addition, the creek exhibits various geomorphic characteristics which allow it to be divided into shorter sub-reaches for the purposes of habitat descriptions. Figure 5 displays reach breaks as identified by various habitat characteristics during the field survey. The reaches described in this section do not necessarily correspond with channel slope breaks or restoration phases as described in subsequent sections of this report.

Historic segments of Goose Creek were digitized to determine channel sinuosity at various locations within Big Meadows and to provide design guidance for the restored stream. The 1932 photography revealed reaches within Big Meadows where the channel lost definition, resulting in discontinuous channel digitization. Poor channel definition may be due to areas of the meadow that are particularly flat and contain a braided channel, areas where the channel has a very dense riparian corridor which overlays the channel, or where the reduction in image quality prevents obvious identification of the channel. Figure 27 illustrates historic and existing channel planform of Goose Creek through Big Meadows and includes calculated sinuosity for each digitized channel segment. Channel segments in this figure do not necessarily correspond to slope breaks in Figure 14 or reach breaks in Figure 5.

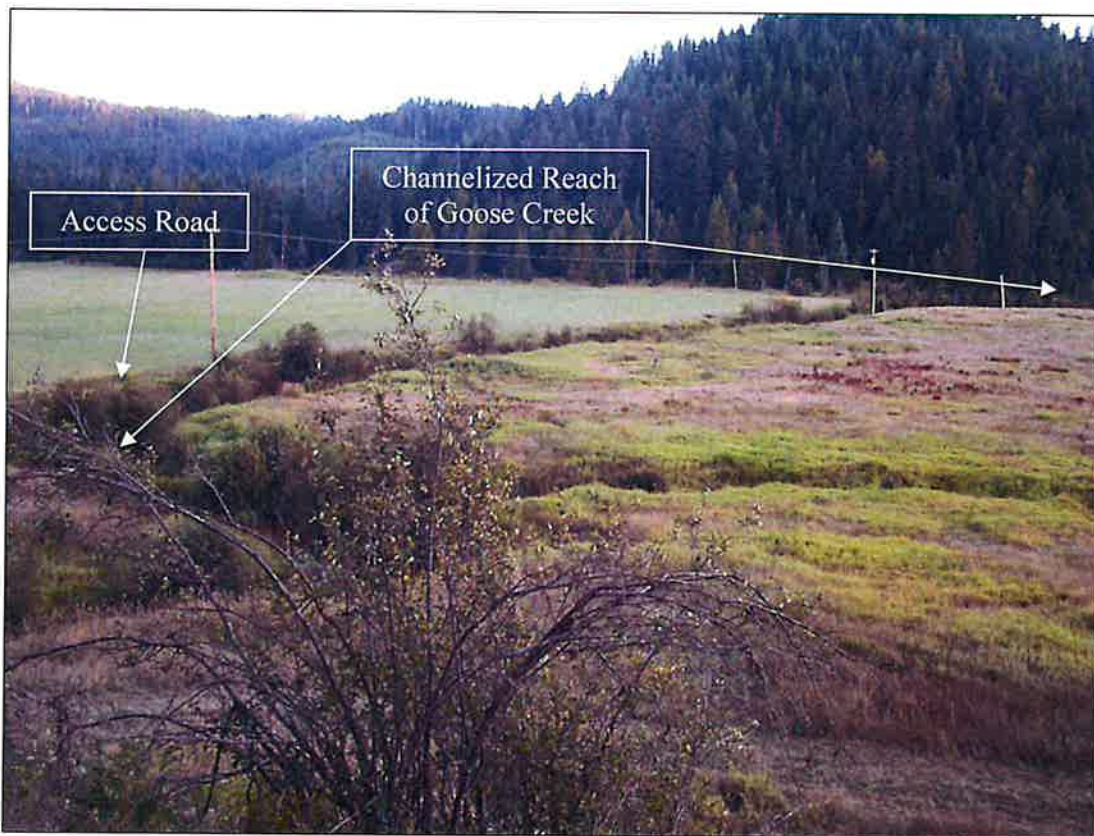
Figure 8. Channelized segment of Goose Creek in Reach A.

As the creek approaches the access road, it deviates from its historic meander pattern and enters a channelized reach which continues downstream to the bridge crossing. Once the creek becomes channelized, habitat complexity becomes drastically reduced. Pool quality is degraded due to the absence of meander sequences and shrub cover is reduced to a thin boundary of alders along the fringe of the channel. Much of the creek has been armored along the access road to protect it from eroding at high flows. Overall habitat quality in this channelized reach is poor due to planform simplification and altered riparian complexity.

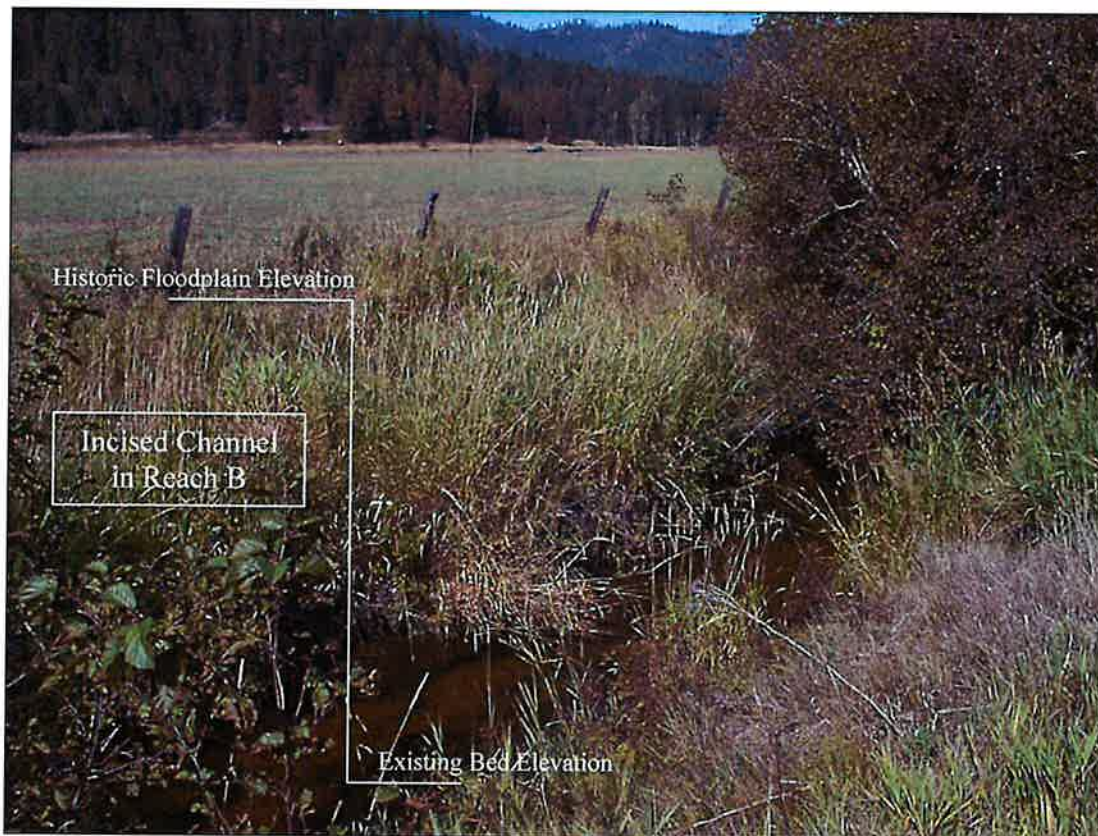
Figure 9. Channelized portion of Goose Creek in Reach B.

Reach B extends from the bridge crossing to a forested portion of the valley bottom. The entire length of Goose Creek in Reach B is channelized. The creek acts more like a drain and conveyance ditch through Reach B and has virtually no habitat complexity in the form of riffle/pool sequences. Aquatic habitat is available in the form of woody debris, as the channel is lined with large alders on both banks. The channel is moderately incised and drains adjacent hay pastures. Upland grasses and forbs grow down to the edge of the channel but provide little cover or habitat. Although the creek has been altered to maximize hay production in this portion of the valley, the stream banks have generally maintained lateral stability and riparian vegetation is vigorous along a thin band immediately adjacent to the creek. Overall habitat quality is relatively poor in Reach B due to simplified plan form, lack of a functional floodplain, and reduced riparian vegetation complexity.

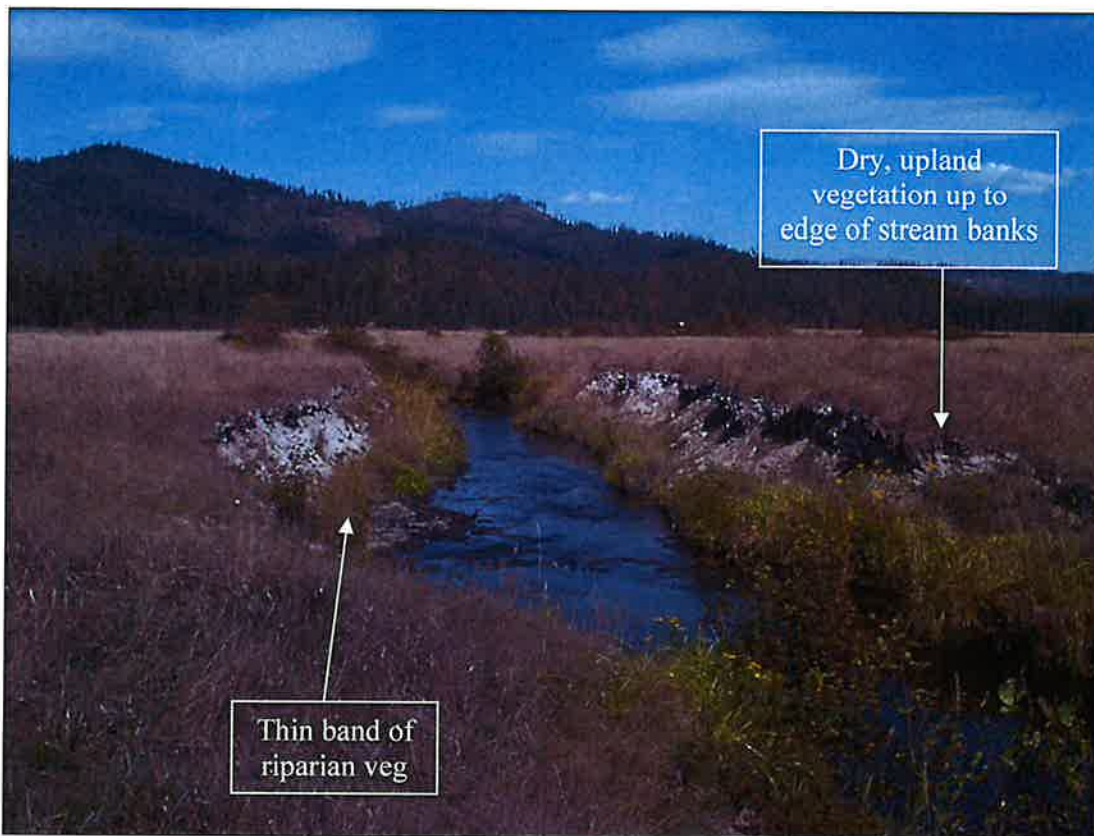
Figure 10. Goose Creek in the lower portion of Reach C.

Reach C of Goose Creek flows through a short, forested portion of the valley and continues into the center of Big Meadows. The channel returns to its historic meander pattern through this reach as identified by 1932 aerial photos. Although the channel displays a relatively natural sinuosity in Reach C, it also shows evidence of vertical incision of the stream bed, including an elevated meander cutoff, high banks, and thin band of riparian vegetation along the immediate banks. Habitat complexity improves in Reach C as compared to the channelized portions in Reaches A and B as the channel is able to scour pools on outside meander bends. Although habitat complexity begins to improve, the bed elevation of the creek is very low as compared to the meadow, and therefore acts as a drain for adjacent pastures used for grazing and producing hay. Riparian vegetation is relatively sparse due to a channel which has been disconnected from its historic floodplain. Bank erosion is evident by sloughing along much of the channel, which provides additional sediment inputs to the watershed.

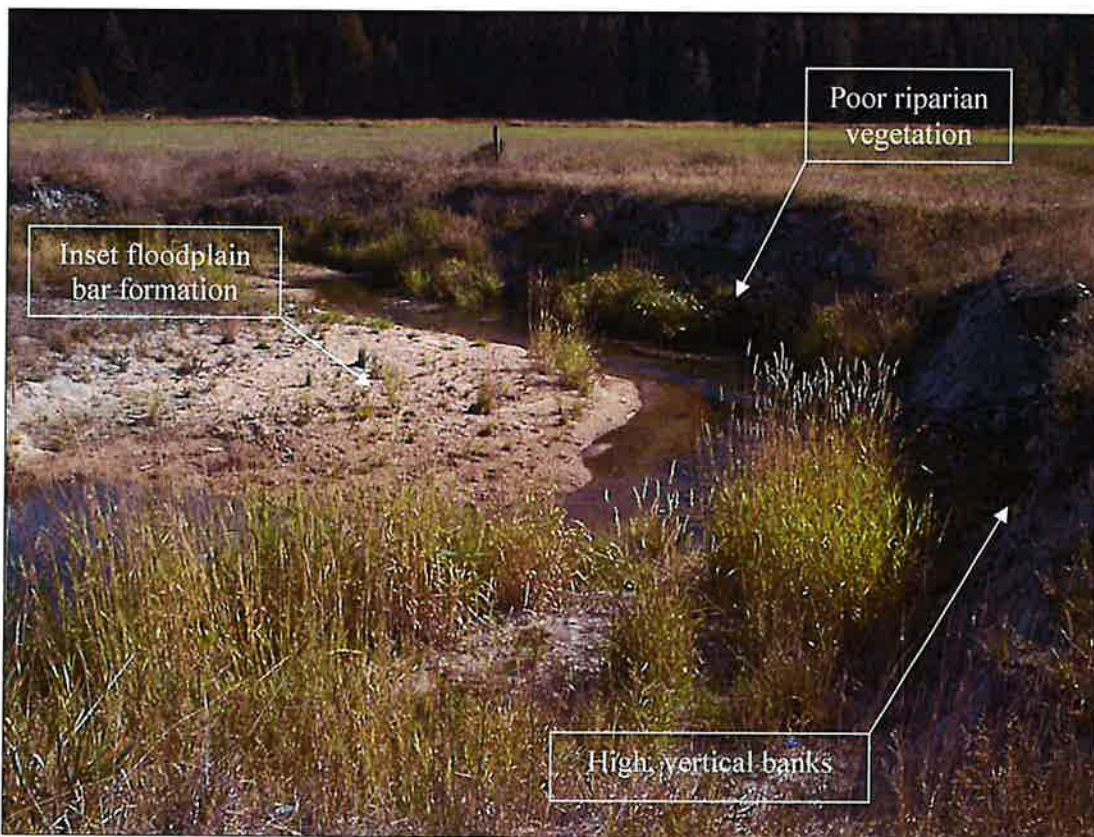
Reach D extends to a culvert which has been placed in the channel to provide a crossing for equipment access. The creek flows along nearly the same meander pattern as shown in 1932 aerial photography, indicating relatively minor lateral movements in the past 70 years. The channel continues to show signs of incision, including high bank heights, inset floodplain formation, and sparse riparian vegetation along the fringes of the channel (Figure 11). The relatively natural sinuosity in Reach D enables pool formation along the outside of meander bends that provide added habitat complexity. However, riparian vegetation throughout the reach has been reduced to a very thin band of grasses and occasional alders which provide little cover and shade. Overall aquatic habitat in Reach D is poor due to eroding banks, poor riparian vegetation density, and reduced floodplain connectivity.

Figure 11. Goose Creek in Reach D showing inset floodplain formation and incised channel.

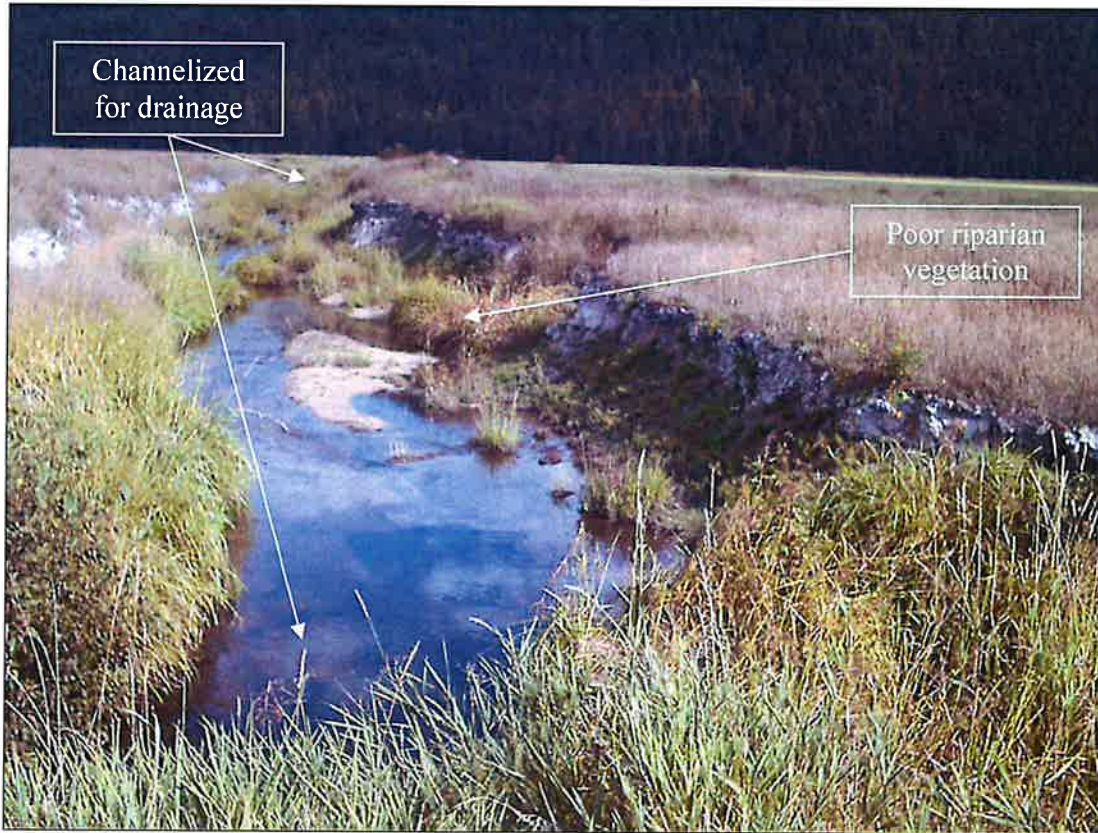
Figure 12. Channelized portion of Reach E.

Reach E of Goose Creek extends downstream of the culvert to a bridge crossing at the lower end of Big Meadows. The majority of this reach has been recently channelized and dredged (~10-15 yrs ago) to drain the meadow and improve hay production. As a result, habitat complexity is severely degraded and woody riparian vegetation is nearly absent throughout the reach. Sparse alders remain along the fringe of the channel and provide some cover and shade, but the majority of the channel has little overstory or canopy layer. Immediately downstream of the culvert, the channel remains incised with very high bank heights, one large meander cutoff, and upland vegetation growing up to the channel edge. The degree of incision lessens as the channel approaches the east side of the meadow, although it remains channelized to the bridge. As the channel begins to regain connectivity to its natural floodplain near the downstream end of the reach, vegetation characteristics favor more wetland species, denser alders, and spirea. Habitat complexity in Reach E is poor due to the simplified planform and highly altered riparian corridor.

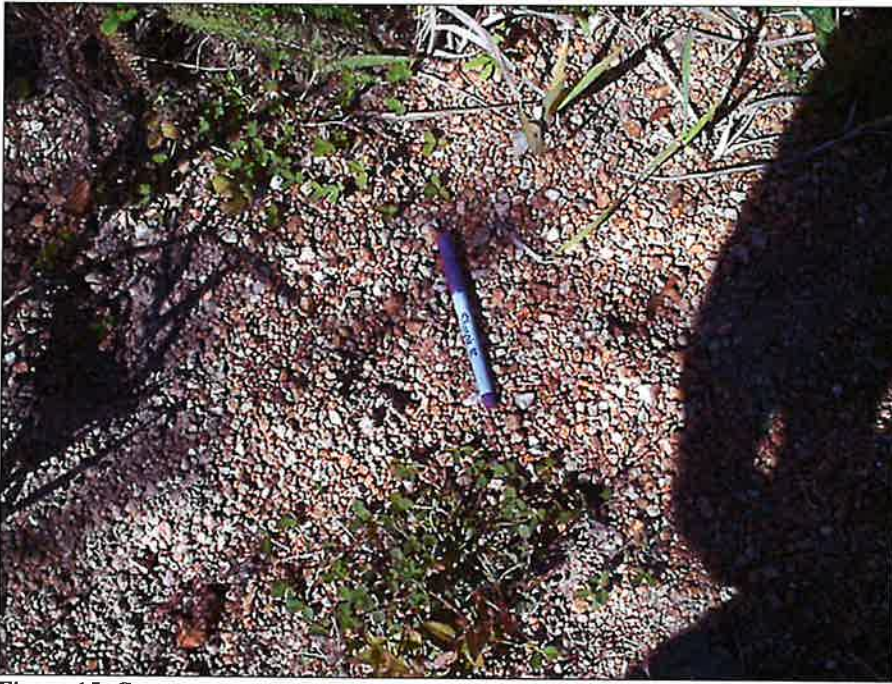
Figure 15. Concentrated gravels in channel bed, Goose Creek.

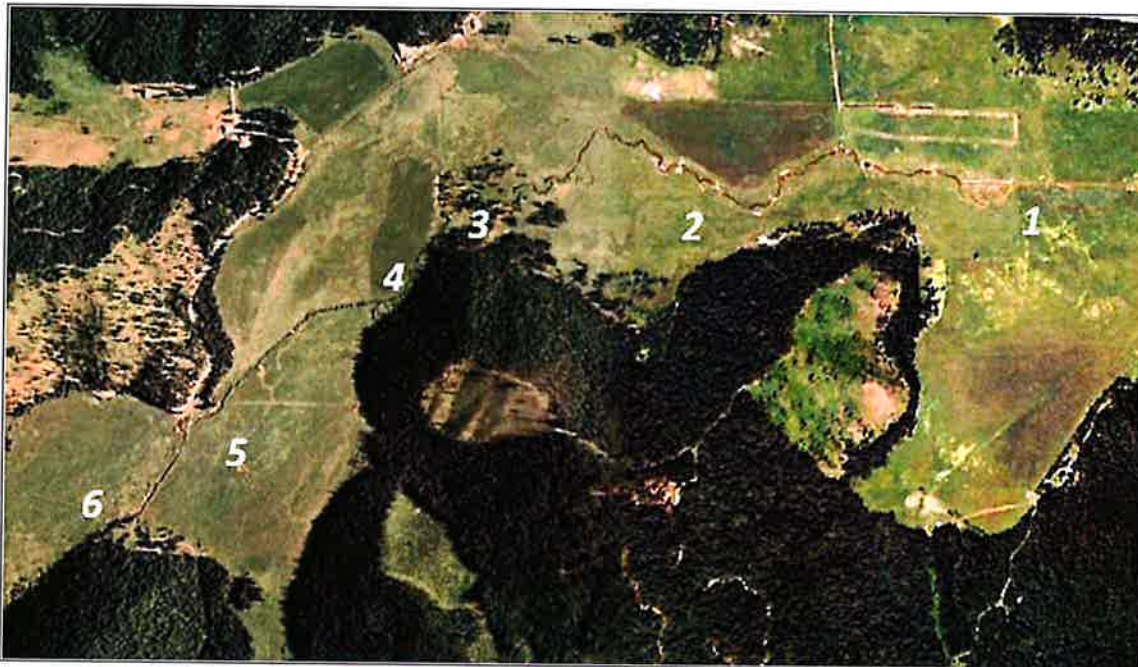
Figure 17. Soil pit locations, Goose Creek project reach.

In the fall of 2009, six soil pits were excavated by backhoe within the project reach to characterize subsurface materials (Figure 16). Pit locations were selected to provide a general representation of subsurface conditions on the anticipated reconstructed channel course (Figure 17). Total pit depths ranged from 6.5 to 9.5 feet; maximum excavation depths were limited by pit wall stability, groundwater levels, or backhoe reach (Figure 18). Appendix C contains the field logs collected for each pit.

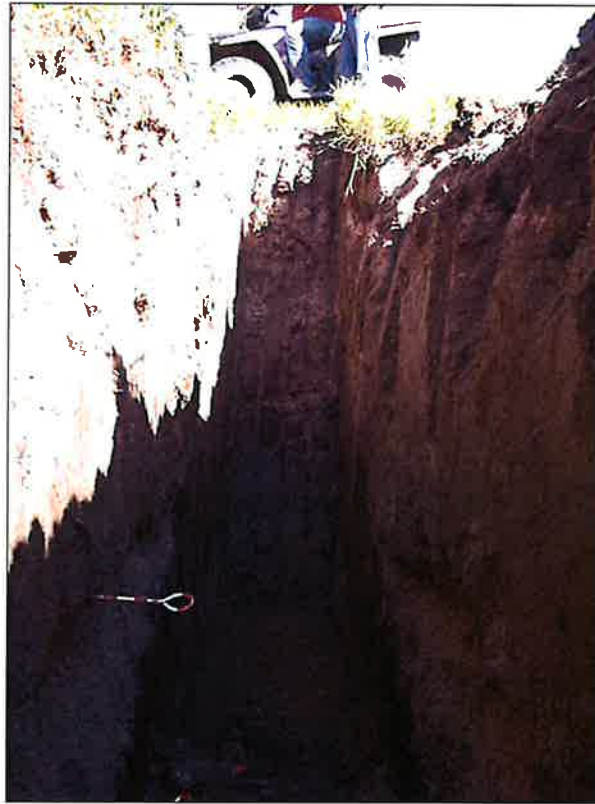
**Figure 18. Backhoe pit showing maximum depth at approximately 7.5 feet (Soil Pit 2).**

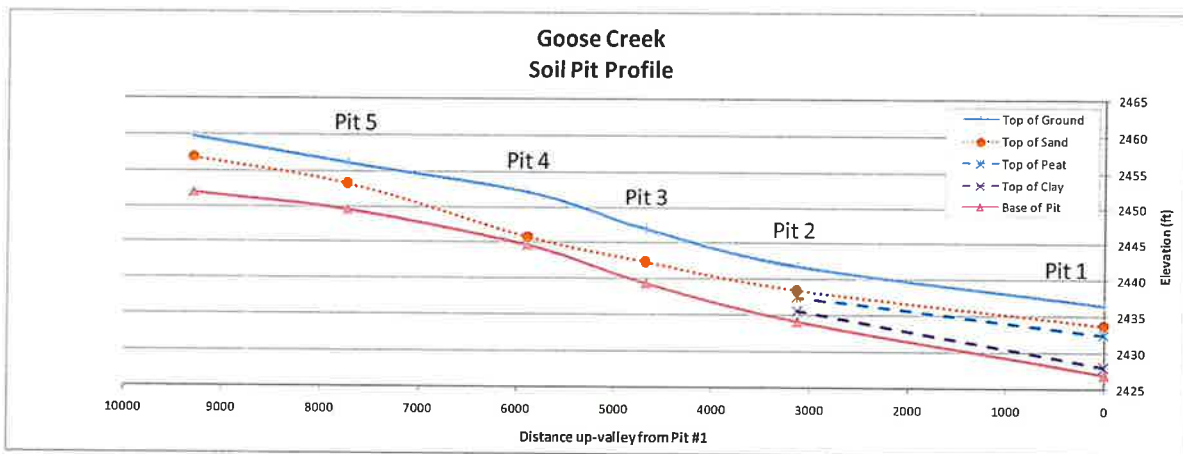
Figure 19. Soil pit profile compiled from pit logs and site elevation survey.

A generalized profile of the observed pit stratigraphy is shown in Figure 19. The plotted results show that in the lower portion of the valley, clay and peat were encountered in the deepest portion of the section. The clay encountered at the base of both Soil Pit 1 and Soil Pit 2 consists of a blue/gray, highly cohesive massive clay (Figure 20). The unit was 1.0 to 1.3 feet thick, which should be considered a minimum thickness as the lower contact elevation is unknown. In Soil Pit 2, the clay contained some interbeds of gray sand.

Overlying this unit, a peat unit ranges in thickness from 4.5 feet in Soil Pit 1 to 2.0 feet in Soil Pit 2, indicating that the unit may thin in the up-valley direction. This unit consists of a brown peat that has a low density and contains distinct reedy plant fragments (Figure 21). Neither the basal clay nor overlying peat were observed in any of the pits located up-valley from Pit #2. If these units were deposited in relatively flat lake or bog conditions, they likely extend up-valley at a deeper level than that reached by Pits #3 through #6.

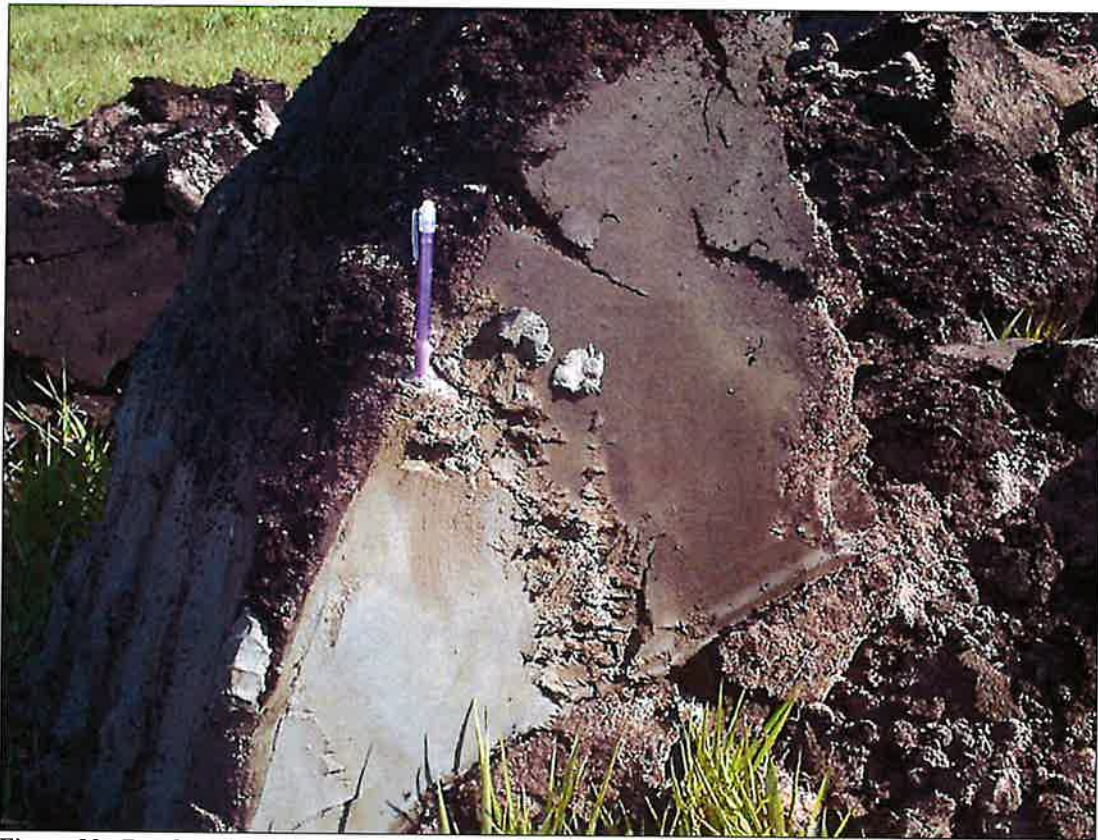
Figure 20. Basal glacial clay, Soil Pit 1.

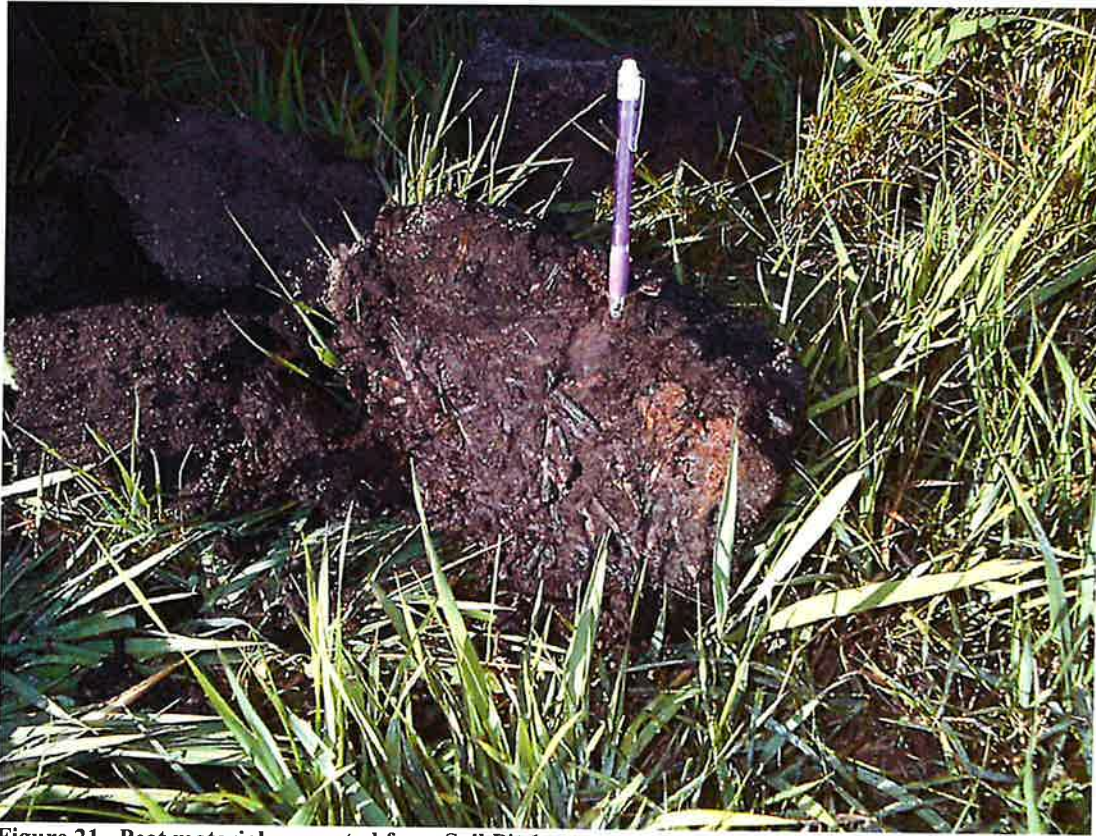
**Figure 21. Peat material excavated from Soil Pit 1.**

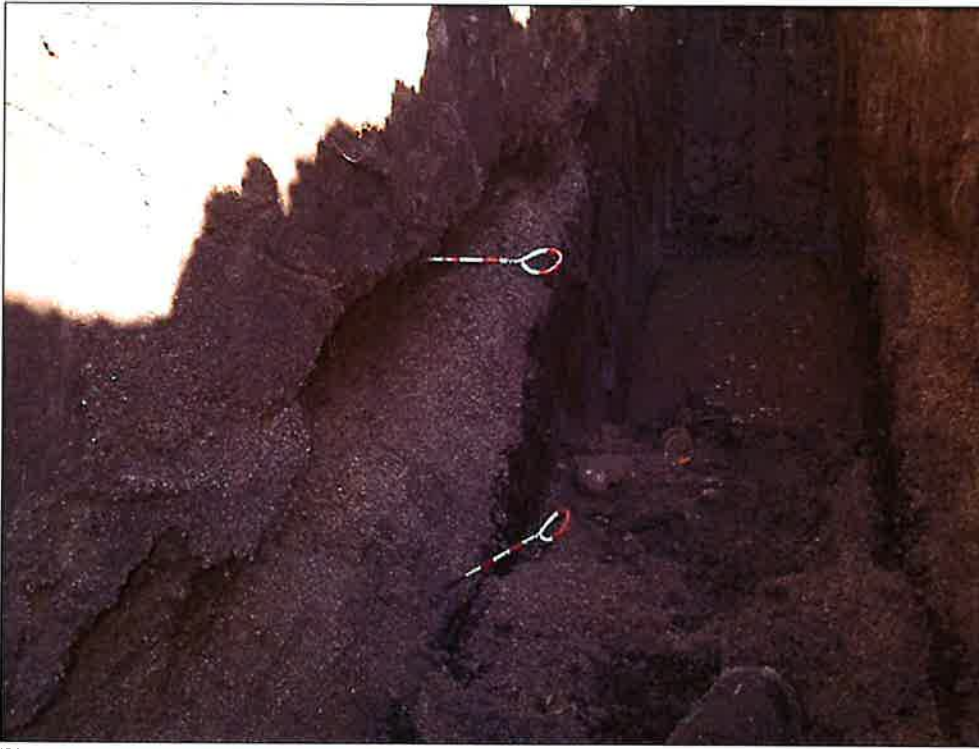
Figure 22. Wall of Soil Pit 2 showing non-cohesive, sand channel overlying peat.

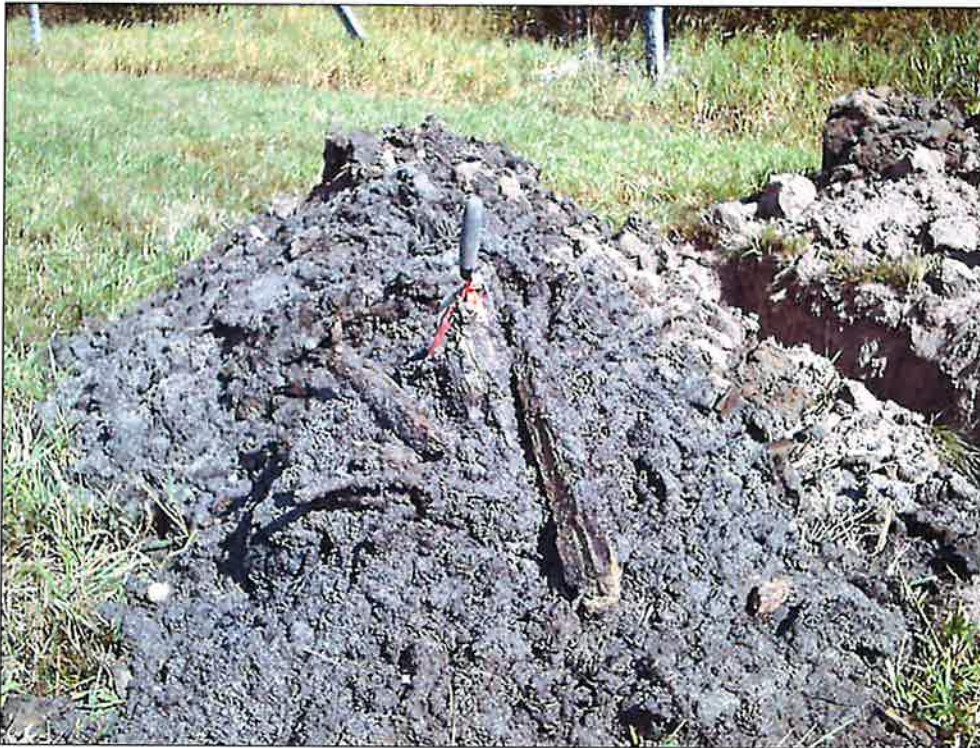
Figure 23. Wood fragments excavated from non-cohesive sand horizon, Soil Pit 4.

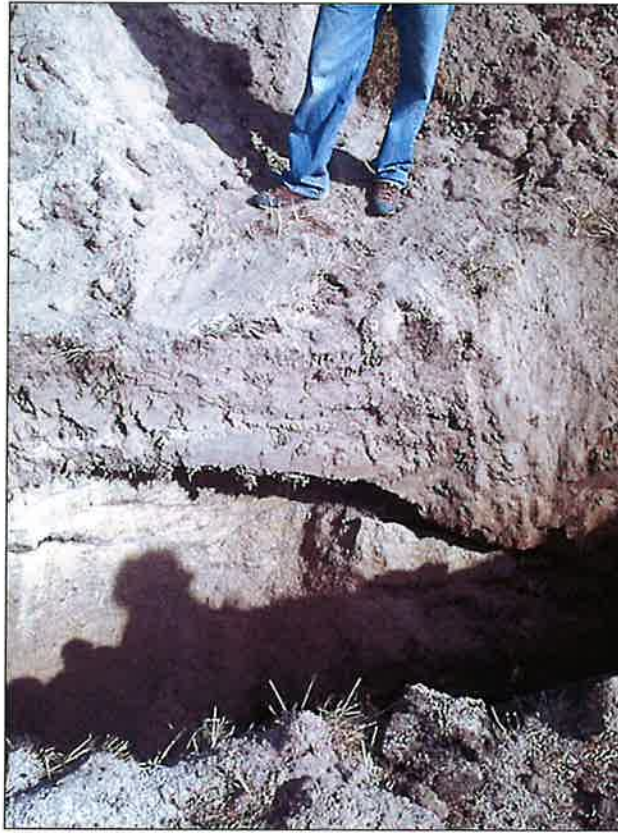
In all of the soil pits, the sand horizon was overlain by variably stratified fine silts. In some locations, a distinct ash horizon was present within the silt. This unit was consistently several feet thick and sufficiently indurated to provide stability to the pit walls. In most cases, the uppermost portion of this unit was massive and structureless, suggesting that it had been tilled as part of agricultural activities in the valley. In Pit 5, the silts overly a non-cohesive, convex bar deposit that suggests overbank infilling of an abandoned channel segment (Figure 24).

**Figure 24. Massive silts overlying a convex point bar deposit of non-cohesive sands, Soil Pit 5.**

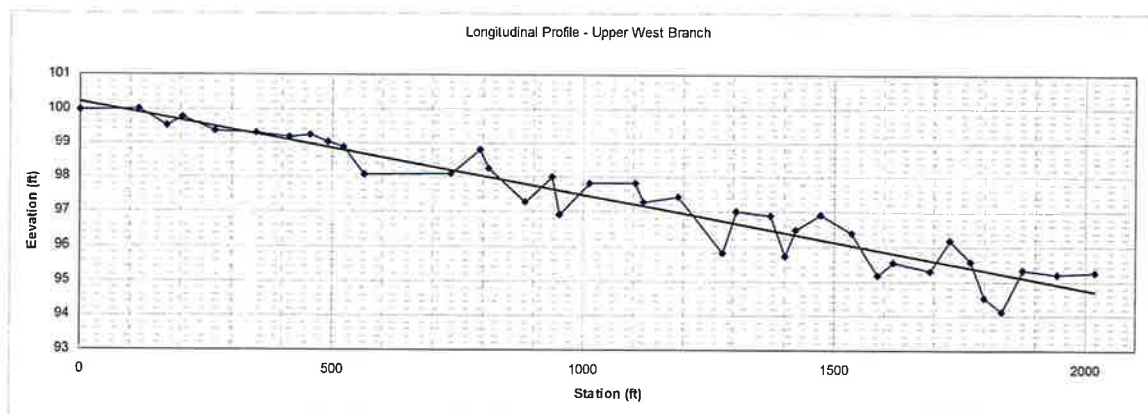
Figure 26. Longitudinal profile of Upper West Branch reference reach.

A 2,000 foot longitudinal profile was surveyed in the selected reference reach of the Upper West Branch. Results of this profile allow for comparisons of channel slopes to those found in Goose Creek. Results of the longitudinal profile are illustrated in Figure 26. Thalweg slope averaged 0.0025 ft/ft for this reach of the Upper West Branch.

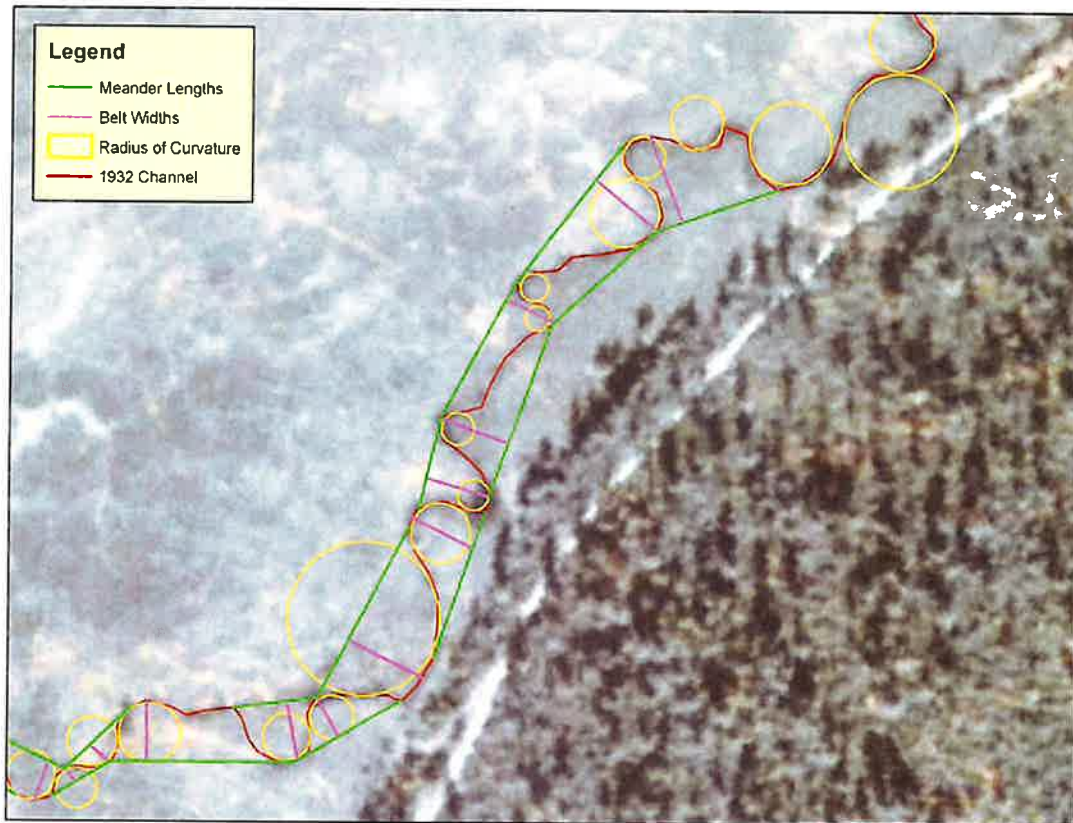
Figure 28. Planform dimensions digitized from 1932 aerials.

Each of these planform components was measured for each meander sequence within each of the 1932 channel segments illustrated in Figure 27. An example illustration of digitized meander lengths, belt widths, and radius of curvature from the 1932 aerial photos along lower Reach E is shown in Figure 28. Meander geometry results for each channel segment are included in Table 13.

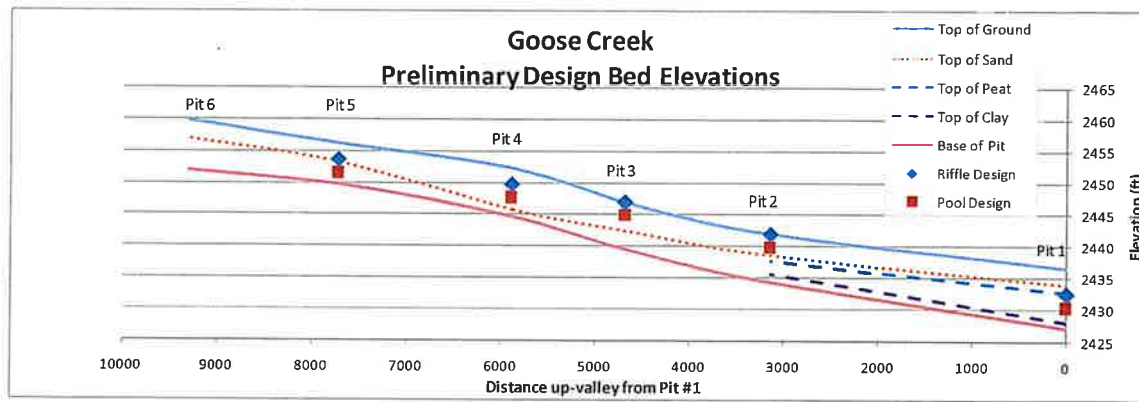
Figure 29. Valley fill stratigraphy and proposed riffle/bed elevations.

At Soil Pit 1, the channel will be held within a deeper, compound cross section that contains an inset floodplain margin. As a result, the deeper cross section will extend down through the sands and into peat for both riffles and pools. Peat is similarly exposed in the bed of the existing channel to the north (Figure 30). Although bank failure is common in that channelized segment, the role of peat in that instability is unclear. This layer will not provide immediate bank and bed stability, although it may provide a rich source of seeds and organic matter. This layer may provide a very suitable medium for revegetation of the floodplain and stream banks. As stated earlier, it would be advantageous to refrain from activating this channel segment immediately following channel construction, and wait 1-2 growing seasons for revegetation efforts to mature.

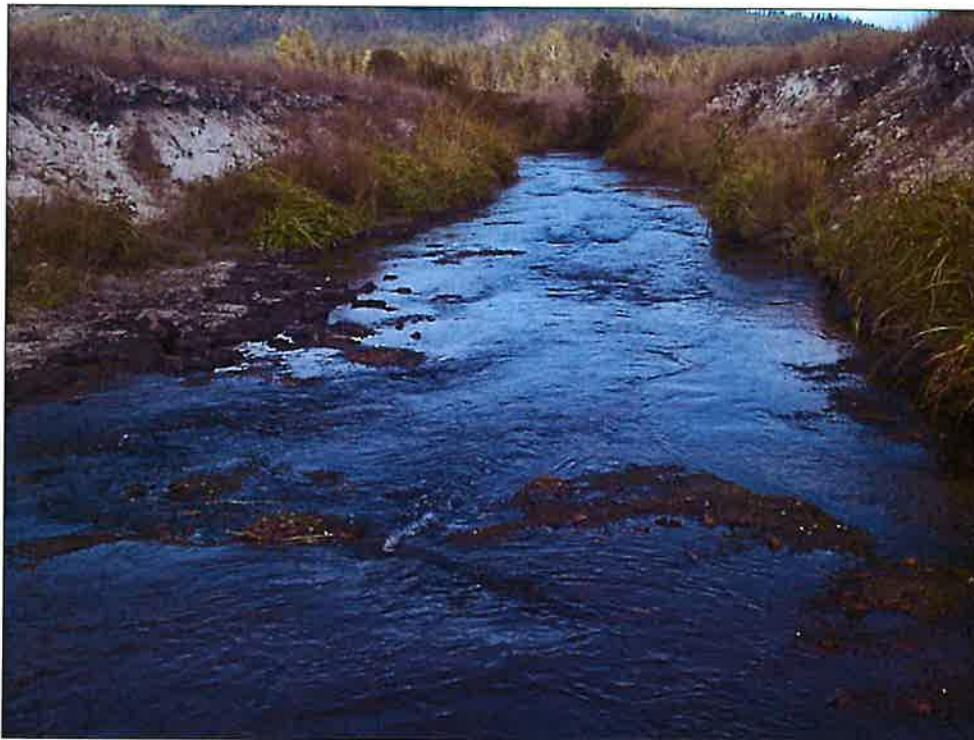
Figure 30. Peat exposures in bed of lower Goose Creek.
