## **Stock Use**

## Aerial Imagery

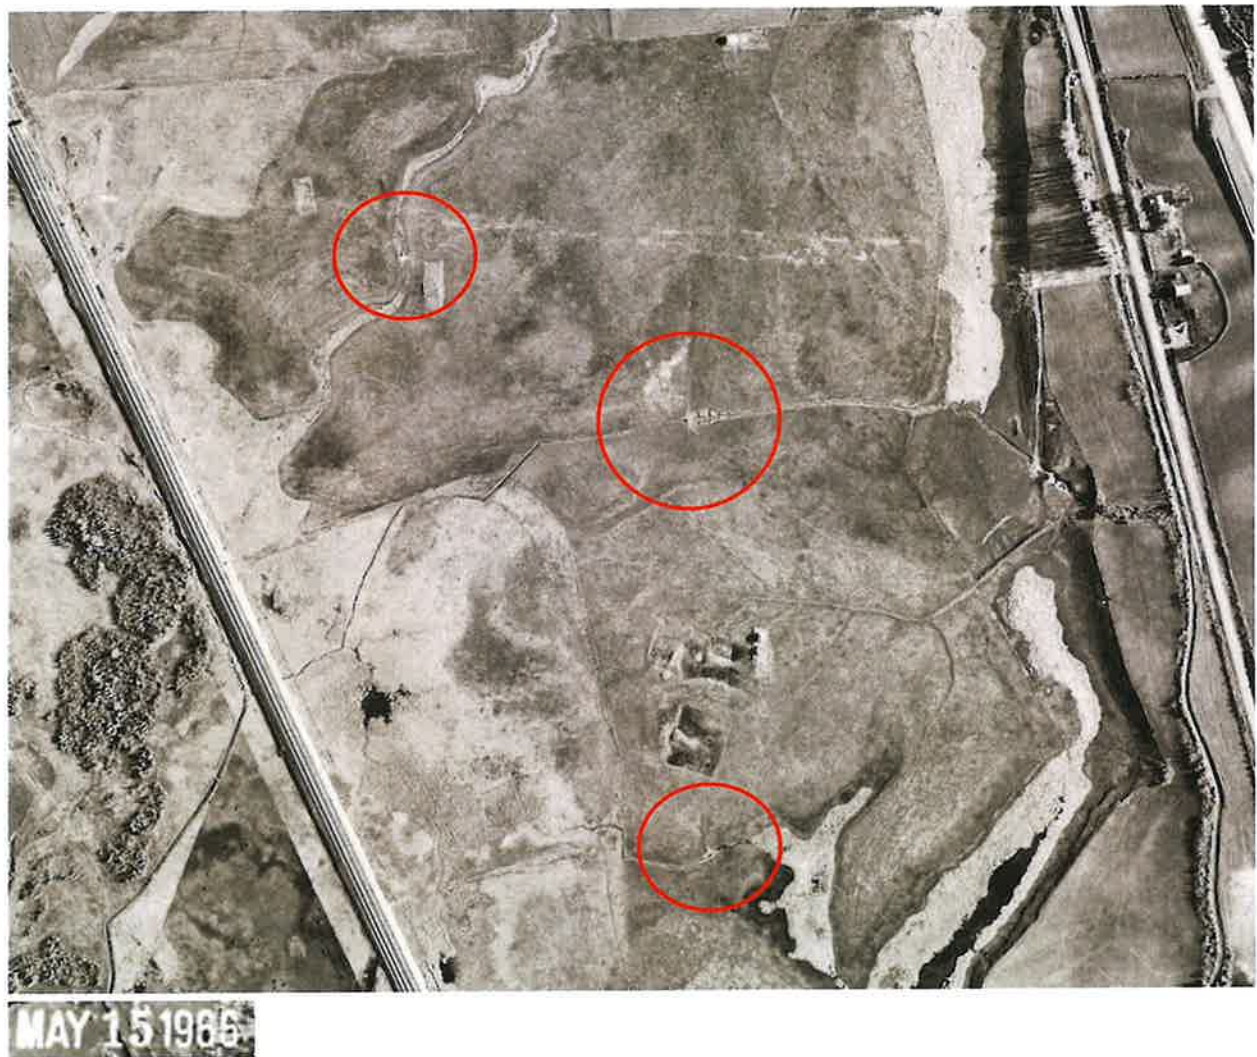
Image 1. Source: USGS Earth Explorer.

Review of aerial imagery covering the claimed POU and POD's consistently shows all three earthen embankments from as early as 5/15/1966 (Image 1). The two images available prior to this in 6/25/1953 (Image 2) and 7/17/1947 (Image 3) do not clearly show all three embankments: only the lower two. From 5/15/1966 on to present day imagery on 7/23/2024 (Image 4), three embankments clearly exist. Because of this, an accomplished transfer of POD to add the northernmost POD will be recommended.

I am comfortable recommending a diverted stock water use with a priority date of 12/31/1949, as supported by aerial imagery and the claimant's personal knowledge in the supplied affidavit.

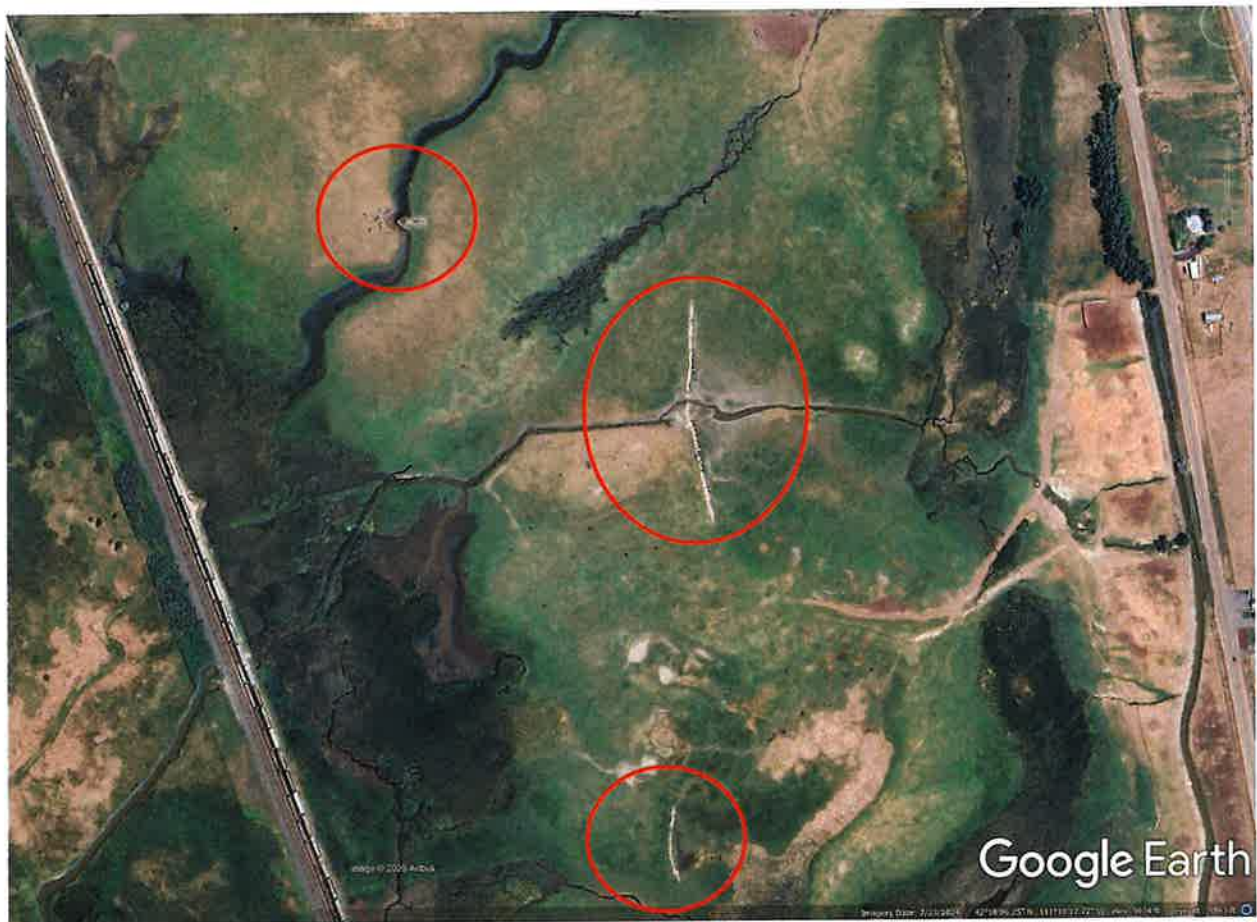
Image 4. Source: Google Earth.

On 9/4/2012 (Image 5), the northernmost embankment begins to erode from the west end where the overflow around the embankment is occurring. By 7/23/2024, the embankment is completely washed out, and the spring flow has reverted to its natural state. Whether this is a recurring issue or not, the stock water use here has remained consistent.
