## Accomplished Transfer Evidence 11-2041B

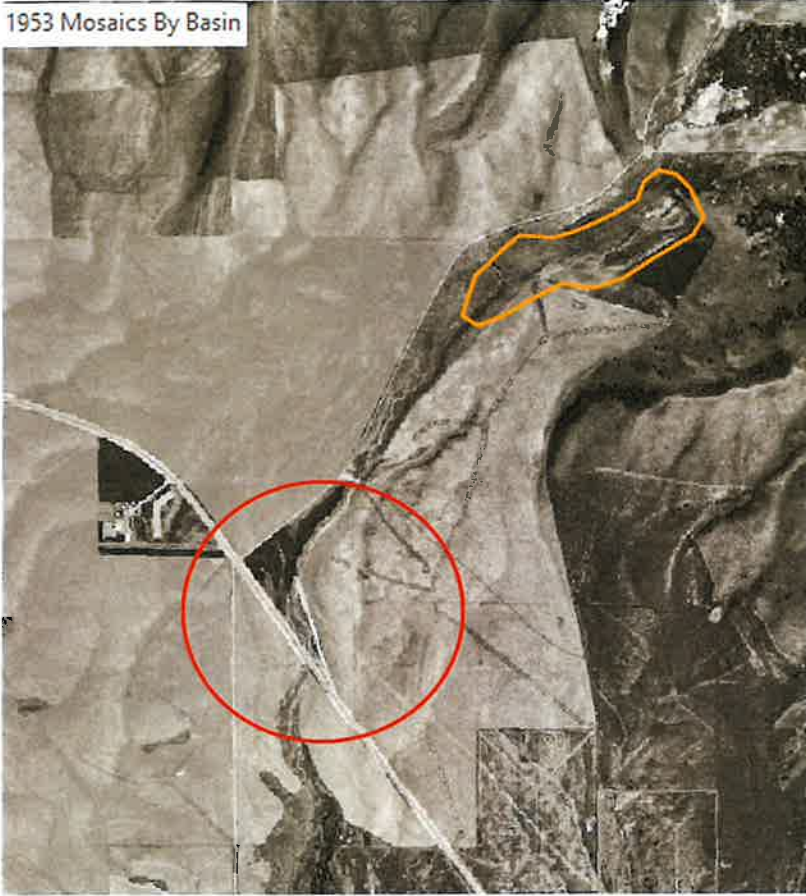
1953 Mosaics By Basin

Imagery from the IDWR 1953 Mosaic layer shows the Licensed POU (red outline) and accomplished transferred POU location (gold outline). In 1953 there are clear channels visible throughout the licensed POU indicating active irrigation.

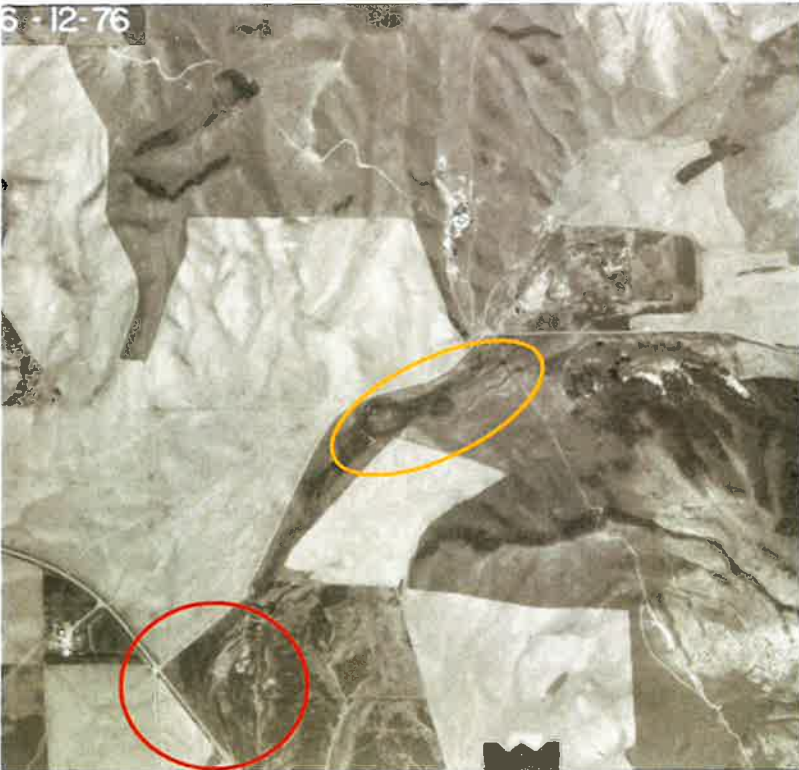
6-12-76

Imagery from USGS 1976 aerial imagery shows the Licensed POU (red outline) and accomplished transferred POU location (gold outline) shows no signs of beneficial use. This is supporting the claimant verbal statement during the office visit of the halting of use in 1975 due to the curtailing from the breaching of a dam upstream.

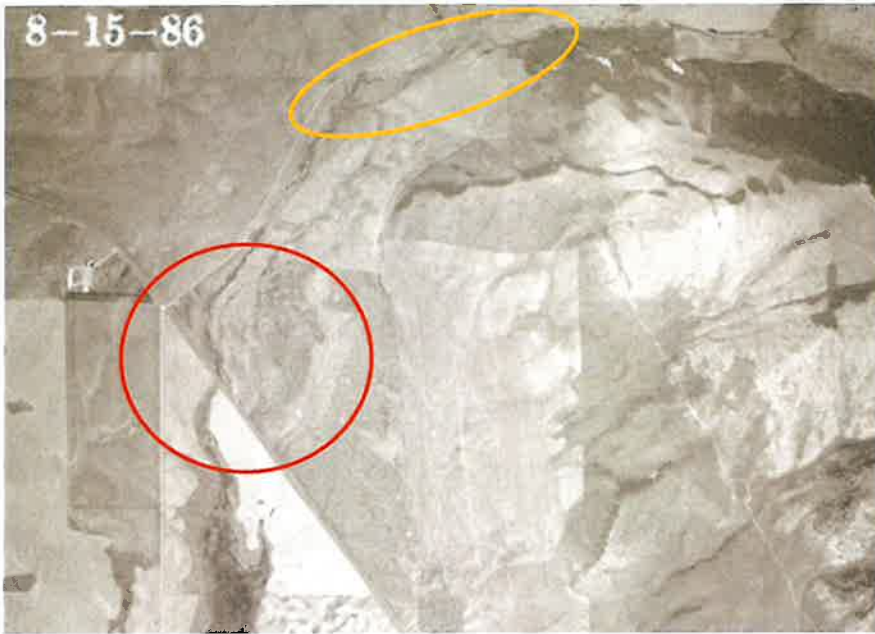
Imagery from USGS 1986 aerial imagery shows the Licensed POU (red outline) and accomplished transferred POU location (gold outline) continues to support the lack of use in the original POU area.

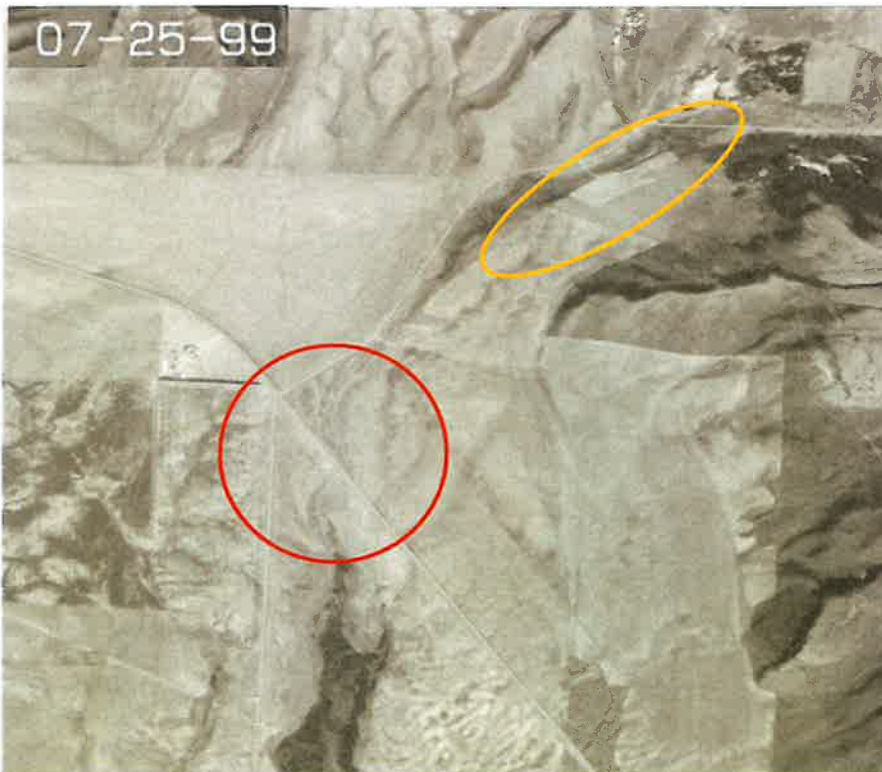
Imagery from USGS 1999 NAPP imagery shows the Licensed POU (red outline) and accomplished transferred POU location (gold outline) continues to support the lack of use in the original POU area and the continued development within the claimed transferred POU zone.

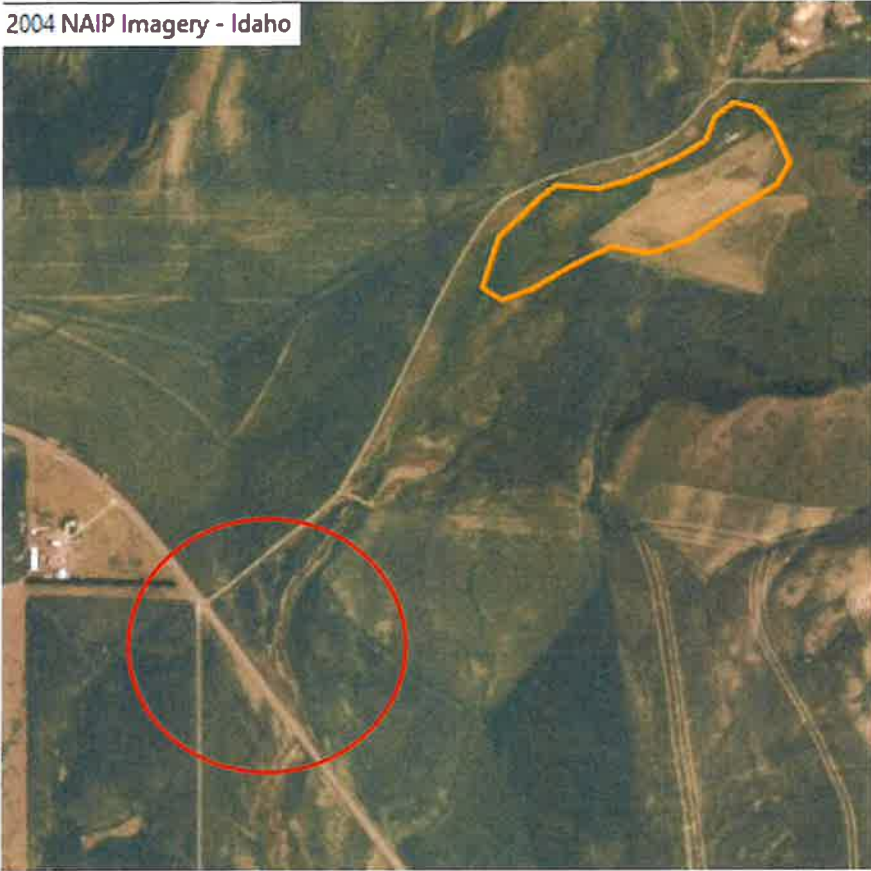
2004 NAIP Imagery - Idaho

Imagery from the IDWR 2024 NAIP layer continues to support the Licensed POU (Red outline) and the POU transferred POU location (Gold outline).
