STATE OF IDAHO  
DEPARTMENT OF WATER RESOURCES  
BENEFICIAL USE FIELD REPORT

**Permit No:** 63-33327  
**Exam Date:** 08/20/2021

Permit 63-33327 - Taylor

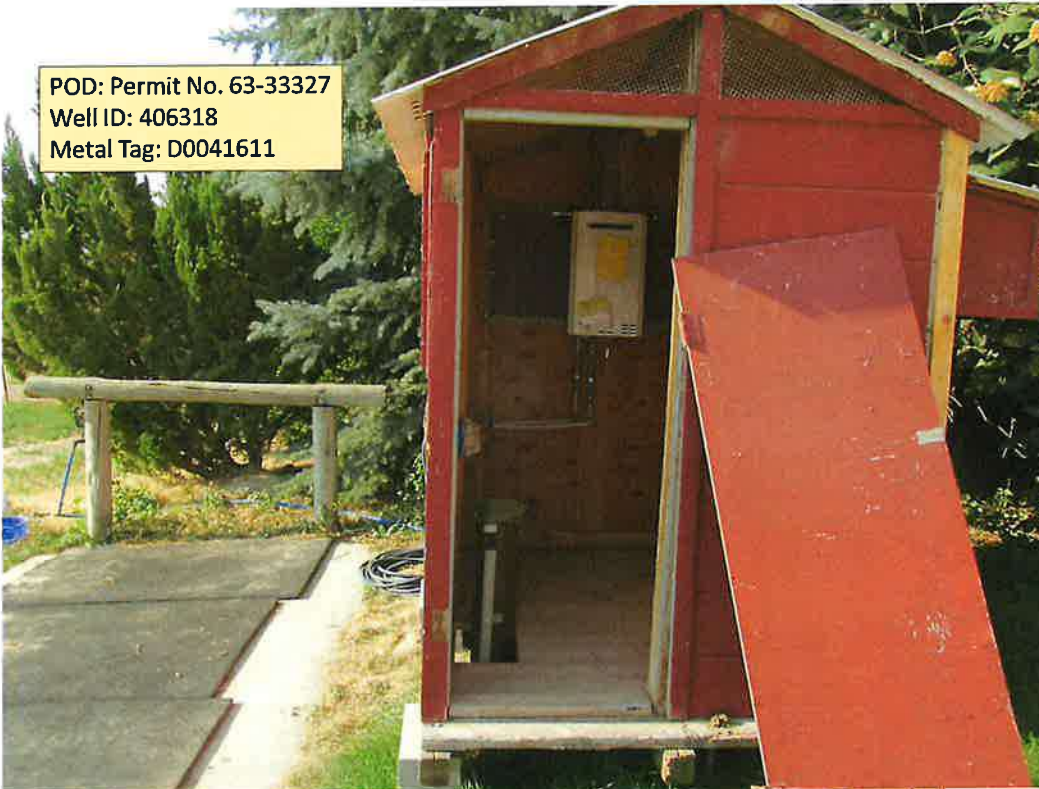
POD: Permit No. 63-33327  
Well ID: 406318  
Metal Tag: D0041611

(Top Left) Well that provides for domestic use and the point of diversion (POD) for irrigation through permit no. 63-33327.

Small water heater on back wall of the wellhouse provides water to wash livestock using the cement pad to the left (east) of the well house.

All other water use from the well is diverted through water tank that is in the outbuilding northwest of the home.

The point of a diversion (POD) for this permit is a well that was constructed in 2005 for domestic use at the home on the property (Well ID No. 406318, Metal Tag No. D0041611). The permit holder said that the well uses a 5 hp pump but did not have information on the make or model of the pump. The pump control box (located in the garage attached to the home on the property) is also labelled as having a 5 hp pump connected to the well.

Within the well house there is a water heater that provides water for cleaning horses on the cement pad next to the well house on the east side. All other water use from the well passes through a 119 gallon pressure tank (Make: Well-X-Trol; Model: WX-350) located in an outbuilding northwest of the home. The pressure tank provides water for domestic use at the home and for all of the irrigation on the property. The electrical control boxes for the well and the irrigation system for the yard are inside the garage attached to the home.

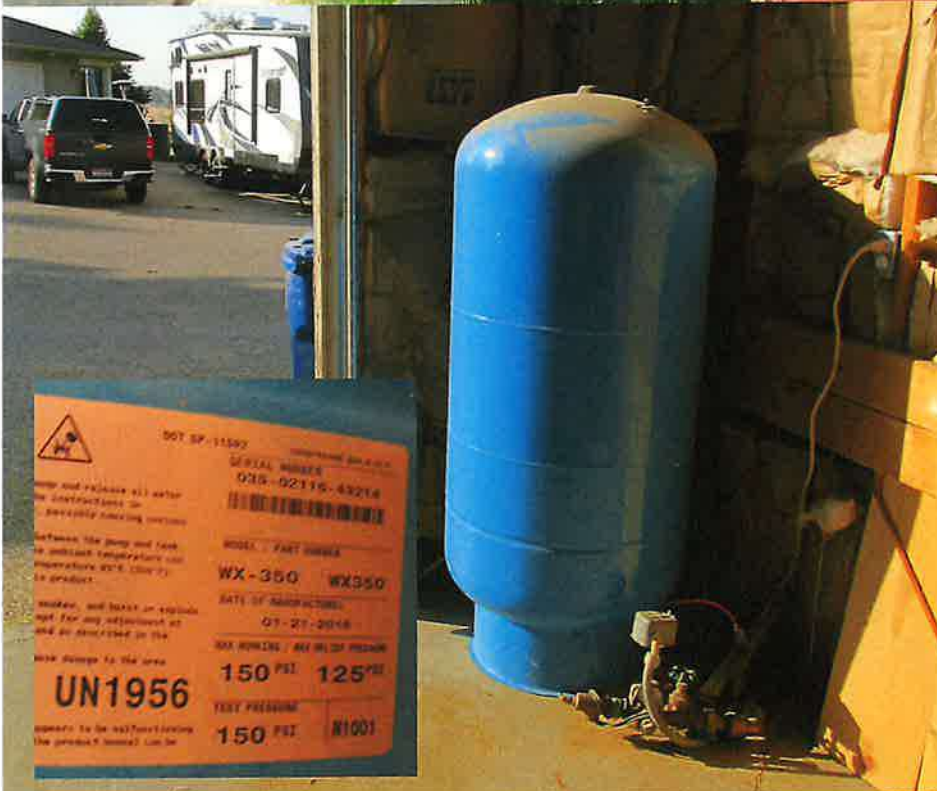
(Left) Photo facing southeast towards the home.

119 gal. pressure tank in outbuilding to the northwest of the home.

Inset photo includes information about the pressure tank:

- Make: Well-X-Trol
- Model: WX-350

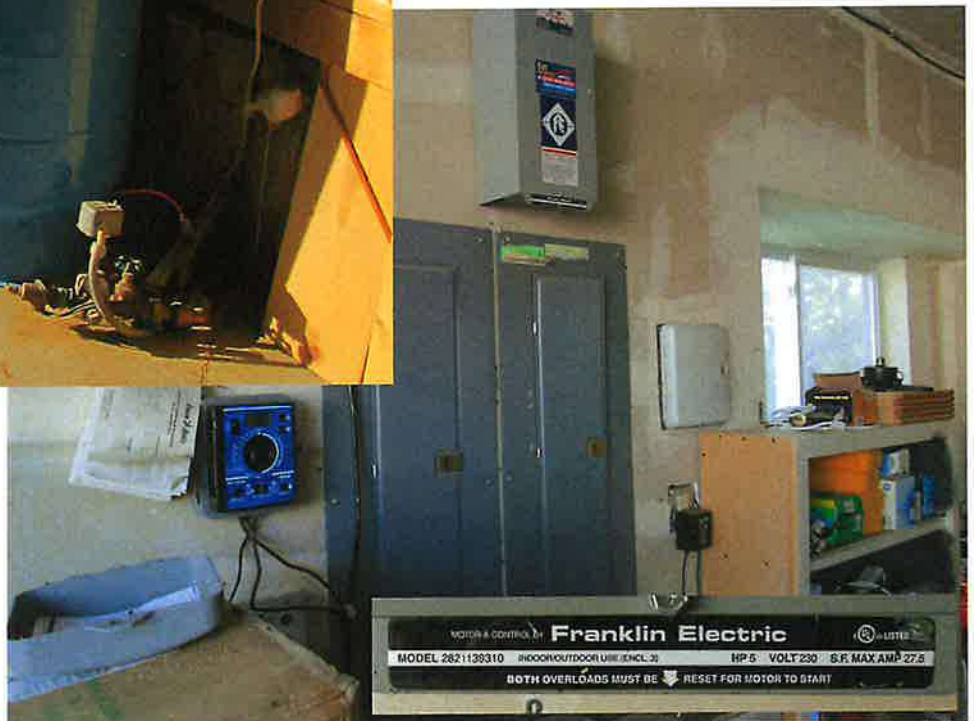
Control box: East

Both control boxes (above) are battery powered.

I was unable to measure the rate of diversion from the well directly because the mainlines diverting from the well are buried. The control boxes for the East and South pastures did not have batteries at the time of the visit and I was unable to verify the capacity of the pasture irrigation sprinklers while on site. 2.9 acres were irrigated during the development period. Although the sprinkler system was developed, the permit holder confirmed that the South pasture was not irrigated during any portion of the development period. A theoretical estimate of the diversion rate based on a 5 hp pump was used to calculate an estimated rate of diversion (See item E. "Flow Calculations" above).

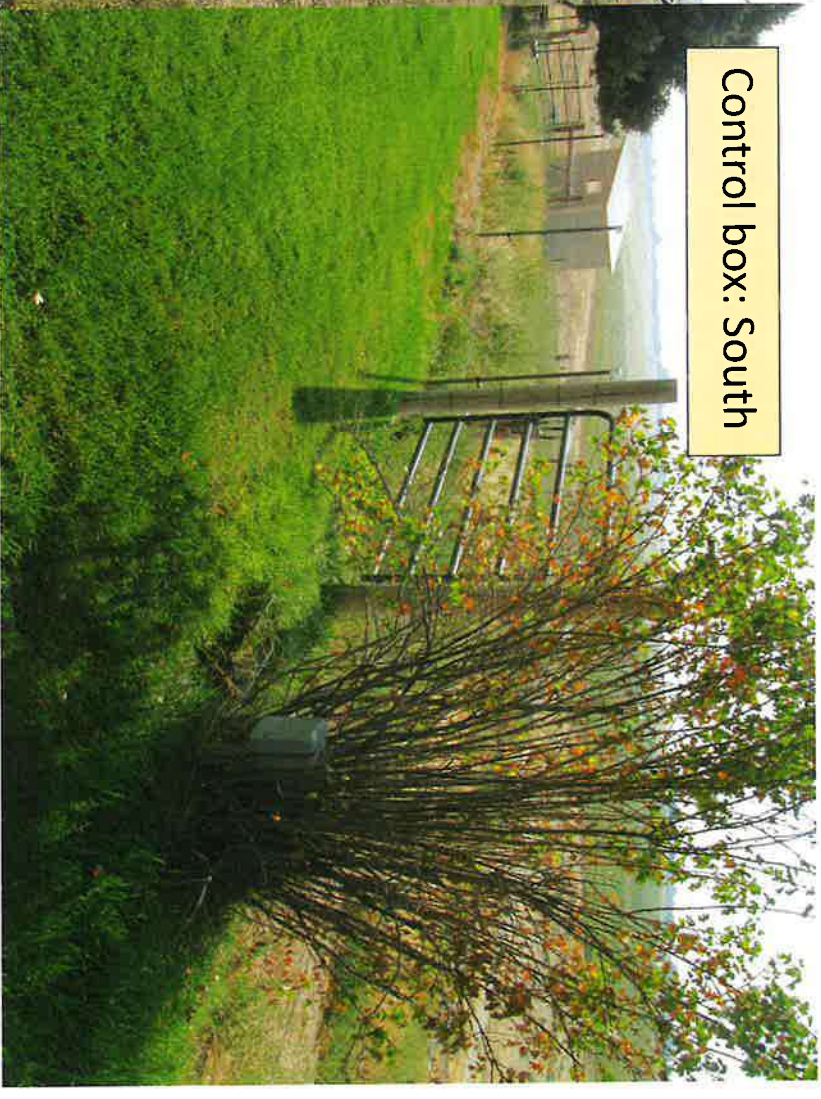
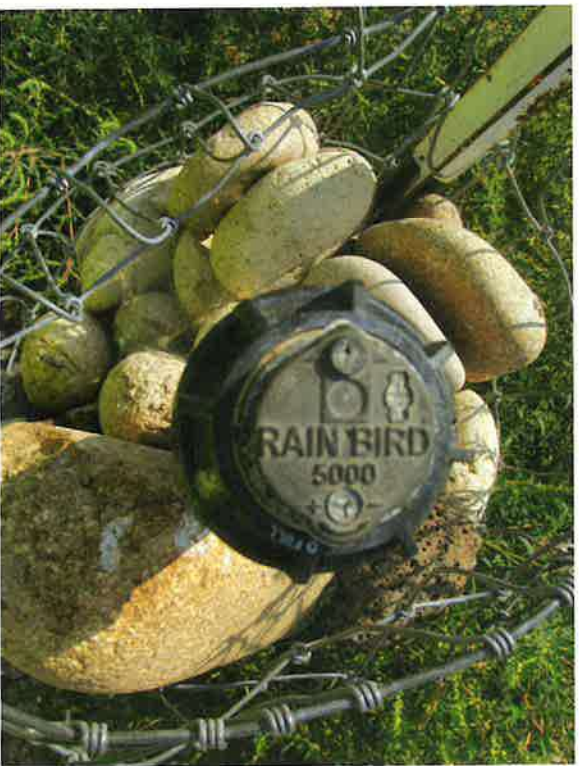
Permit No. 63-33327 – place of use includes  
irrigation of pasture

Combined, the east and south pastures have a total of 38  
sprinkler heads standing in protective cages filled with  
stone. The permit holder said that all the sprinkler heads  
are the same model as in the picture to the left.

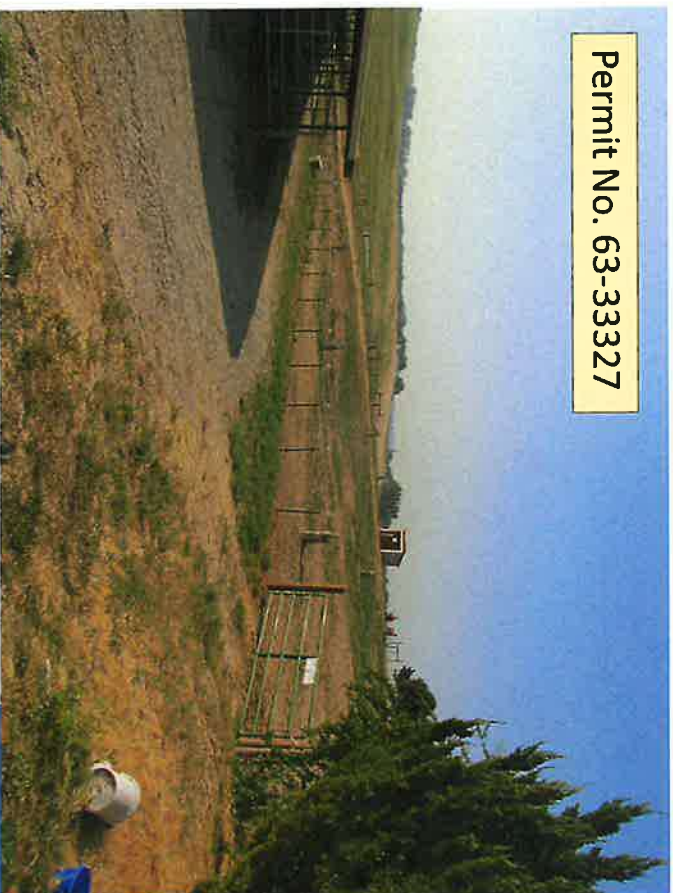
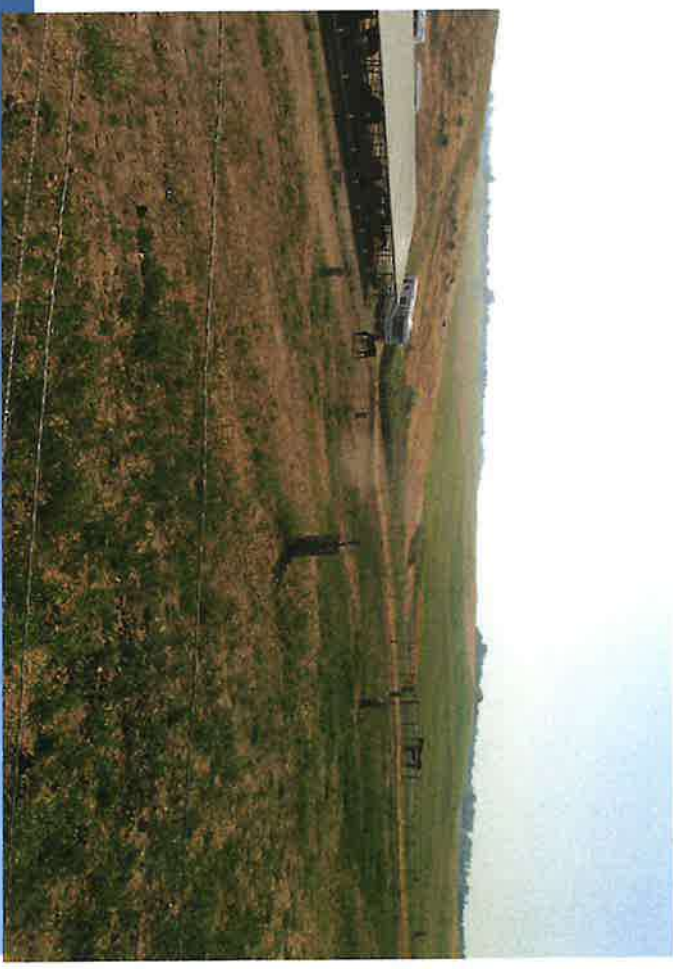
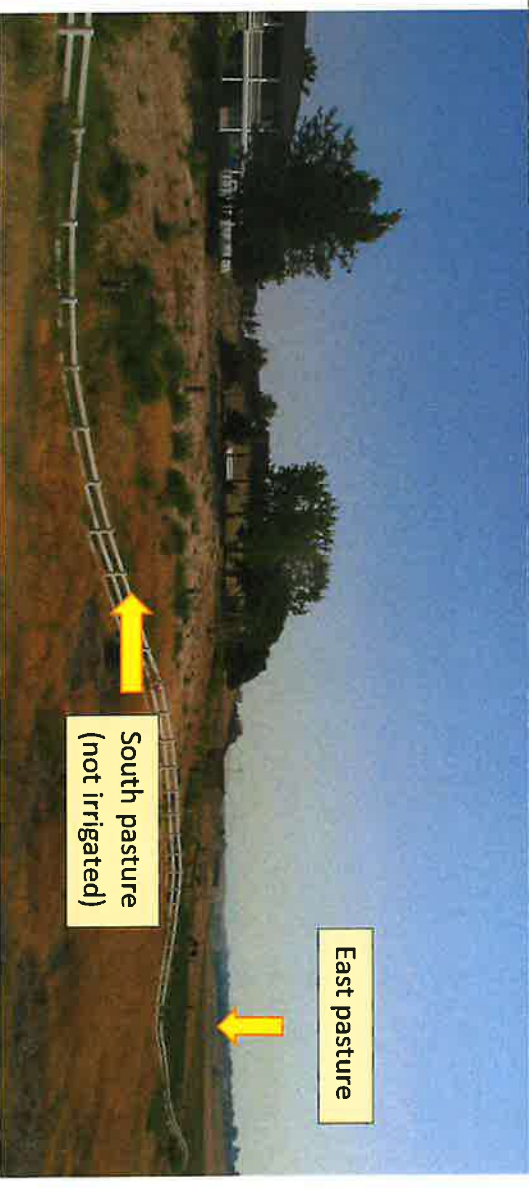
Permit No. 63-33327

**Top left:** East pasture – Photo taken next to well house.

**Top right:** East pasture – photo taken next to control box for east pasture. Rock stands supporting rainbirds are visible in middle.

**Bottom:** South pasture and home. Southern end of east pasture visible.

Yard around the home connected to same well and general diverting works.
