IDAHO DEPARTMENT OF  
**WATER RESOURCES**

**BRBA FIELD EXAMINATION REPORT**

**Claim Number: 11-4093**

**Exam Date: 09/09/2026**

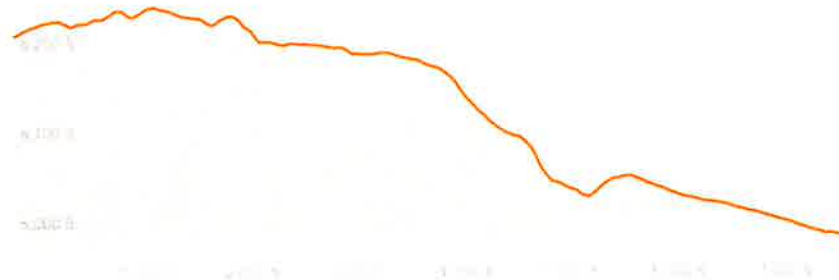
#### Ground

Length  
8,698.4 ft

Max  
6,247.1 ft

Gain  
97.1 ft

Avg  
6,123.9 ft

Loss  
324.9 ft

Max Slope  
↑ 7.6° ↓ 13.6°

Min  
5,985.6 ft

Avg Slope  
↑ 2.1° ↓ 2.8°

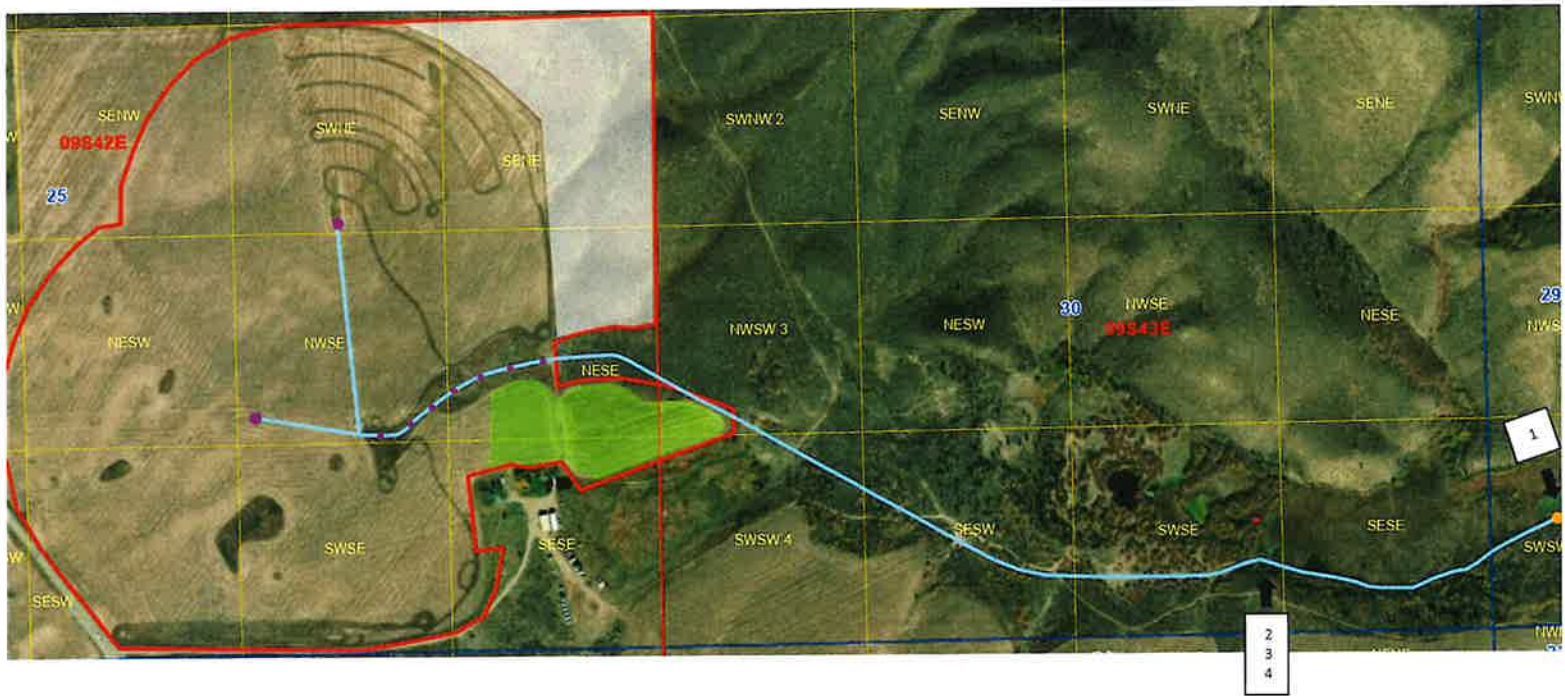
## System Map:

David opened the headgate and activated the system so agents could observe operation and take a measurement. Agents then traveled to the POU to inspect the risers shown on the map provided in this examination. These risers and associated hand lines irrigate portions of the POU that are not reached by the pivots.

Agents next visited the central pivot, where David turned on water at the pivot tower. Agents attempted to take an accurate in-pipe measurement but concluded that it was not possible. To take an accurate measurement the instrumentation would need to be installed on a section of pipe that was buried and inaccessible. David then drew the alignment of the buried pipe on a map, indicating how water is conveyed from the source to each of the pivots.

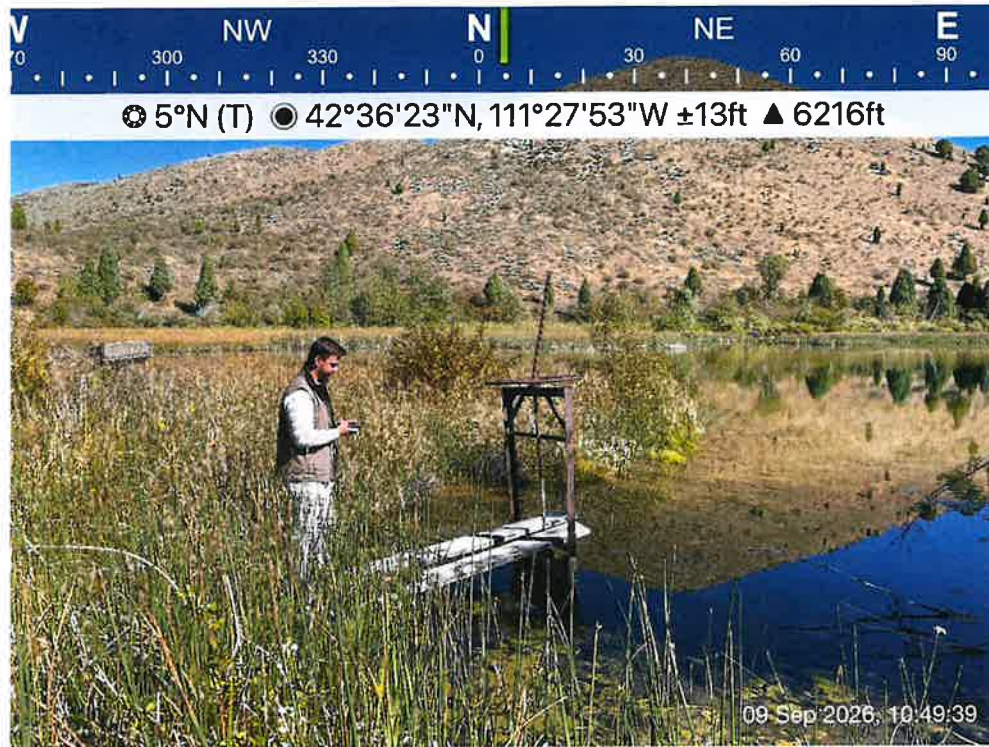
*Figure 1: Point of Diversion out of Lakey Reservoir.*

David then guided agents to the point of diversion (POD) and showed them Lakey Reservoir, which he reported was near its high-water mark. From the reservoir, water is diverted through a headgate (Figure 1) into a canal. The canal runs west to a second headgate (Figure 2), which diverts water into a concrete structure that captures and regulates the flow (Figure 3). The water then passes over a debris-screening surface and enters a 12-inch pipe (Figure 4). The system is gravity-fed to the POU.

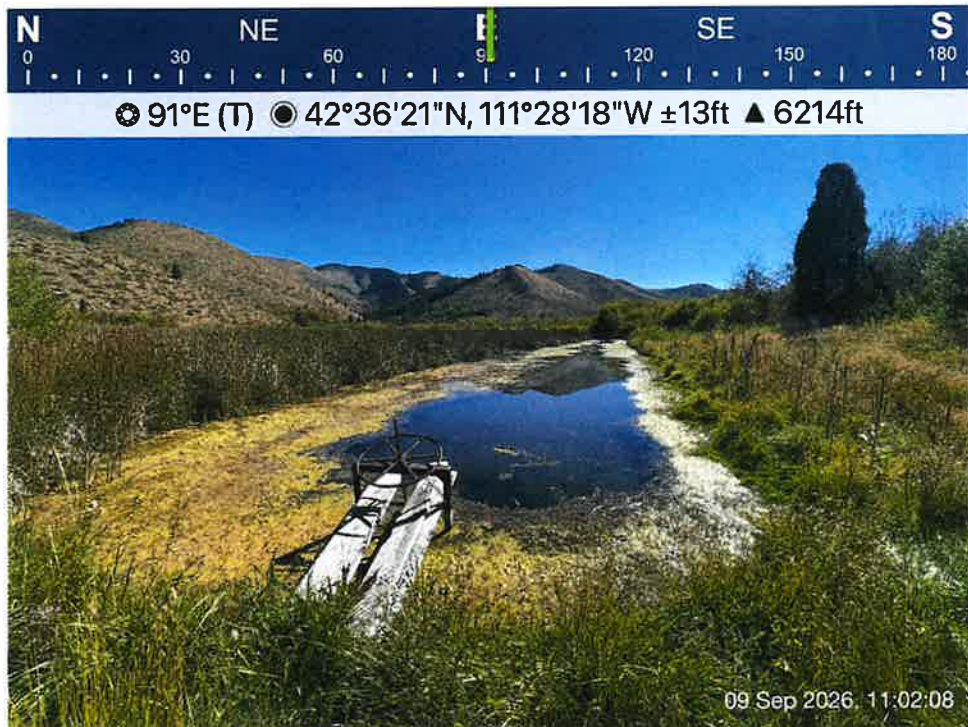
*Figure 2: Second headgate that diverts water from the canal to a screen.*

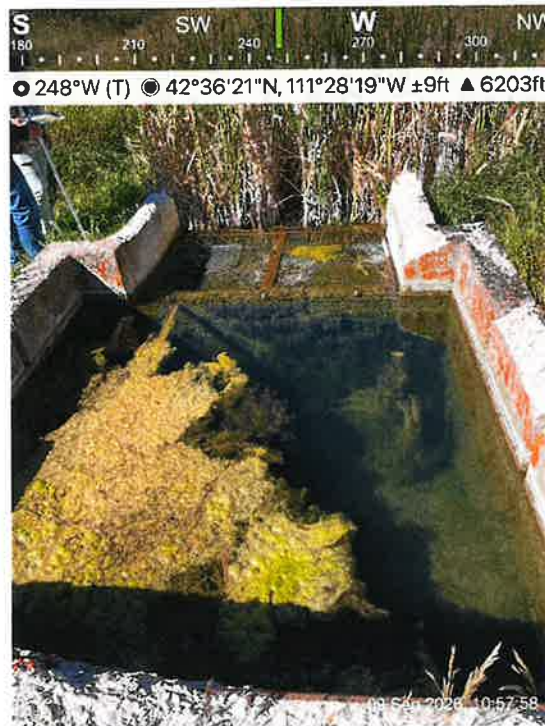
Figure 3: Screen that transfers the water to a pipe. This water is supplied by the headgate in figure 2.

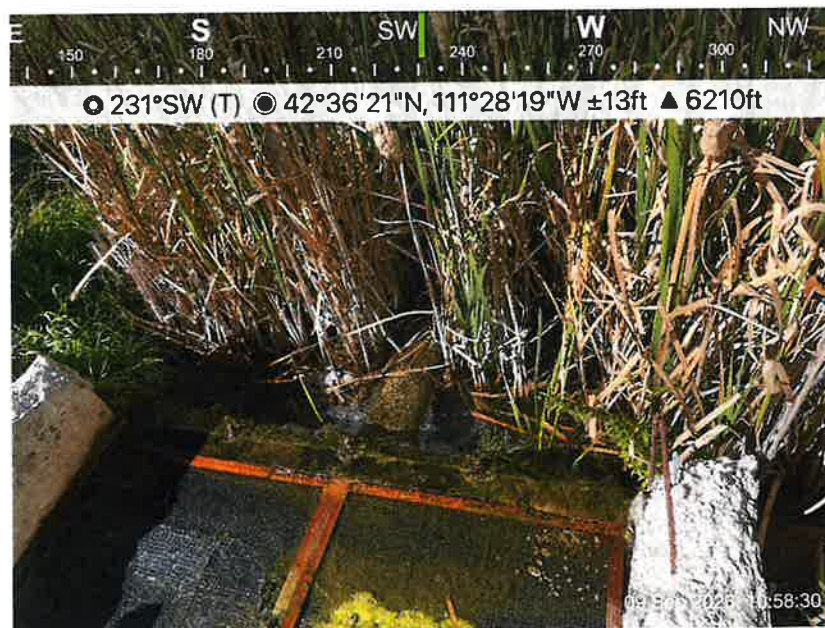
Figure 4: Pipe that takes the water from the screen in Figure 3.
