# Claim 11-7791 Use Evidence

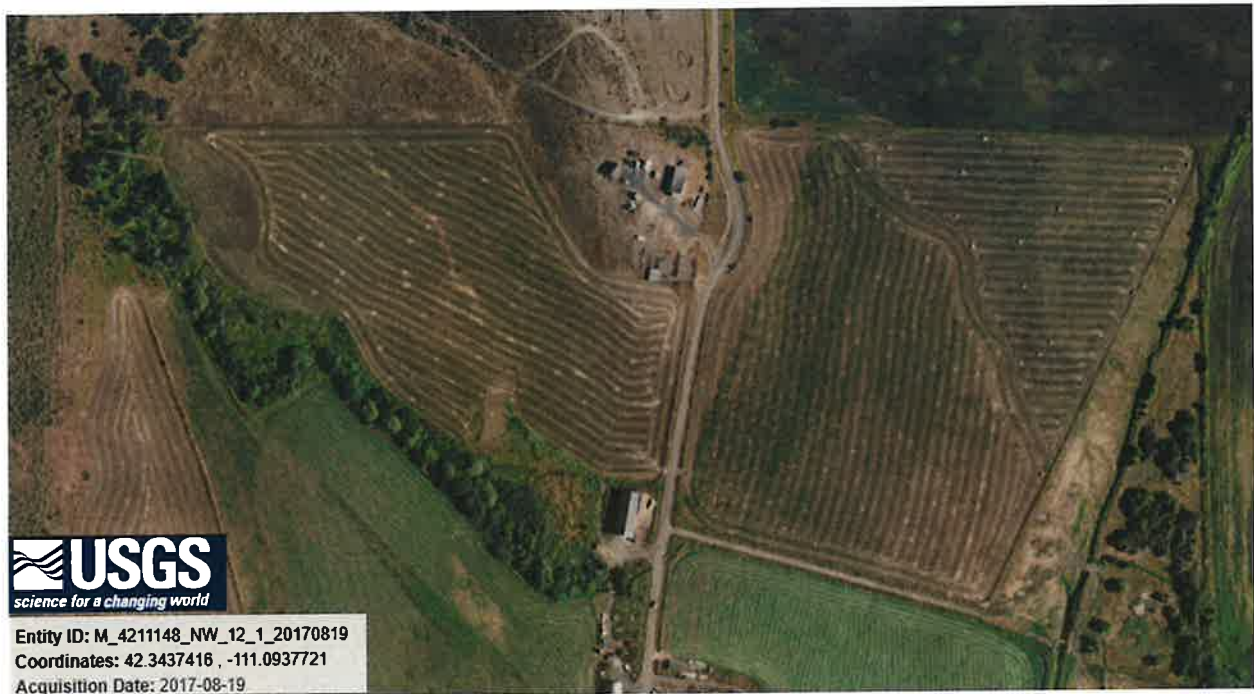
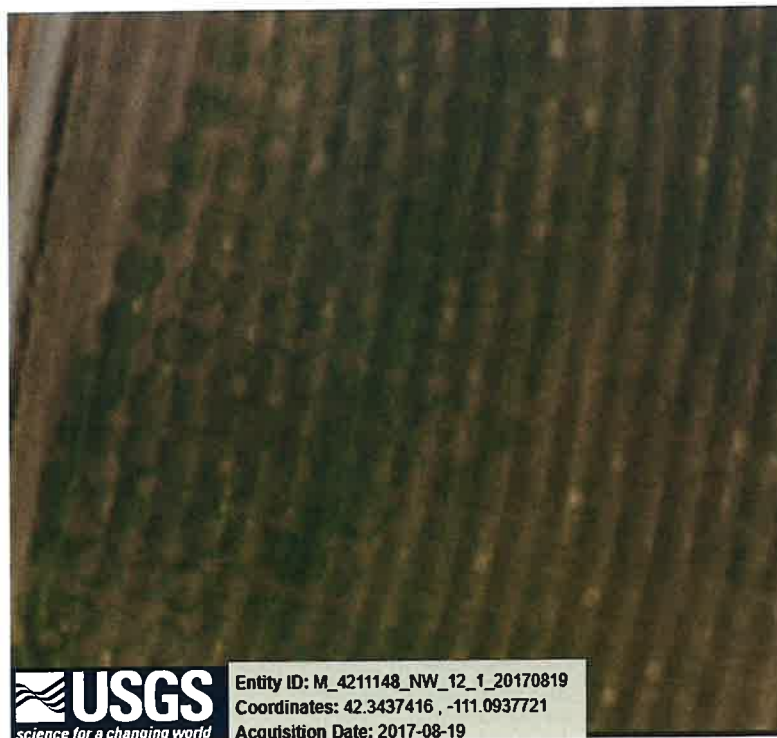
2017 NAIP imagery from USGS shows series of evenly spaced, circular patterns arranged in rows across the eastern field. The circles appear uniform and distributed in a regular grid-like arrangement.

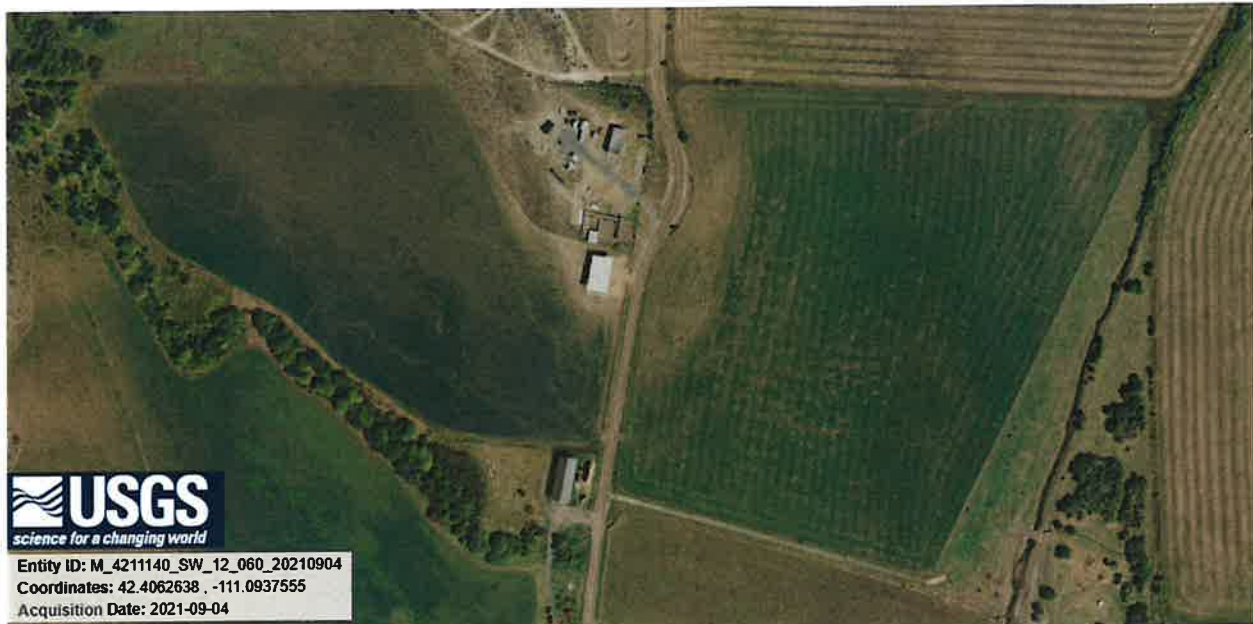
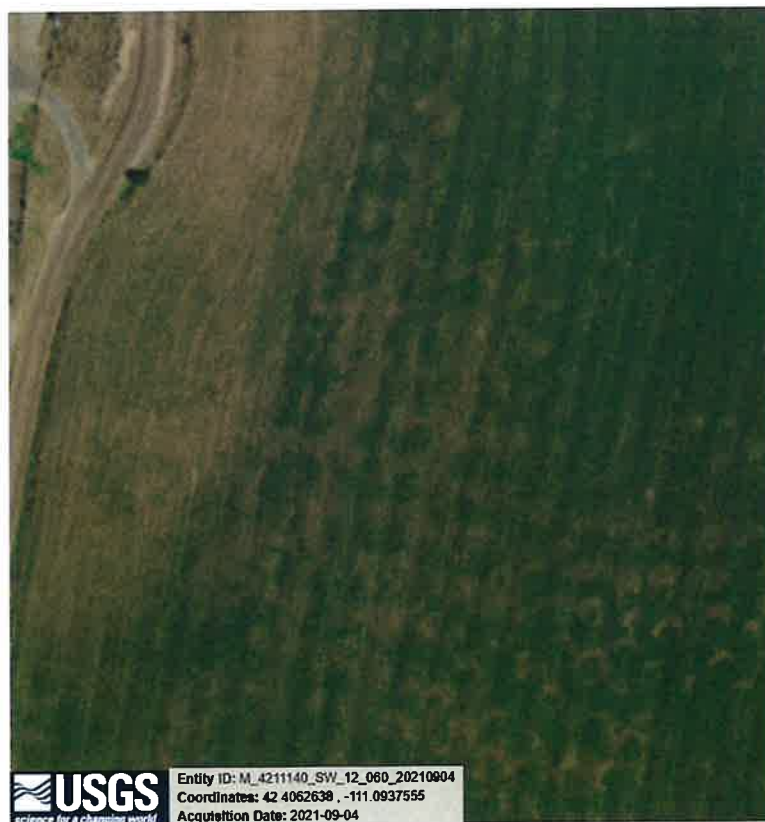
2021 NAIP imagery from USGS shows repeated spot-like patterns resemble zones that received slightly different amounts of water. The spot-like patterns are a semi-regular arrangement that consists of overhead sprinkler activity.
