## MEMORANDUM

**Re:** Water District 63-C, 2014 Cat Creek, Little Camas Creek Measurements, Basin 63

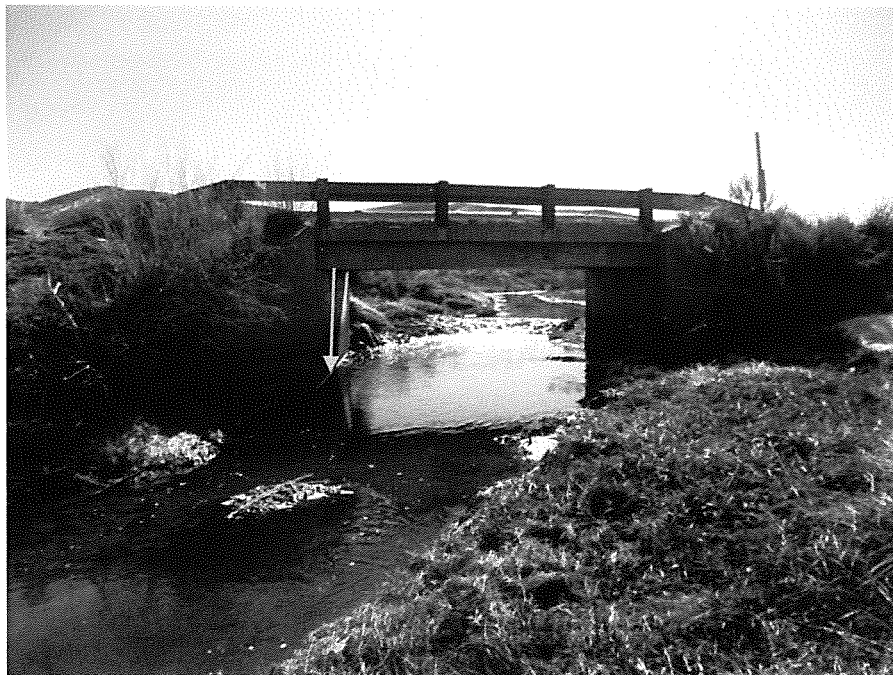
Cat Creek Bridge crossing, 3/19/2014. Looking east. FlowTracker measurements typically done about where photo is taken from relative to the bridge. Depth measurement consistently taken at spot arrow above points to.

**Cat Creek:** Measurements were taken at the bridge over the creek off Wood Creek Road. A total of eight site visits were made between 3/19/2014 thru 5/23/2014.

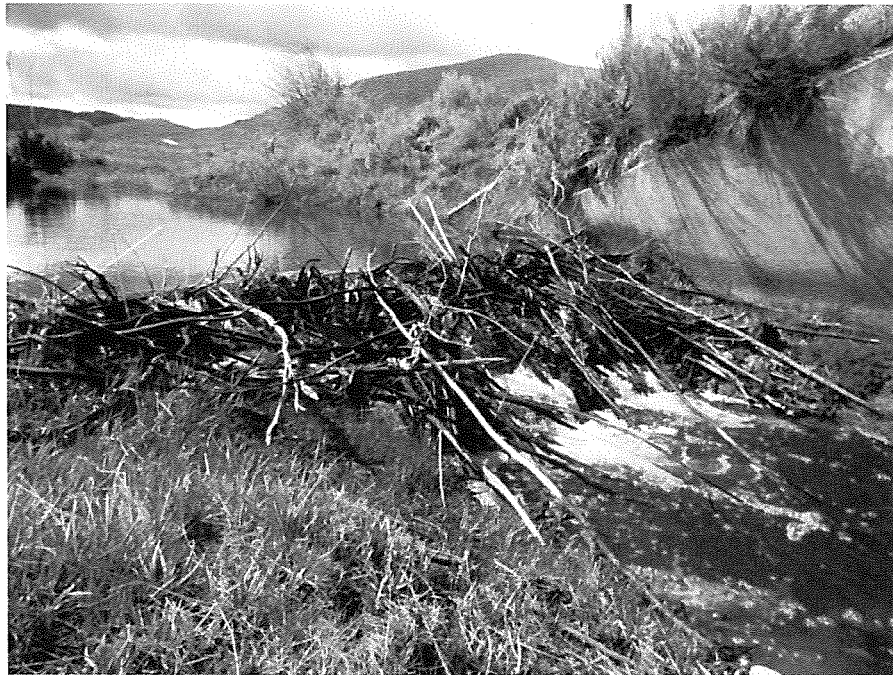
Flows varied from a high of 5.5 cfs to a low of 0.7 cfs. Inches in depth varied from a high of 15 inches to 7 inches at the bridge. Should be noted beavers did cause variations in flow. Below is a picture taken just on the east side of the bridge. The beaver dam was constructed within a week. Photo taken 5/9/2014.

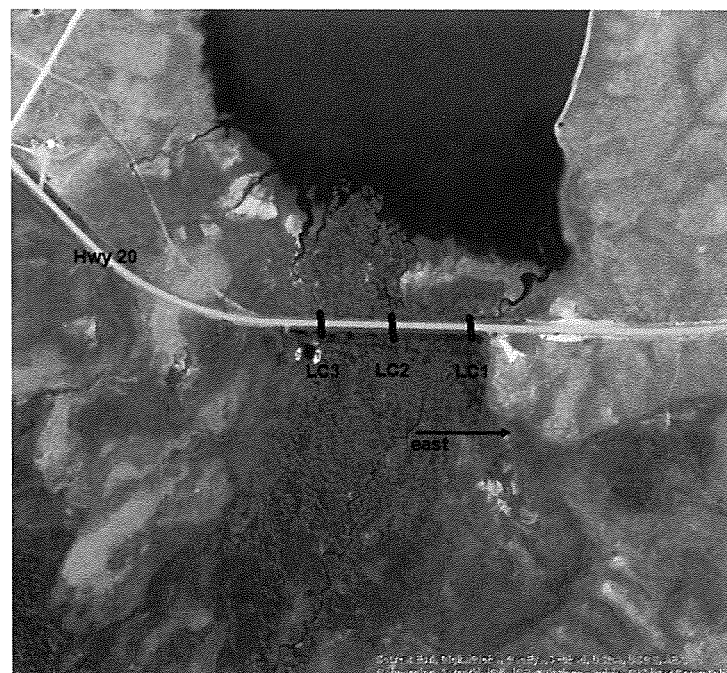
**Little Camas Creek:** Eight measurements were taken at Little Camas Creek, done at 3 points/culverts that pass under Highway 20. Culverts designated as **LC1**, **LC2**, and **LC3**. The rating curve developed was an average of the three culverts. As with Cat Creek, beaver construction obstructed/altered flows between measurements.

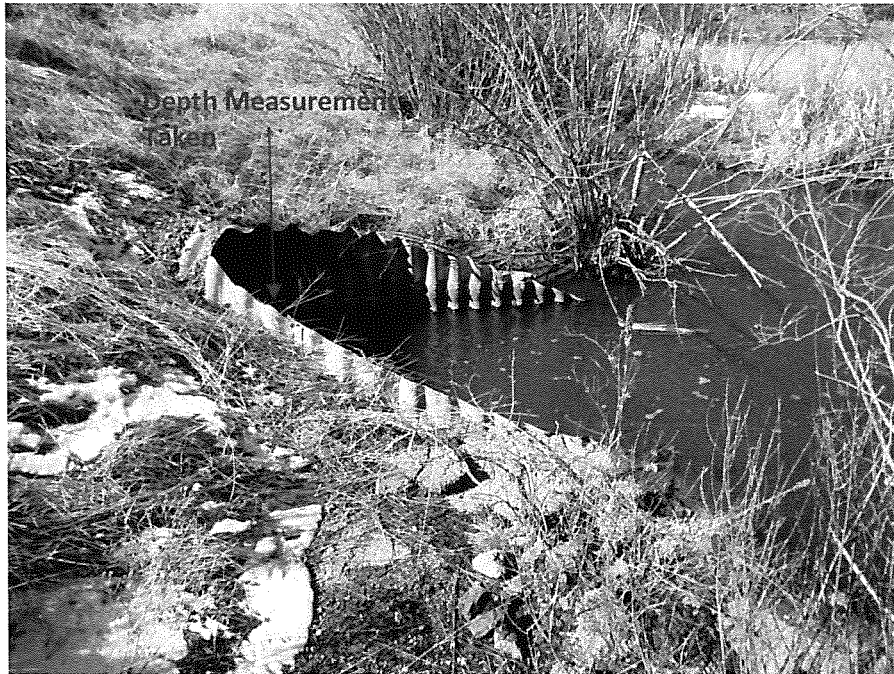
**LC1:** This culvert of the three was typically the highest flowing. FlowTracker measurements were done on a point in the creek about 100' from where water exited the culvert. Depth measurement was made at the very center of the end of the culvert (picture below).

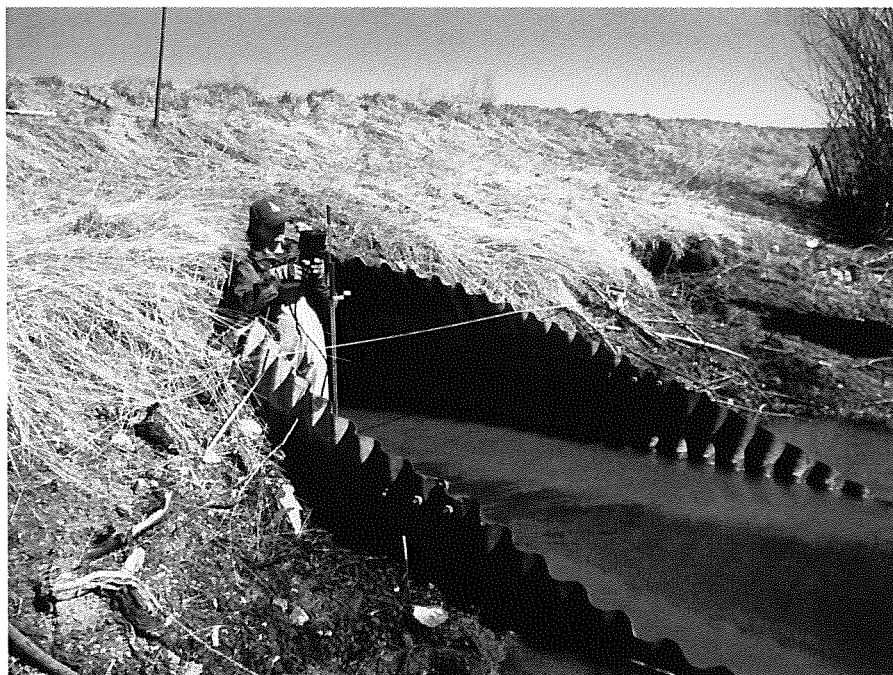
**LC2:** FlowTracker measurements were done at the beginning of the culvert on the south side of the road. Depth measurements were made at the same spot (picture below).

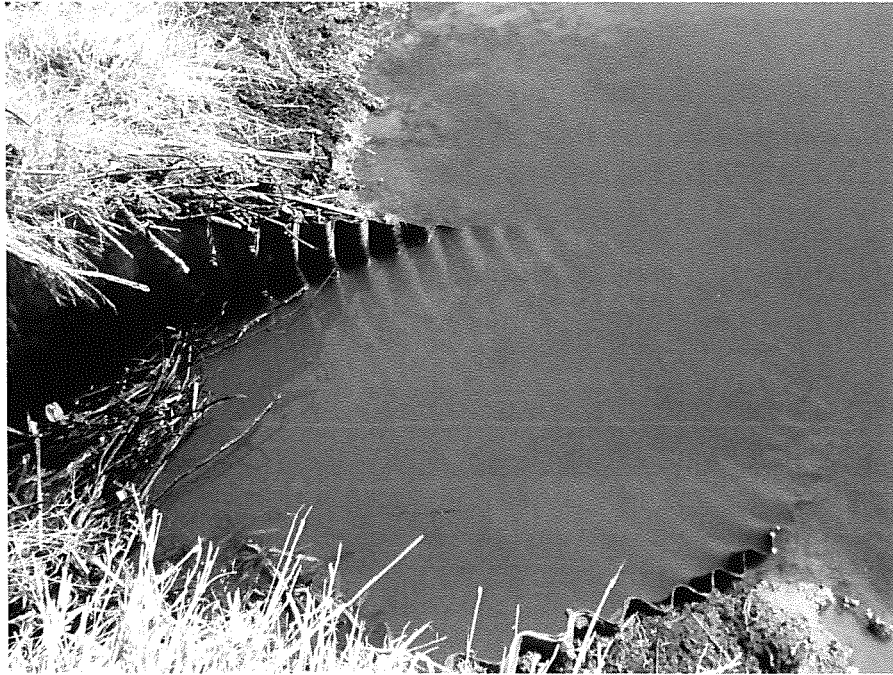
**LC3:** This culvert was typically the lowest flowing. FlowTracker measurements were done at the beginning of the culvert on the south side of the road. Depth measurements were made at the same spot (picture below). Note the beaver work in the culvert.

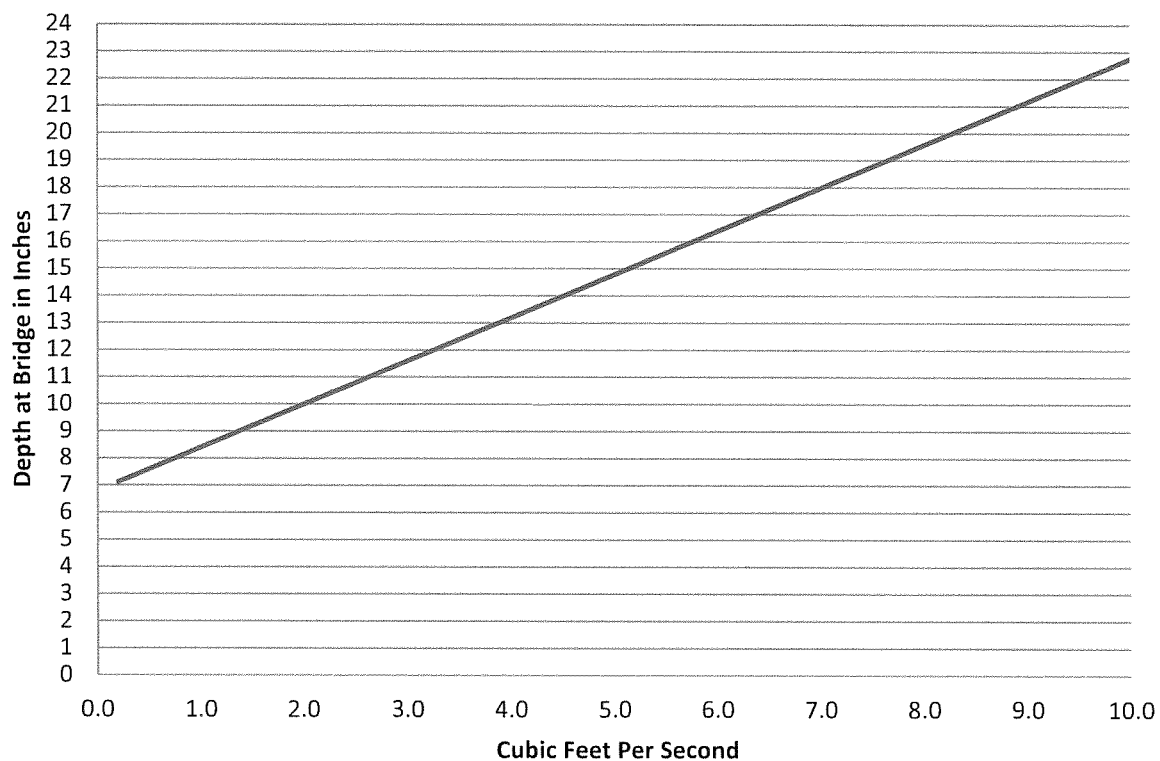
### Cat Creek at Wood Creek Road Bridge

The primary inflows to the reservoir are Cat Creek and Little Camas Creek. Goal of the field work request is to establish a rating curve versus structure flow depth for both sources of inflows to the reservoir. The rating curve will help the watermaster of Sub-District 63-C quickly ascertain inflows from both sources. The rating curve was developed by determining a set location at each creek and 1) use a FlowTracker meter to get a cfs value 2) get a depth reading in inches. This will allow a quick estimate of cfs from a depth reading. Rating curves attached to this memo. **These rating curves should not be considered precise - estimates only.**
