RE: Delivery of Pomerelle Diversion

Memo

Subject: Field Visit to Pomerelle Ski Area diversion for 45-04114

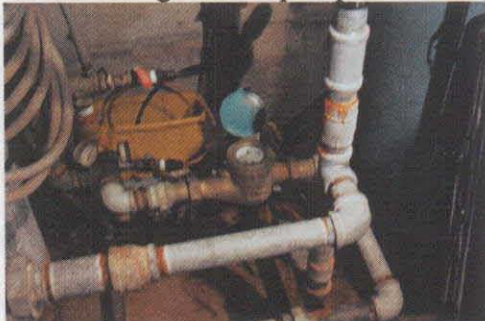
After the tee to the reservoir, water continues down the pipe and over to an iodine injection site then to a pressure tank then back out through the meter and then to the distribution line for uses at the lodge and residences. All water currently used in these facilities is metered. Mr. Anderson has provided copies of the records since 1997. The attached spreadsheet is based on his records. Note that the meter totalizes water use and reads out in hundreds of gallons. We took a reading of 08443. The previously recorded reading was 08442 on 5/5 indicating a use of 100 gallons in 11 days. During this inspection John flushed toilets and turned on water and the meter moved and appeared to be in good operating condition.

-I recommend that the watermaster be instructed to monitor the use using the existing meter and require Andrwood &/or the USFS to make the records available. The meter record

should be logged by Andrwood &/or the USFS at least weekly through the summer months.
