head Guy  
peterston weir

Guy  
Peterson's

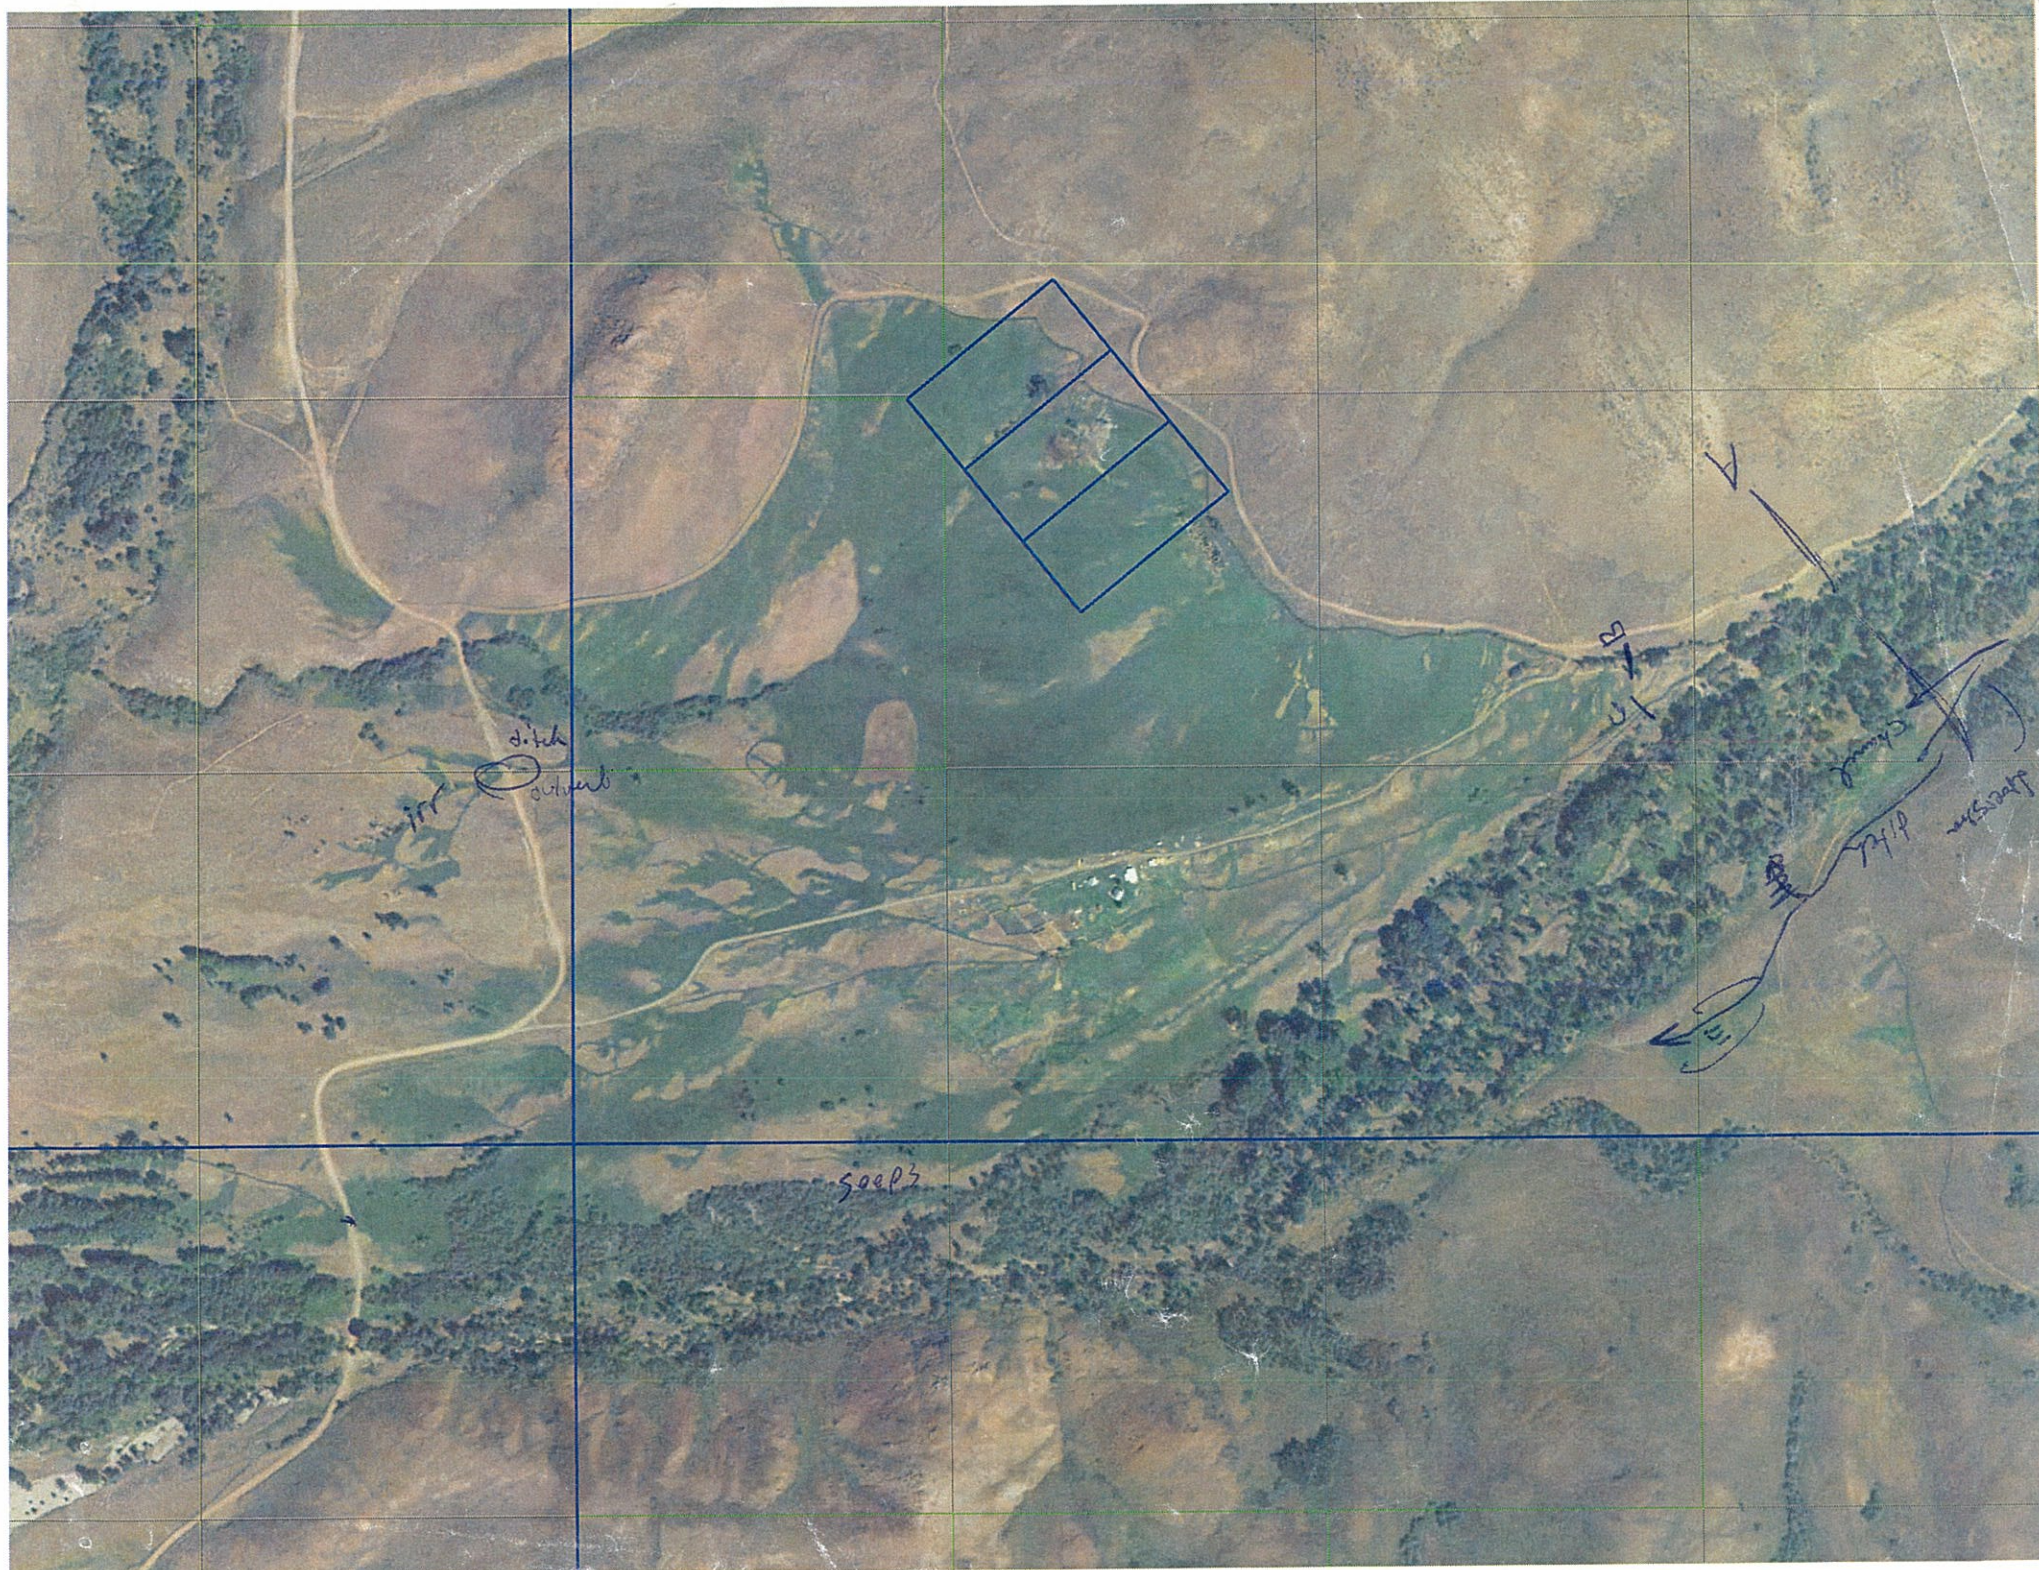
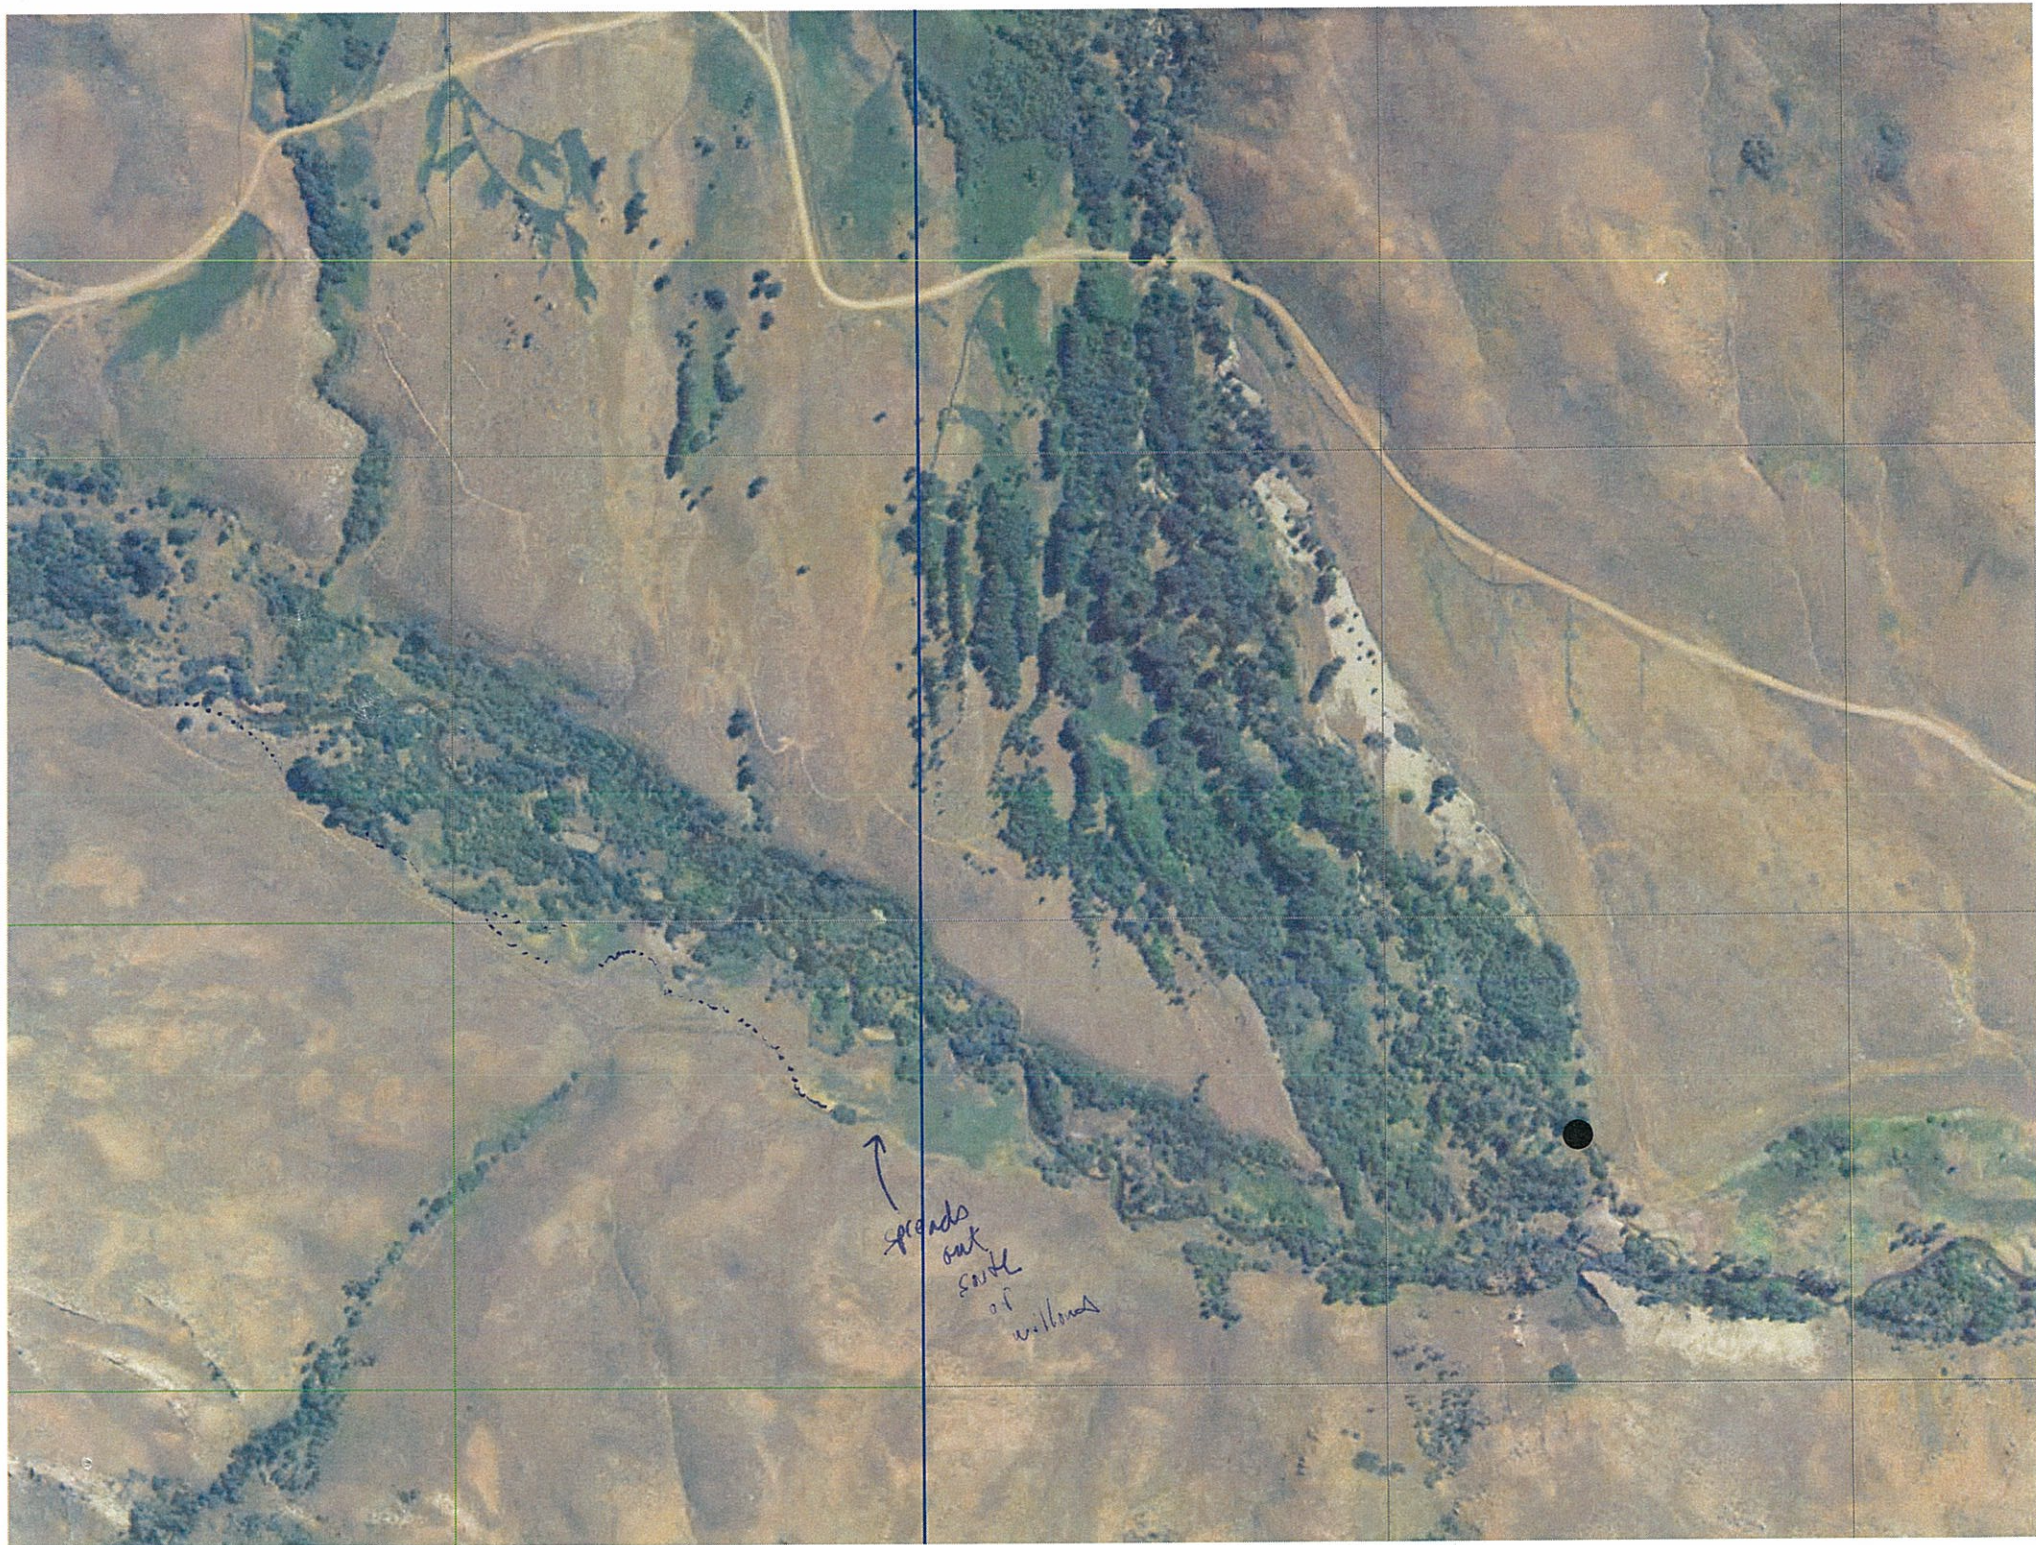
Guy Peterson's diversion 2:57 pm shut off

looks like it had been recently shut  
off

flow leaking ~~are~~ under measuring  
device
