Clayton Fullmer, Water Master
North side Badger Creek diversion near Felt, ID.
4/15/2004 3:57:28 PM

Source: Badger Creek Trib to: Teton River

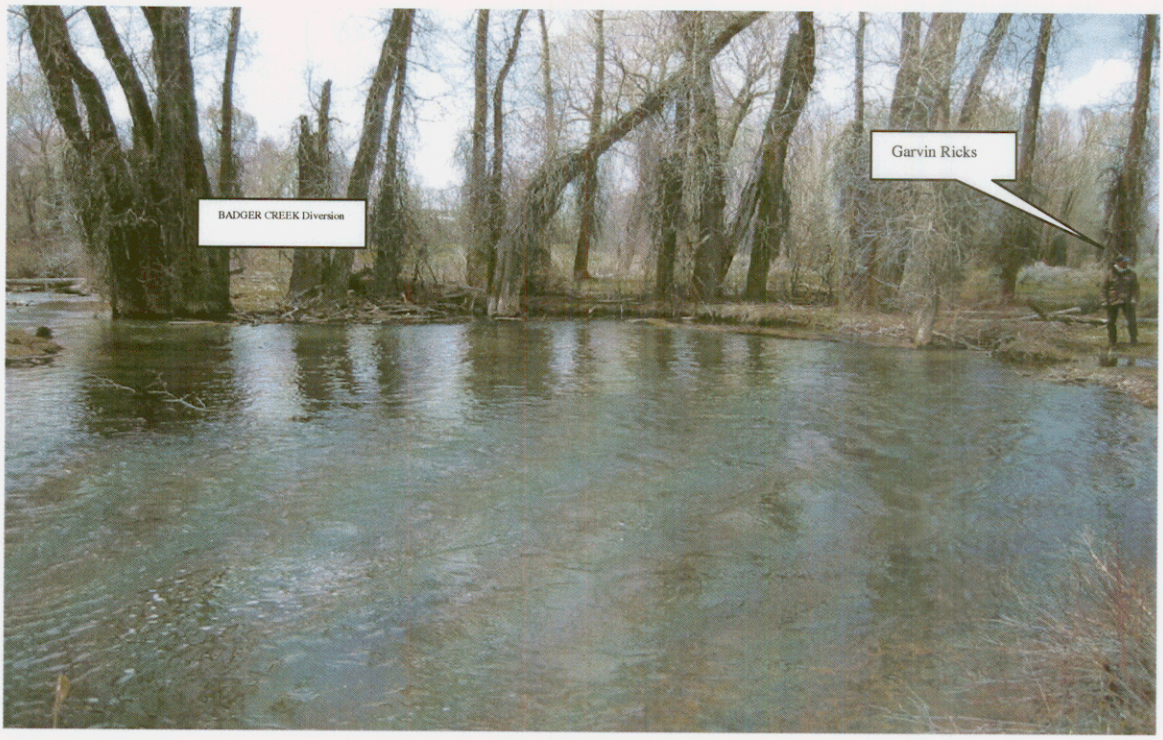
Tag # NO TAG Location: _____

THIS IS WHERE THE CHANNEL OF BADGER CR IS BLOCKED OF TO FORCE WATER INTO BACK CHANNELS FOR FLOOD IRR'S DURING HIGH WATER
