RENDEZVOUS ENGINEERING, P.C.
Civil Engineers and Planners in Wyoming and Idaho

RE: Lapsed Permit No. 22-13178 / Teton Springs

Attached per our discussions and your previous request are additional information and records in support of the Teton Springs permit 22-13178.

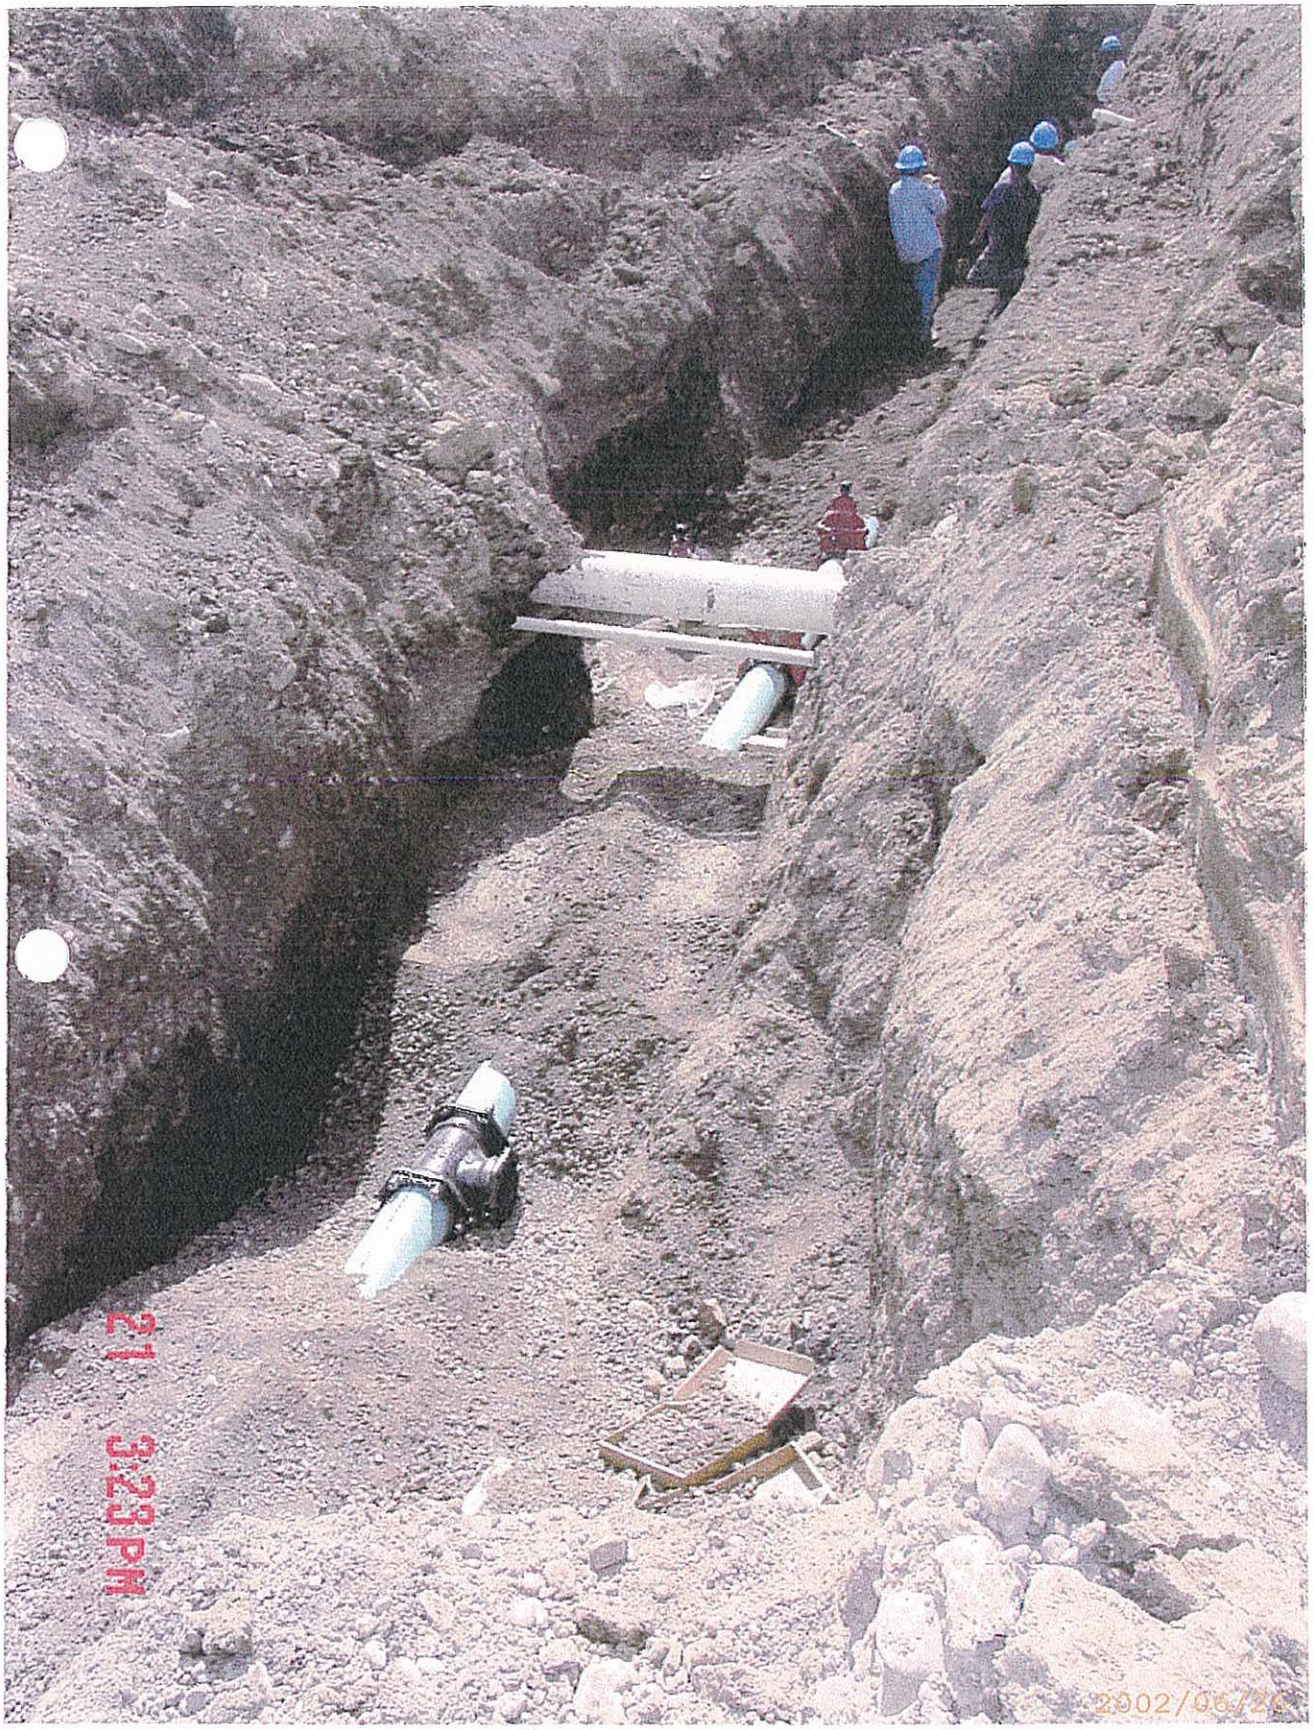
WATER MAIN "A" STA 35+31 SEWER XING W/ 12" Ø SLEEVE 6/02

WATER MAIN "A" STA 35+31 AT SEWER MAIN XING
WATER MAIN SLEEVED W/ 12"Ø PVC W/ THRUST BLOCKS

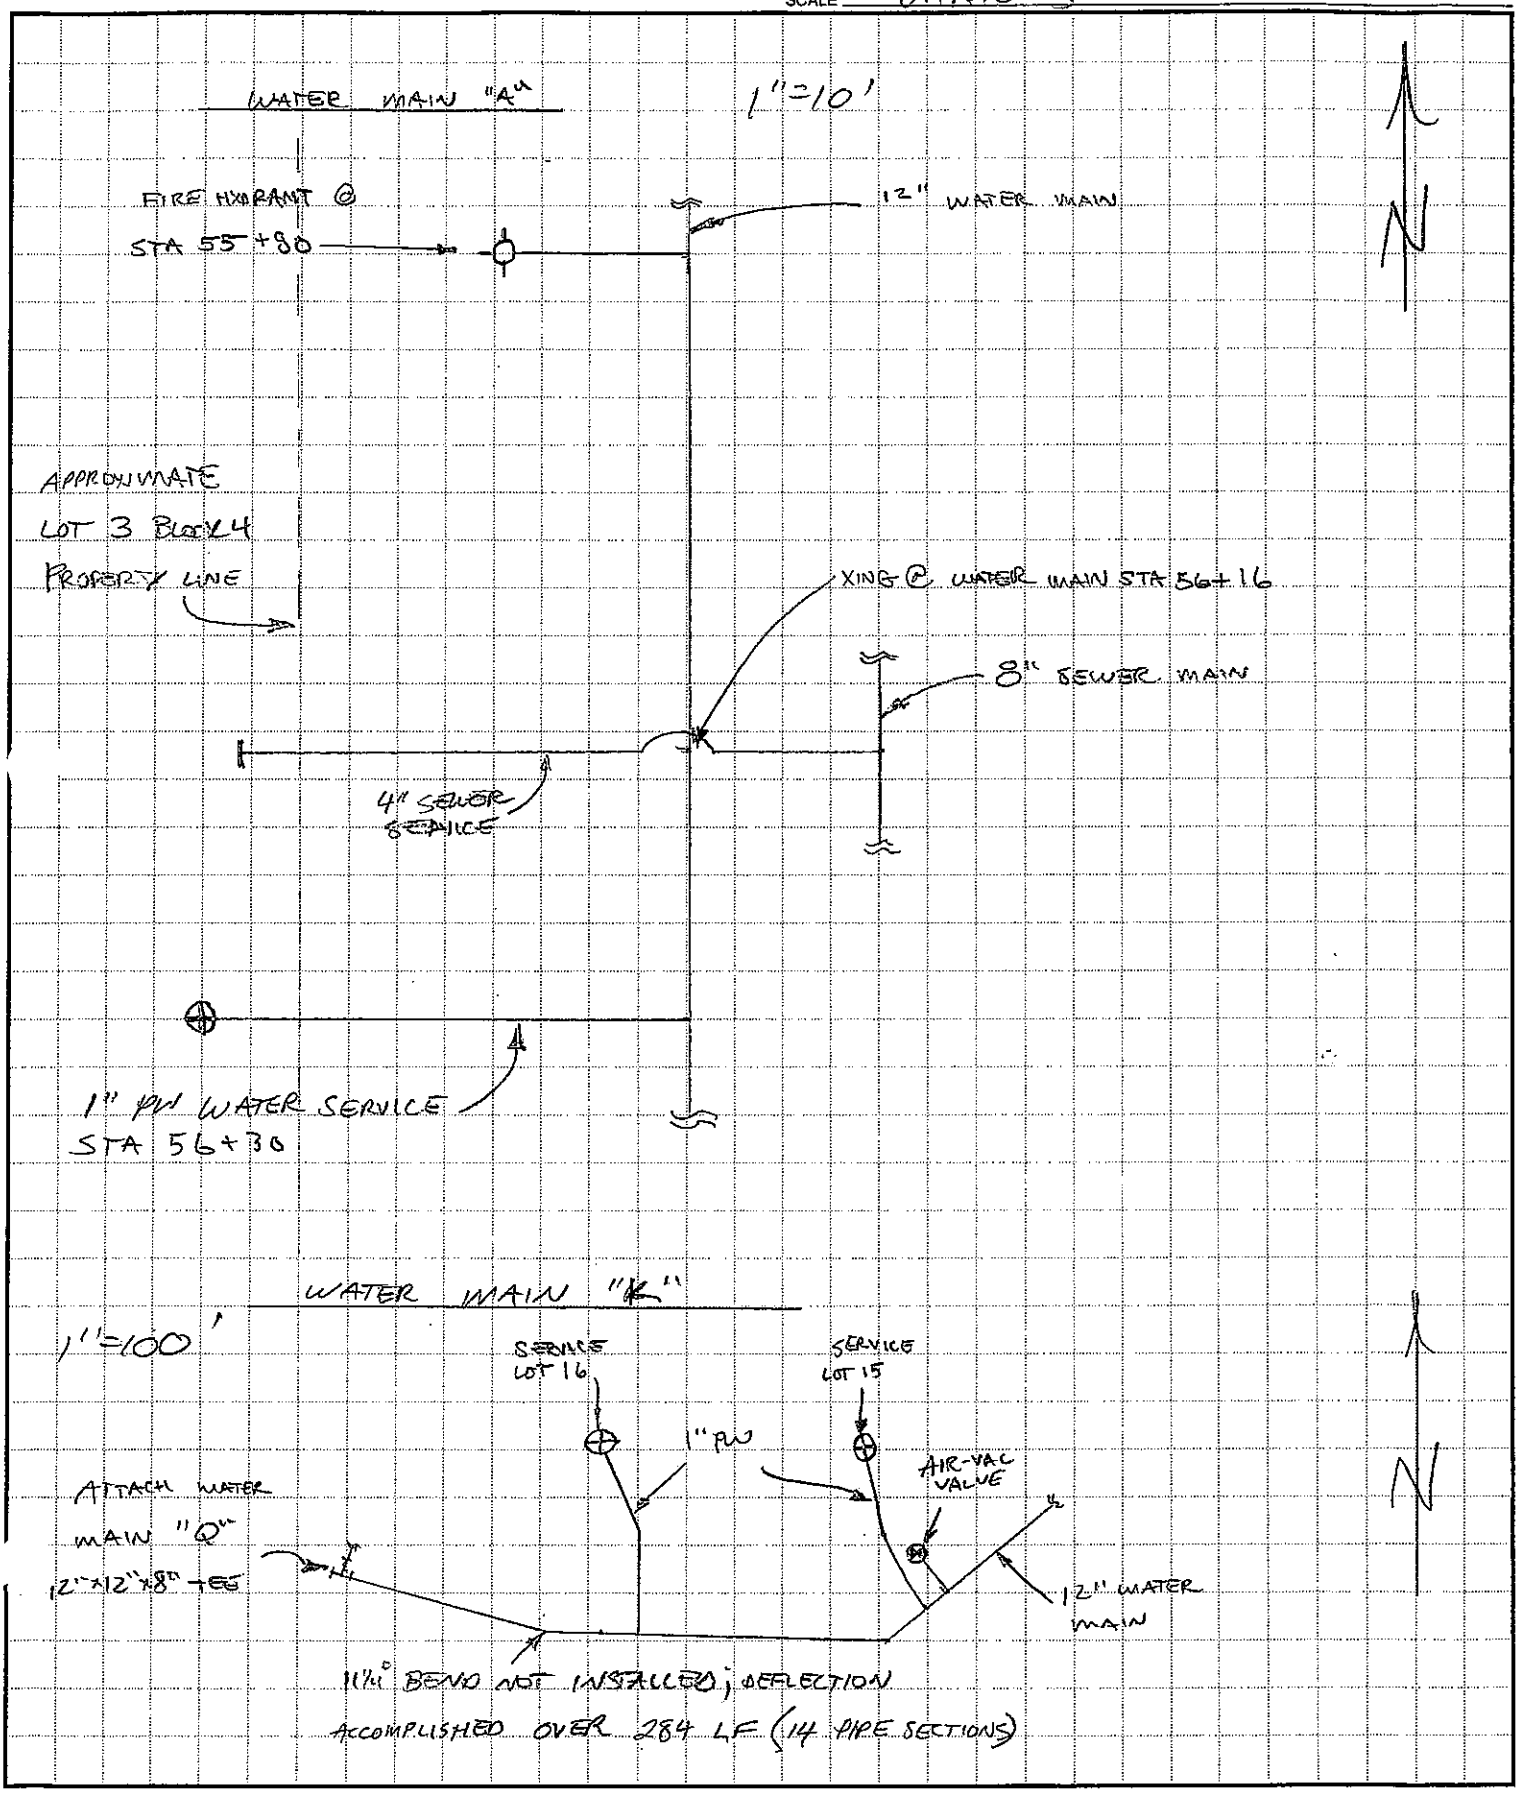
JOB TETON SPRINGS AS-BUILT
SHEET NO. _____ OF _____
CALCULATED BY BDJ DATE 11/12/02
CHECKED BY _____ DATE _____
SCALE VARIOUS

WATER MAIN
CONSTRUCTED 11/27/02

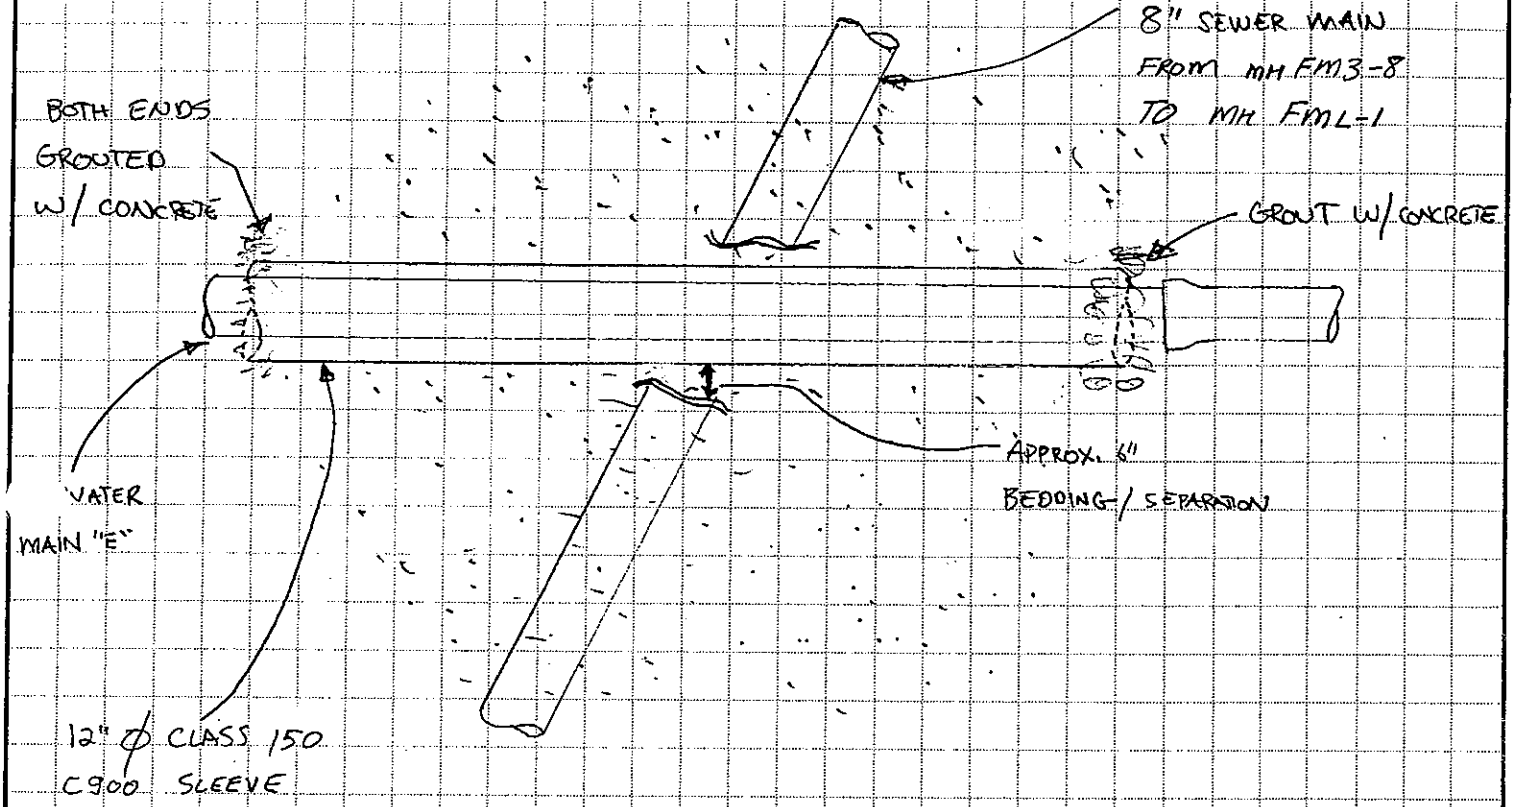
WATER LINE "E" SEWER MAIN XING AS-BUILT

WATER DISTRIBOTION MAIN "E"
8" MAIN W/ 12" SLEEVE (18LF)
AT 8" SEWER MAIN XING STA 49+~~77~~

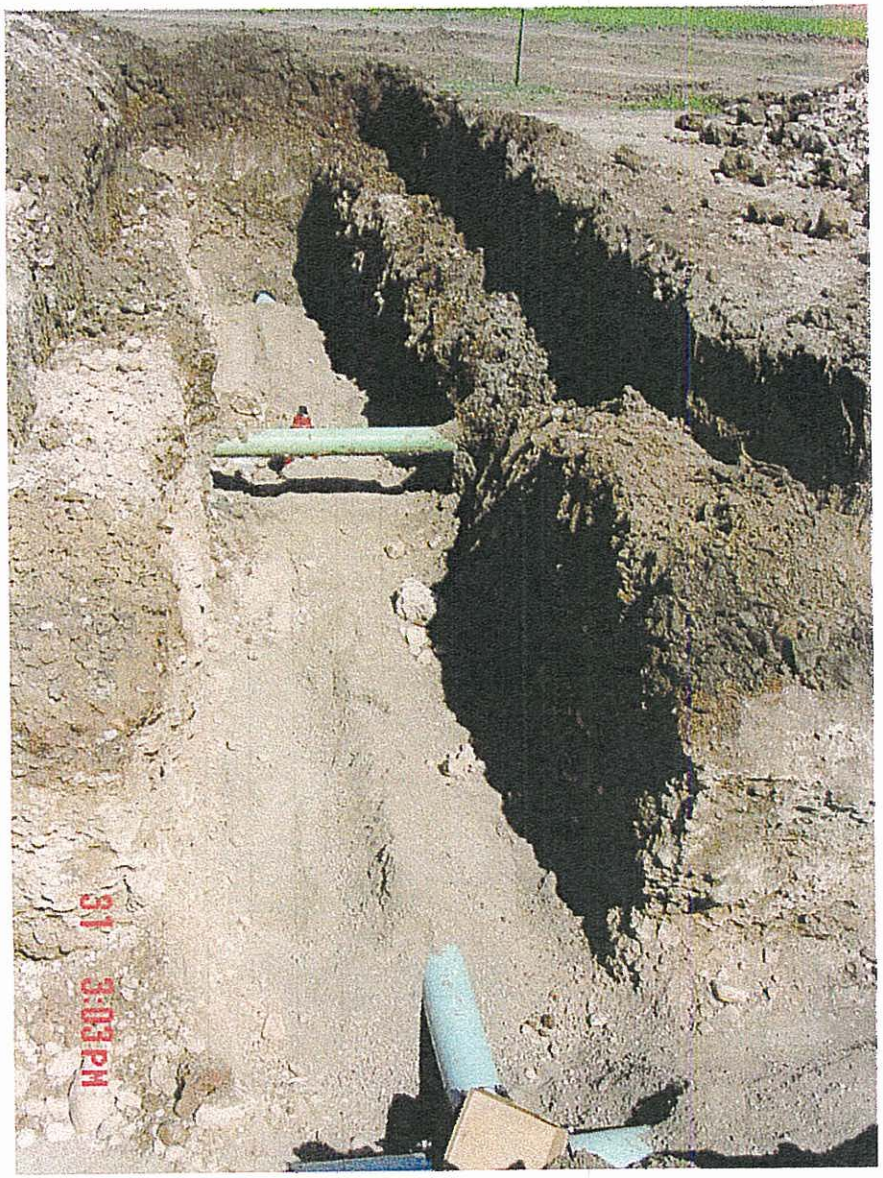
WATER DISTRIBUTION LINE "A"
BARN RIDGE (TARGHEE) TRAIL STA 51+00
8" MAIN CONNECT TO EXISTING LINE BENEATH
(2) 36" Ø CULVERT XINGS

WATER DISTRIBUTION "A"
BARN RIDGE (TARGHEE) TRAIL STA 35+32
8" MAIN WITH 12" SLEEVE FOR 8" SEWER
MAIN XING

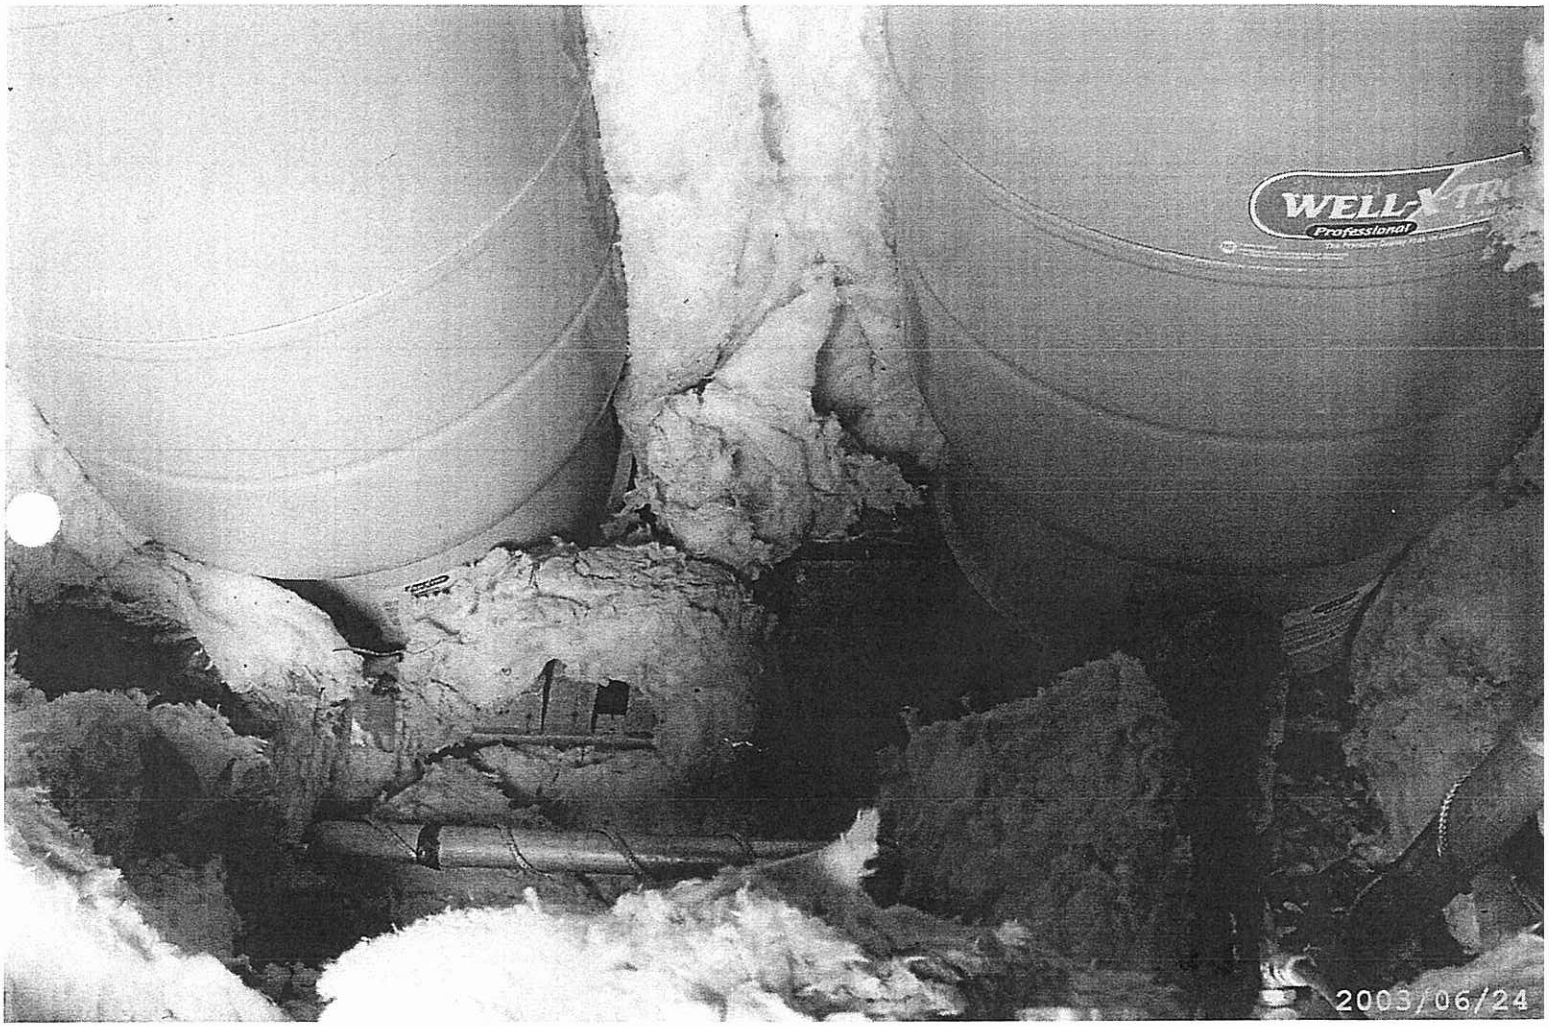
TEMP. TANKS @ WELL #1
