December 2, 2011

**RE: Big Bend Ditch Broad Crested Weir Measurement Device**

Date: November 18, 2011

**RE: Field evaluation of Big Bend Ditch Broad Crested Weir Measurement Device**

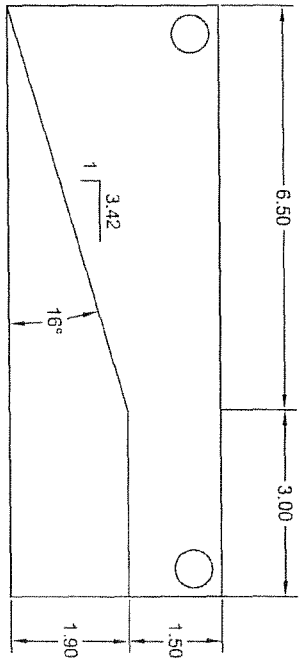
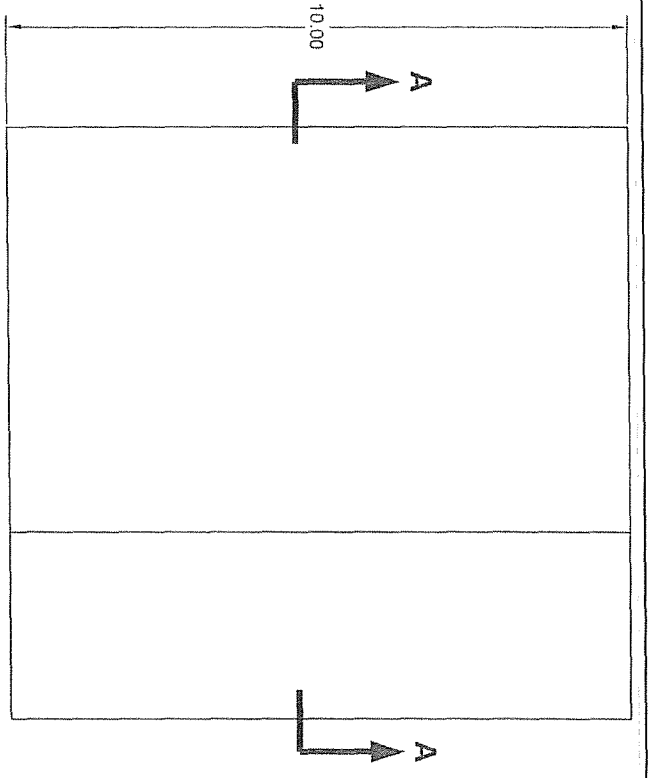
# BIG BEND IRR. DITCH BCW FIELD MEASUREMENTS

In addition, during the site visit we collected field measurements of the as-built conditions of the BCW, which included a width of 10.00 feet, a sill length of 3.00 feet, a sill height of 1.90 feet, and a ramp convergence length of 6.50 feet. Refer to the attached sketch of the BCW and the observed as-built dimensions. The width of the concrete channel upstream of the BCW was measured at 10.50 feet. The following observations were also made which likely affect the accuracy and operability of the device to an unspecified degree.

- Sediment and matted vegetative material with a depth of 3-4 inches observed at toe of weir.
- The high water line indicates high flow water in the channel overtops lateral structural supports.
- Observed gaps between the outside edges of the BCW and the channel walls of ~3-inches.

Based upon the findings of the site visit I analyzed the adequacy of the device for measuring flows using WinFlume32.[1] My analysis indicates that as the BCW was built, there is a fatal flaw in the dimensions of the device that do not allow for the accurate measurement of water in the channel. This is due to the inability of the device to establish critical flow over the sill at flows in excess of 23.2 cfs. Refer to attached 'Summary of Evaluation of Flume Design' for complete analysis summary (2 pages).[2]

- Provide design, or preferably as-built, plans of the existing measurement device.
- Provide a rating curve for the existing measurement device.
- Seal the interstitial space between the edge of the existing measurement device and the existing concrete channel walls, with consideration given to the possible future removal of the device.

- Ensure the device is level and plumb and that the staff gage zero mark is level with the sill.
- Provide wall anchors for the device in the event the Department determines the device is moving within the channel.
- Clear the existing channel of debris, sediment, and vegetative matter upstream of the device, at a minimum distance equal to several feet upstream of the staff gage.

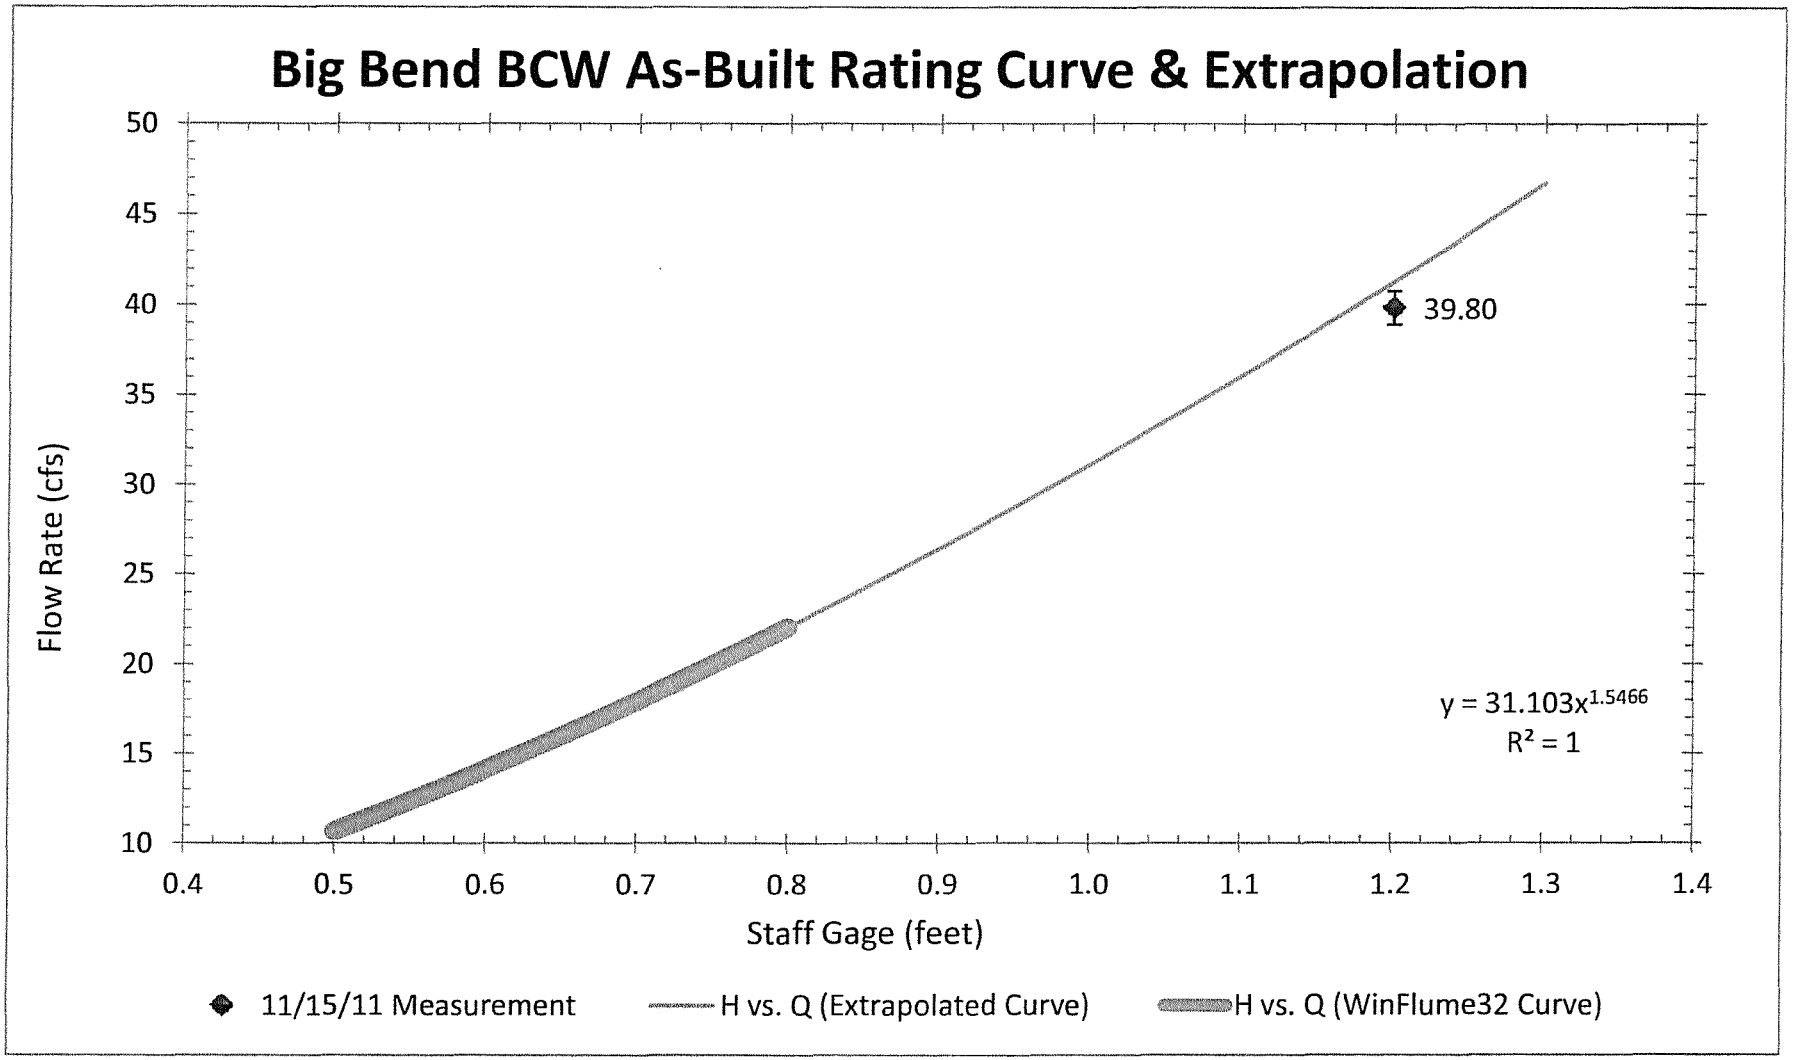
Design is acceptable.

Section shape = RECTANGULAR
Bottom width = 10.000 ft
Sill Height, p1 = 2.900 ft

Assuming a width of 10.00 feet, a ramp convergence length of 7.25 feet, and a sill length of 3.00 feet, a sill height of 2.9 feet would be required to measure the flows observed during the site visit (39.8 cfs) with an accuracy of 10.0% or less. This would result in an upstream water surface elevation of approximately 4.1 feet, which provides a freeboard of approximately -0.1 feet over the existing top of channel wall. Refer to attached 'Summary of Evaluation of Flume Design' for complete analysis summary (2 pages).[3]
