STATE OF IDAHO
DEPARTMENT OF WATER RESOURCES
BENEFICIAL USE FIELD REPORT

Permit No: 63-34168
Exam Date: 08/15/2024

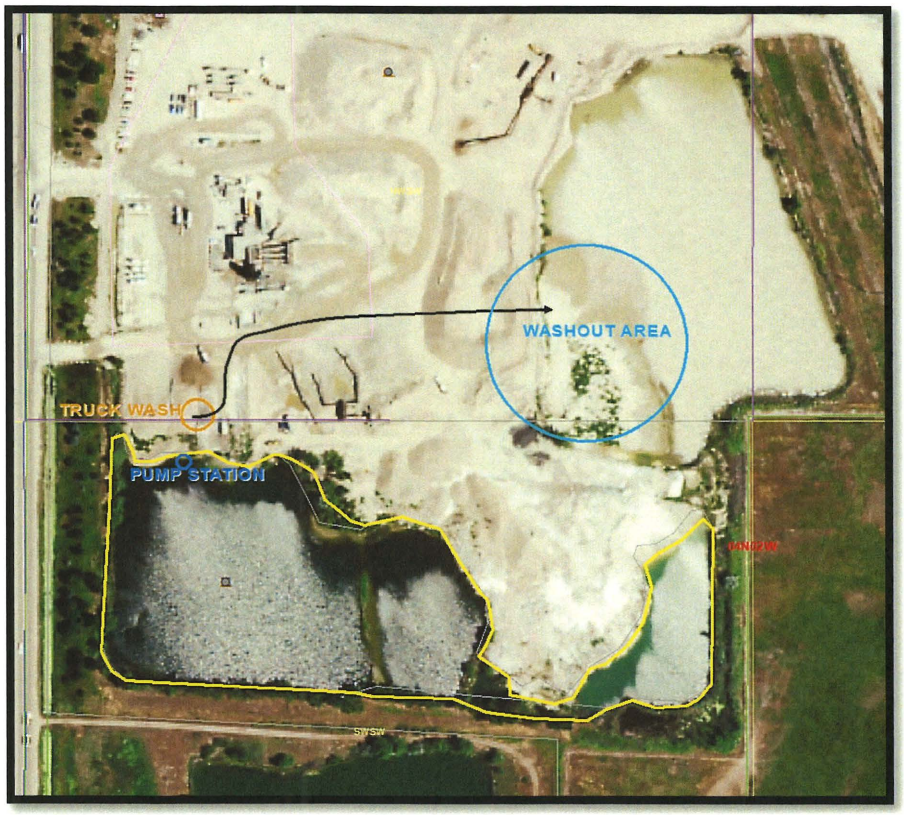
Figures 1a & 1b– System Diagram- 1a. GIS 2017 NAIP Imagery (above) 1b. GIS 2021 NAIP Imagery (below) -Water is diverted via a pontoon pump station with a 25Hp pump that discharges to the elevated filling area.
