# Water Right 29-556

## Willard and Elizabeth Cheirrett

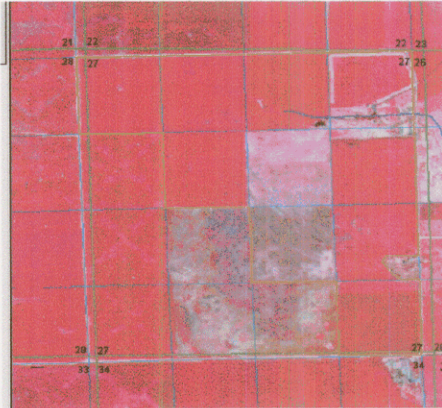
Figure 1. Township 8 south, Range 40 east.

April 13, 2002 I met with Willard and Elizabeth Cheirrett at 10 am for a field examination on their property in the Bancroft-Lund area. Irrigated acreage under this water right is, shown in figure 1 below, located in the NWNW, E1/2NW, NE, NWSE and the E1/2SE all within section 27, township 8 south, range 40 east of the Boise Meridian.
