## FIELD EXAMINATION OF CSRBA WATER RIGHT CLAIM

**Claim Identification Number:** 92-4130, 92-7141, 92-7206, & 92-7212

**Date of Examination:** 5/19/2016 & 5/20/2016

**Examination Location:** 517 Middle Fork Santa Creek Rd, St. Maries, ID 83861

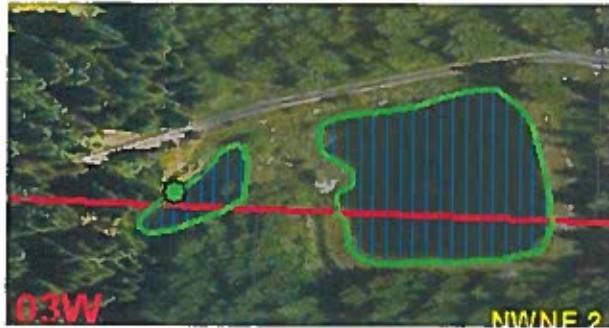
The other 1 seems to be on the smaller of the two ponds to the south. But Field exam notes say that the two southern ponds are "onstream" so there should be a diversion point on each pond if that is the case?

**Question(s):** Should there be a POD on the big pond?  
Where is the natural stream channel?  
Should the POD on the smaller pond be in a different location?

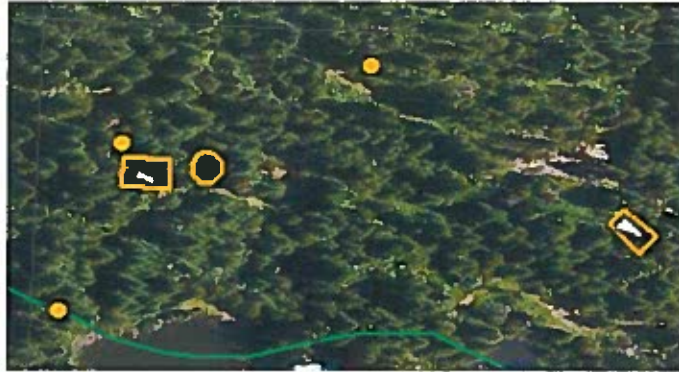
- The attached pic shows a best guess according to the license file, but this is the one we really need to locate where the POD's and POUs are:

Recreation Storage Pond Location: N 47°06.693'  
W 116°41.096'

Currently, the "pond" is empty and contains approximately 8 inches of standing water. There was no clear path to access to the pond and I had to fight through brush to get to it.
