## Panhandle Health District Drinking Water Supply Report

**System:** Conkling Marina & Resort

**Date of Survey:** July 21, 2015

**Conkling Marina & Resort Water System Overview**

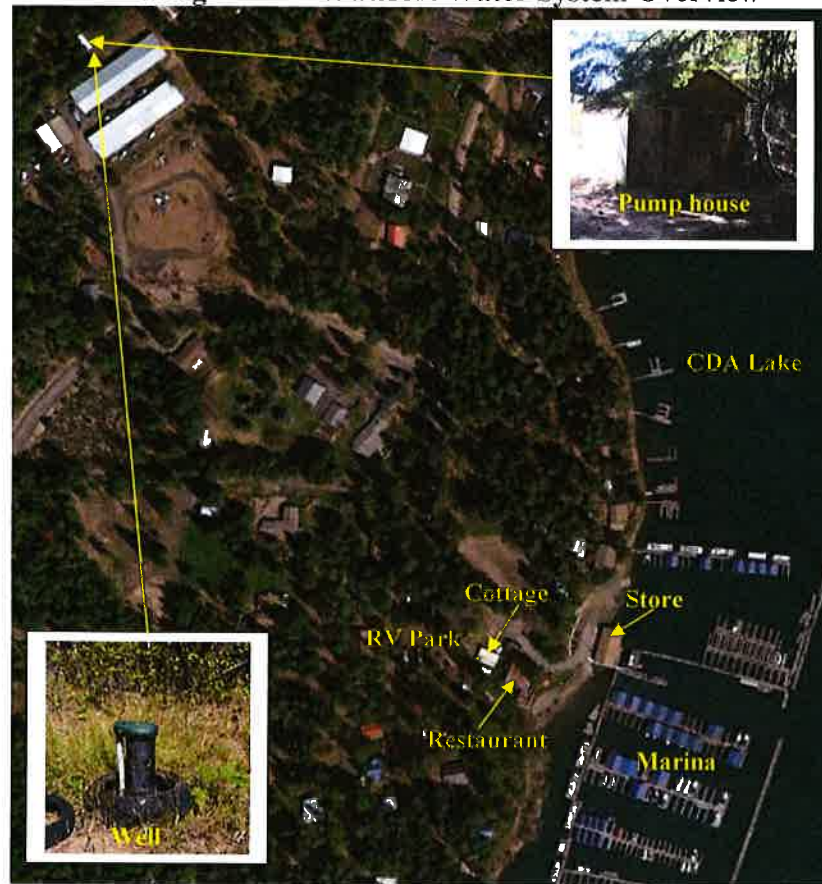
The Conkling Marina and Resort (Resort) water system is a privately owned transient non-community public drinking water system located near the southwest end of Lake Coeur d'Alene in Worley, ID. The drinking water system is supplied by a single groundwater well. Disinfection is provided with contact time in a 10,000 gallon storage tank. Treated water discharges via gravity to the distribution system serving 17 connections (cottage, restaurant, store/marina, and 14 RV hookups).
